# OHIO HISTORIC INVENTORY

1. No. ERI-1553		4. Present Name(s) O'Toole's Cottage		1. No. ERI-1553	
2. County ERIE		5. Other Name(s) Henry Lang House			2. County Erie
3. Location of Negatives C.H.S.

6. Specific Location South side of Chapel St., first house west of Addison		16. Thematic Category Ethnic, Agricult.,		4. Present Name(s) O'Toole's	
7. City or Town If Rural, Township & Vicinity Kelleys Island, Ohio		17. Date(s) or Period c. 1860

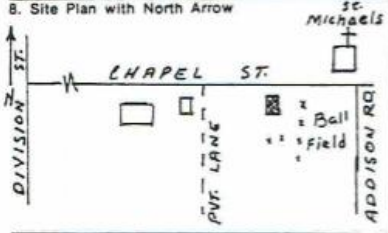
8. Site Plan with North Arrow

22. Description of Environment and Outbuildings The house sits close to the sidewalk. There is a public playfield and ball diamond to the east.		23. Endangered? By What? Yes <input type="checkbox"/> No <input checked="" type="checkbox"/>		39. Endangered? By What? Yes <input type="checkbox"/> No <input checked="" type="checkbox"/>
