March 13, 2014 - Tennis Committee Report

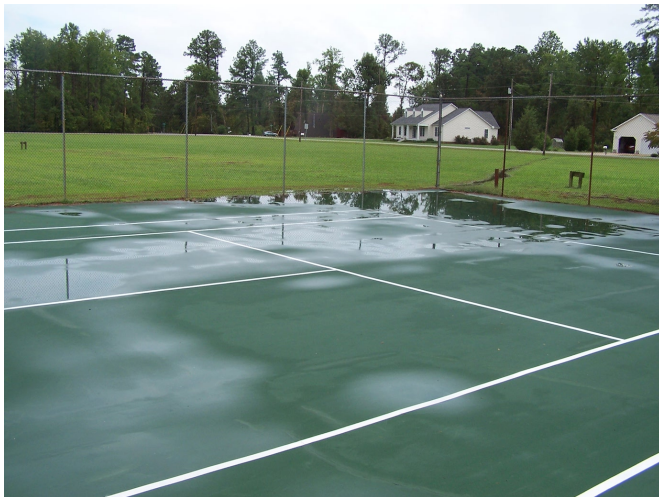
CBTB tennis court #1, closest to the gate has the same asphalt that was put on the court in 1970 when it was constructed. The old asphalt is now thin, has large and long cracks, the cracks go down to the ground so it can't be patched. Stick a knife down the cracks and you will see. The patching that was done didn't work and now the tennis court has uneven bumps and cracks on the court. When water from the pool is drained out in the fields, the water flows under the tennis court and causes cracks to appear on the surface. This court is now closed as it is too dangerous to play on. The tennis net was taken down. A sign was posted on the tennis fence. This tennis court has to be reconstructed and raised so it is higher than the surrounding area.

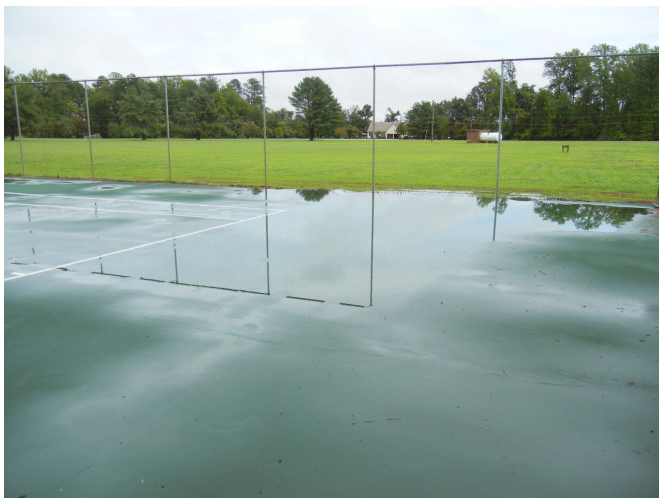
Tennis court #2, away from the gate. It was resurfaced in 2008. Underground water and surface water draining in from the surrounding land after rain and storms have caused cracks to appear on the tennis court surface. The asphalt is also bubbling up in areas which is dangerous to the tennis players. This tennis court also has to be raised and resurfaced.
