# OHIO HISTORIC INVENTORY

1. ERI-1746		4. Present Name(s) "The Big House"		ERI-1746
2. County ERIE		5. Other Name(s) George Becker Farm		
3. Location of Negatives O.H.S.				
6. Specific Location North side of Woodford Rd., east of the State Park Land and 2200 ft. west of Monoga		16. Thematic Category Ethnic, agriculture	28. No. of Stories 2	"The Big House"

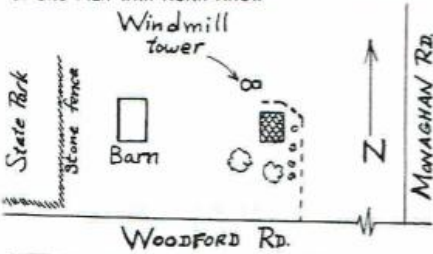
8. Site Plan with North Arrow

44. Description of Environment and Outbuildings The house sits far back from the road shaded by mature trees. A gravel drive on the east edge of the property leads to the back of the house. The tower of a windmill stands to thenorth west of the house with a small gable roofed board & batten shed at its base. Cedars and apple trees line the		40. Visible from Public Road? Yes <input checked="" type="checkbox"/> No <input type="checkbox"/>

44 western edge of the drive. The large dairy barn stands in an open but overgrown field 200 ft. west. A stone wall (ERI-1670) lies west of the barn, perpendicular to the road, and separates the pasture from the adjacent property.
