OHIO HISTORIC INVENTORY

1. ERI-1747		4. Present Name(s) Peg's Place		ERI-1747
2. County ERIE		5. Other Name(s) Henry Trieschman, Jr.'s House		
3. Location of Negatives O.H.S.

6. Specific Location South side of Woodford Rd. 2000 ft. west of its inter- sect with Monaghan Rd.		16. Thematic Category Commerce		Erie
7. City or Town If Rural, Township & Vicinity Kelleys Island		17. Date(s) or Period c. 1894

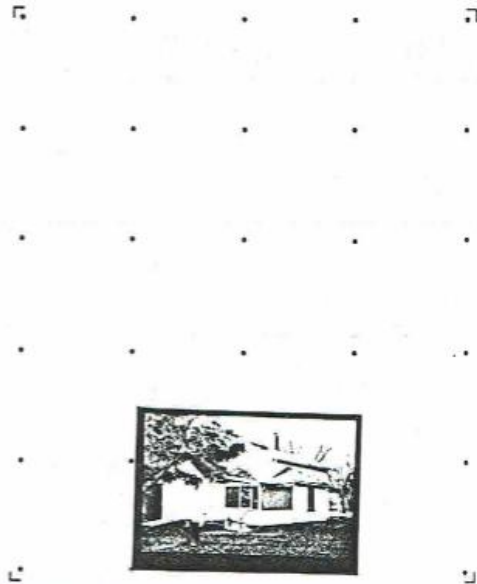
54. Photo 5 12
 Roll No. 32 Picture No(s). 32

36. Changes (Explain in #42) Addition <input checked="" type="checkbox"/> Altered <input type="checkbox"/> Moved <input type="checkbox"/>		37. Condition Interior _____ Exterior Good

42. Further Description of Important Features (Continue on reverse if necessary) This front-gabled house has a central brick chimney and a single-story, hipped bay on the eave wall. Fenestration is a mix of 6/6 windows in the gable and unequal-sash windows in the bay and flanking the door. The hipped front prch is set upon turned columns and sawn balustrades; the entrance is focused under a small gable.
