# Property Inspection Report

**Property Address:**  
65 West 1st Street  
Inspectionville NJ 76666

**Terra Home Inspections LLC**

<b>Date:</b> 9/16/2015	<b>Time:</b> 10:00am	<b>Report ID:</b> 20150288
<b>Property:</b> 65 West 1st Street Inspectionville NJ 76666	<b>Customer:</b> Tony Inspection	<b>Real Estate Professional:</b> Sally Realtor

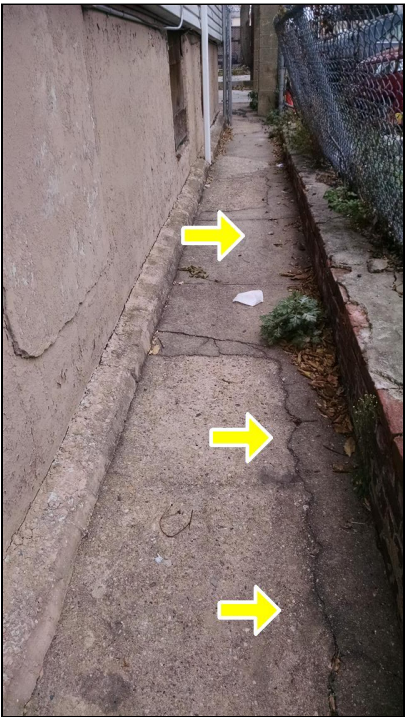
1.1 Item 2(Picture)

1.1 The front sidewalk as well as the front and right side walkways all have numerous cracks present. If the walkways and sidewalk are not repaired, further deterioration could occur. Recommend further evaluation for repairs by a qualified, licensed contractor.

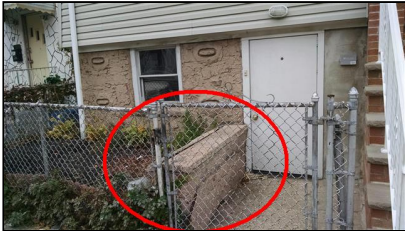
1.4 Item 2(Picture)

1.4 The front masonry retaining wall is extremely deteriorated. If not repaired, further deterioration of the retaining wall could occur. Recommend further evaluation for repairs by a qualified, licensed contractor.

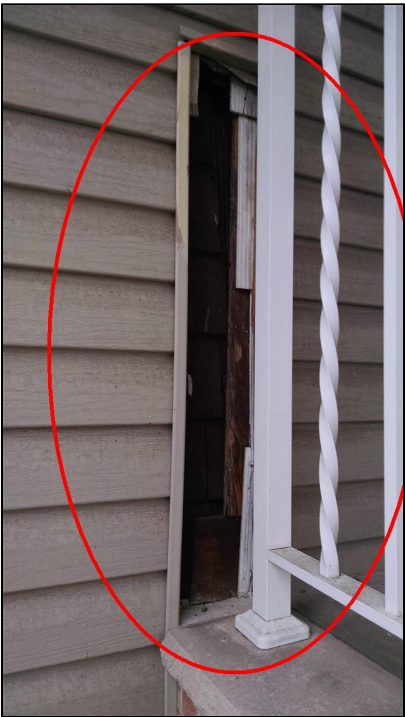
2.0 Item 2(Picture)

**2.0** There were numerous small sections of vinyl siding that appeared to be damaged or missing on the front, right side and rear of the house. Further damage to the siding and deterioration of the structure behind the siding could occur if the needed repairs are not completed. In addition, in the rear where the vinyl siding is missing, you can see what appeared to be 3 different types of exterior cladding that was installed on the house over the years. The middle exterior cladding material is called fiber cement siding may contain asbestos fibers. Asbestos cement is a composite material consisting of Portland cement reinforced with asbestos fibers. Asbestos fiber cement siding has been known to have been used on homes built from the 1920's until the early 1970's. In 1973, the EPA banned the use of asbestos in the manufacturing of building products. Asbestos materials are considered safe by the EPA if they are not disturbed, torn, ripped, or damaged. No torn, ripped, or damaged fiber cement siding materials were observed. All of the suspect fiber cement siding except where it is visible in the rear and in the rear basement stairwell appears to be covered up by the vinyl siding that is on the house currently. Recommend further evaluation of all of the exterior siding on the house for repairs by a qualified, licensed contractor. If client has any concerns regarding asbestos materials, an asbestos testing lab should be consulted for further review to ensure safety prior to closing.

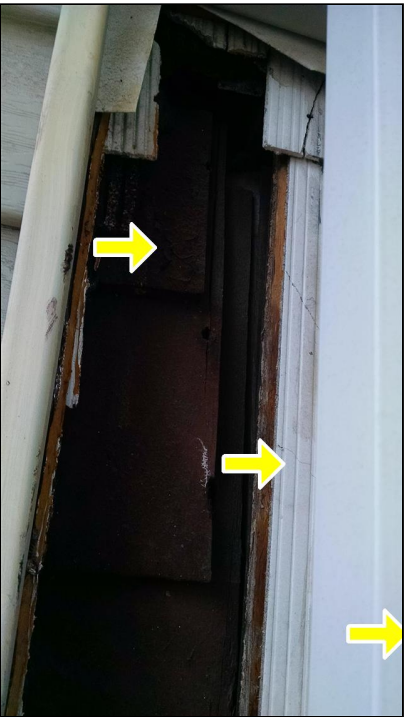
2.0 Item 3(Picture) 3 layers of siding

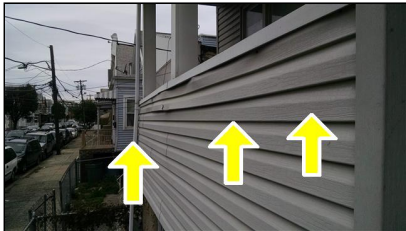
2.0 Item 4(Picture) Vinyl siding buckling on front porch

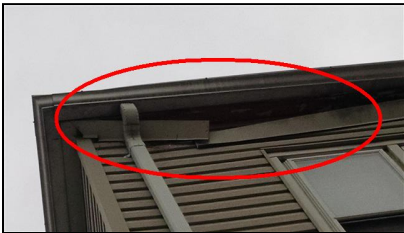
2.2 Item 1(Picture)

2.2 (1) There was a piece of aluminum soffit trim on the front of th house that was damaged. Recommend further evaluation for repairs by a licensed contractor.

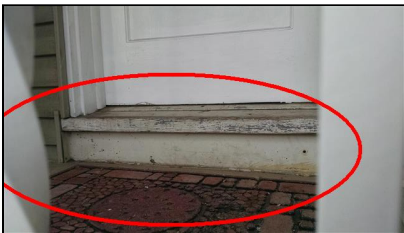
2.2 Item 3(Picture)

2.2 (2) The paint on numerous areas of the wood trim on the exterior of the house (doors, windows, etc.) as well as the some of the door jambs was peeling leaving the wood exposed to the elements. If not repaired, moisture damage and wood rot could occur. Recommend further evaluation of all of these areas for repairs by a qualified, licensed contractor.

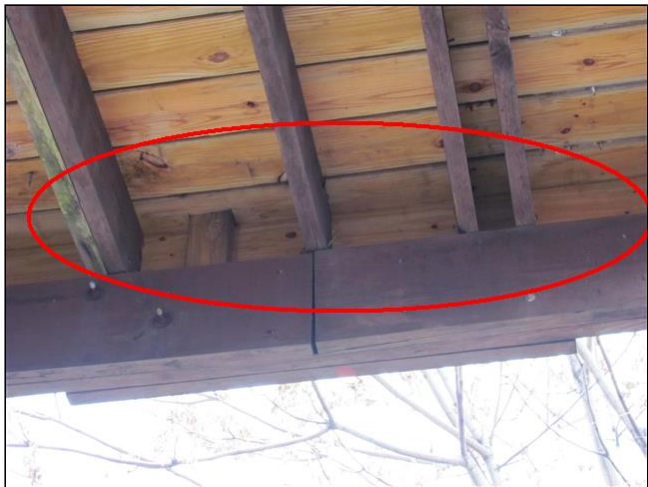
2.8 Item 2(Picture)

2.8 Numerous issues were observed pertaining to the rear deck...to name a few- 1) there are no support post to footing mechanical connectors 2) there are no support post to beam mechanical connectors 3) there are no beam to joist mechanical connectors 4) the entire guardrail assembly is extremely loose, not properly mechanically attached to the primary structure of the house and deck and is just overall poorly built 5) the main vertical support posts are made up of 3 framing member lag bolted together (these should be solid 6"x6" posts) 6) the two support posts on the right are not plum and are leaning 7) there are no lag bolts attaching the ledger boards to the primary structure of the house 8) no portion of a deck should be attached to any cantilevered portion of the house 9) there were two splices in the main support beams that did not have any support posts under them (any splices should have a support post underneath it). These are all safety and structural issues and with the guardrail being so loose, I would recommend not using this deck until the entire deck is further evaluated by a qualified, licensed contractor and the needed repairs are completed.

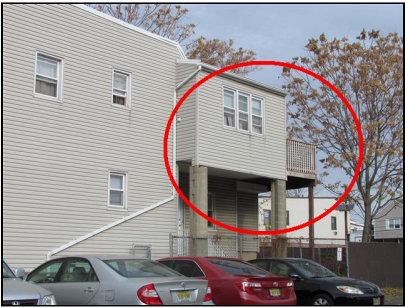
2.8 Item 13(Picture) Deck attached to cantilevered portion of the house

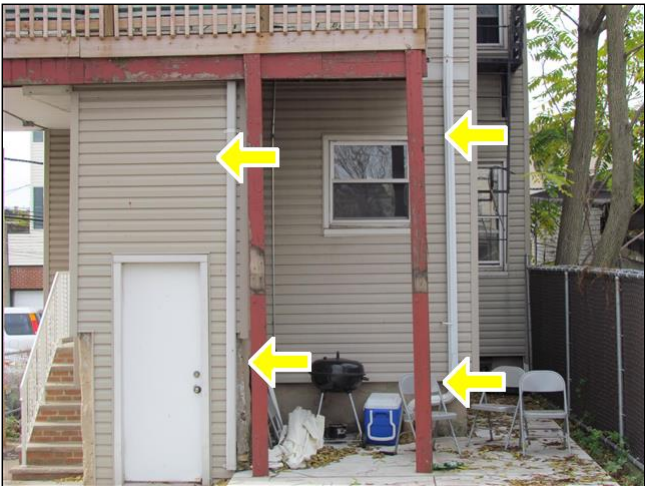
2.8 Item 15(Picture) Support posts leaning to the left

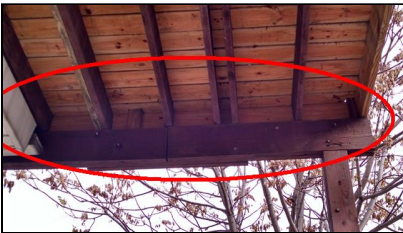
2.8 Item 18(Picture) No joist hangers

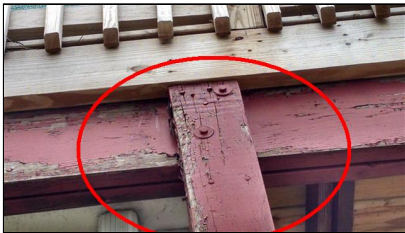
2.8 Item 19(Picture) No mechanical connectors

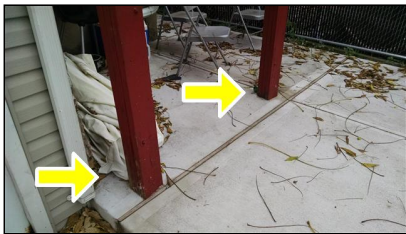
2.8 Item 20(Picture) No mechanical connectors

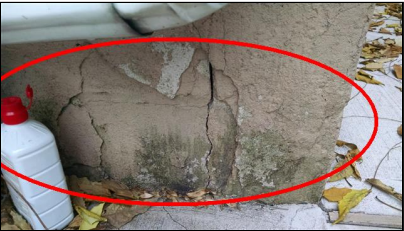
4.0 (1) Observed on the interior and exterior masonry foundation wall surfaces, there were several vertical cracks visible and the paint was peeling off of these surfaces in numerous areas. In addition, the parging on several areas of the interior and exterior foundation walls was cracked/missing/flaking off, portions of the basement concrete floor were cracked and portions of the brick foundation in the rear was deteriorated. Further deterioration of the foundation could occur if the needed repairs are not completed. Recommend further evaluation of the entire foundation (interior and exterior) for repairs by a qualified, licensed contractor.

4.0 Item 6(Picture) Parging cracked in rear

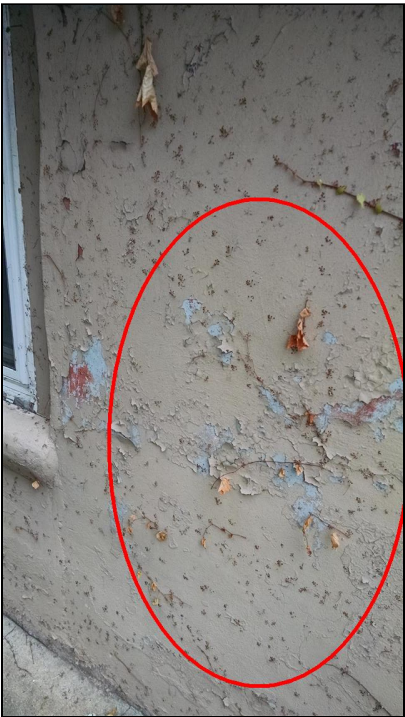
4.0 Item 8(Picture) Peeling paint left side

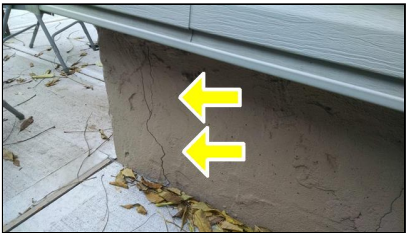
4.0 Item 9(Picture) Cracks in rear

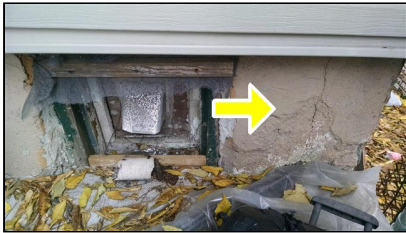
4.0 Item 10(Picture) Cracks in rear

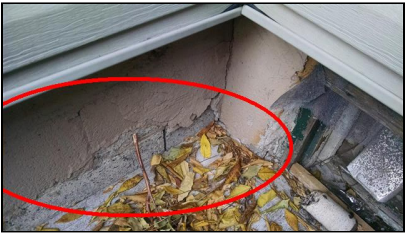
4.0 Item 11(Picture) Parging deteriorated in rear

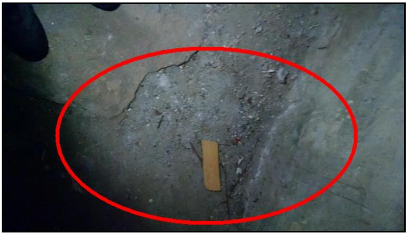
4.0 Item 12(Picture) Cracks in basement floor

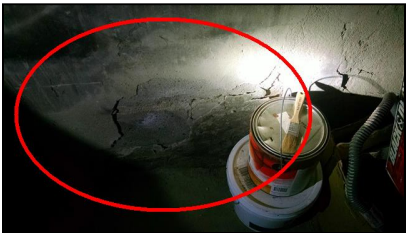
4.0 Item 14(Picture) Interior basement wall

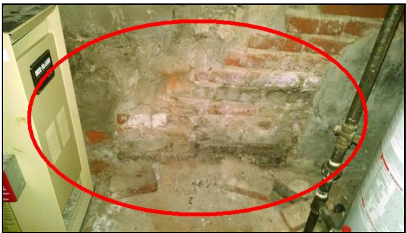
4.0 Item 15(Picture) Brick foundation wall in rear deteriorated- bricks laying on floor

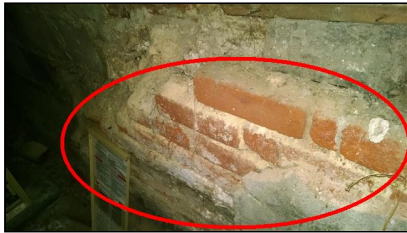
4.0 Item 16(Picture) Brick foundation in rear deteriorated

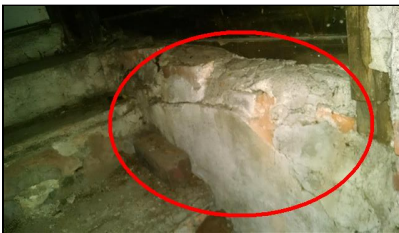
4.0 Item 21(Picture)

**4.0 (2)** The masonry staircase in the rear of the basement for the exterior rear door is severely deteriorated. Further deterioration of this staircase could occur if the needed repairs are not completed as well as this being a safety issue. Recommend further evaluation of the entire foundation (interior and exterior) for repairs by a qualified, licensed contractor.

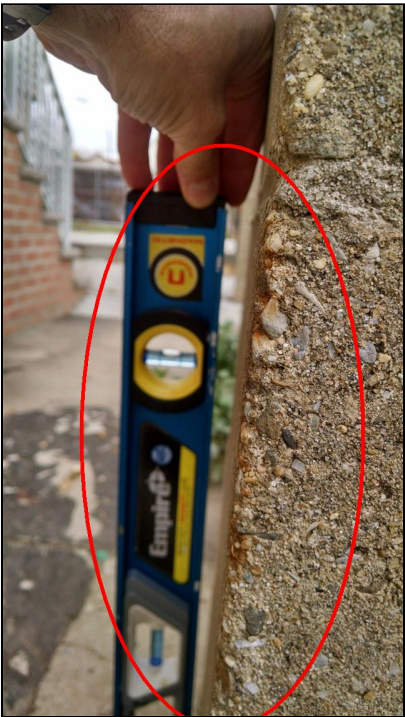
**4.1** The front masonry support column supporting the cantilevered portion of the 2nd floor in the rear has a slight bow in the middle of it. Portions of it are not plumb and there is a crack in the mortar joint between the 4th and 5th blocks at the bottom. This is a safety concern as there may be some structural issues within the house that are causing the column to bow. In addition, just to bring this to your attention, there is no protection in place for these columns from the cars parking in the parking lot on the property to the right of the house. Due to the fire damaged structure that is still in place, the sloping floors and this issue, I would recommend further evaluation of the entire structure of the house for repairs by a qualified, licensed structural engineer.

4.1 Item 2(Picture) Bottom of column not plumb

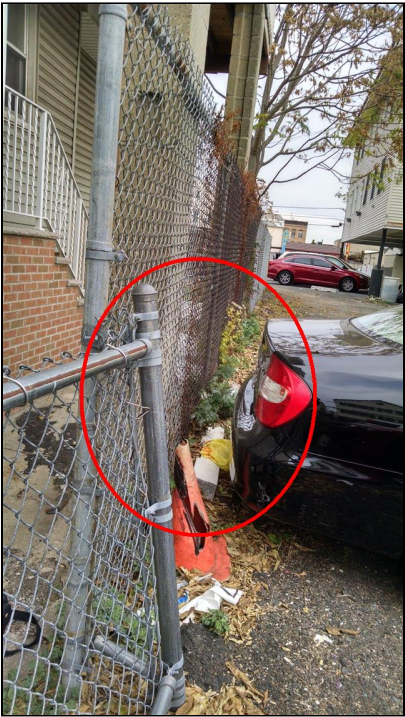
4.1 Item 5(Picture) Columns have no protection from cars parking in the parking lot on the right side of the house

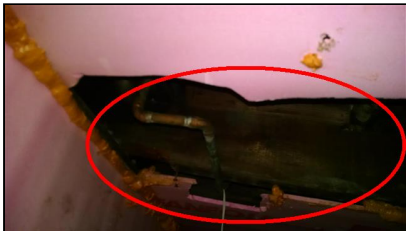
**4.5** (1) There appeared to have been a fire in the basement at one time. There was numerous areas of the 1st floor wood structure (the sections that weren't covered up with drywall in the basement), basement stairs and walls and other areas of the basement that were charred/fire damaged. Also, as viewed from the inside of the 1st floor bathroom, there were sections of the right side exterior wall above the drop ceiling that were charred. Since most of the basement ceiling is covered with drywall as well as the 1st floor living space and the rest of the house, the extent of the fire damage to the structural framing members could not be determined. All this charred wood is a concern, as the fire may have compromised the structural integrity of the structural framing members and the foundation that is still in place. Recommend further evaluation of these areas by a qualified, licensed contractor.

4.5 Item 1(Picture) Charred wood-1st floor bathroom

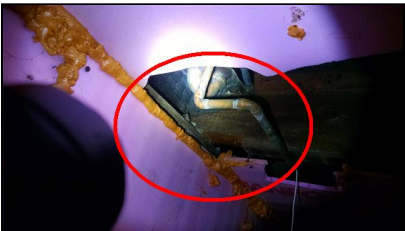
4.5 Item 2(Picture) Charred wood-1st floor bathroom

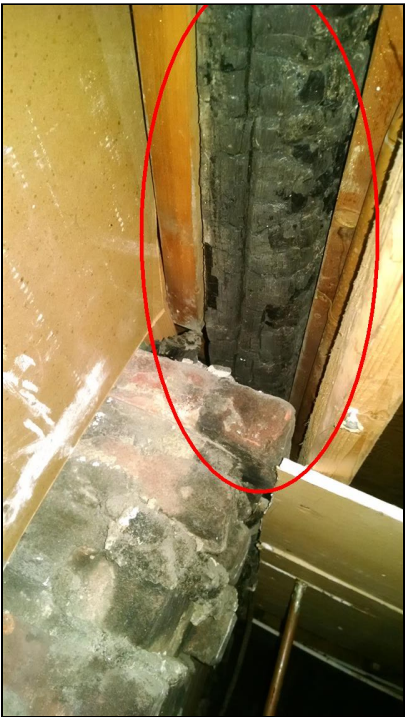
4.5 Item 8(Picture) Main beam in basement

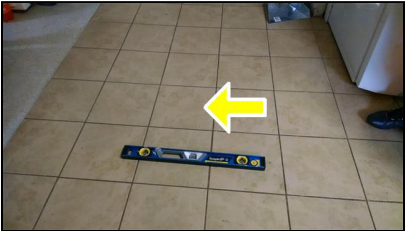
4.5 (2) There were numerous rooms in the house that had noticeable sloping floors present. The areas of concern are as follows- 1) the 2nd floor kitchen floor was sloped downward left to right 2) the 2nd floor hallway floor was sloped downward from the rear to the front 3) the 1st floor kitchen floor was sloped downward from the rear to the front and it had a noticeable hump in it on the left side 4) the 1st floor front bedroom floor was sloped downward from right to left 5) the 1st floor living room floor was sloped downward from the front to the rear. Due to the fire damaged structure that is still in place, the exterior masonry column issues and this issue, I would recommend further evaluation of the entire structure of the house for repairs by a qualified, licensed structural engineer.

4.5 Item 11(Picture) 2nd floor kitchen

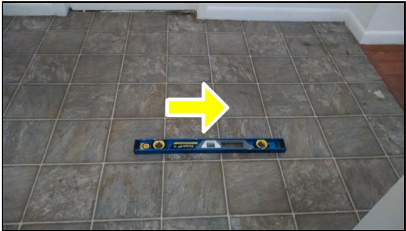
4.5 Item 12(Picture) 1st floor kitchen

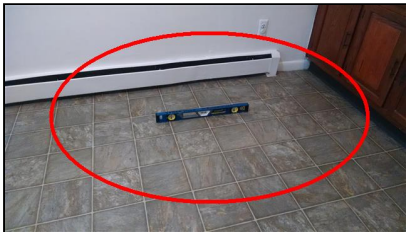
4.5 Item 13(Picture) Hump in 1st floor kitchen floor

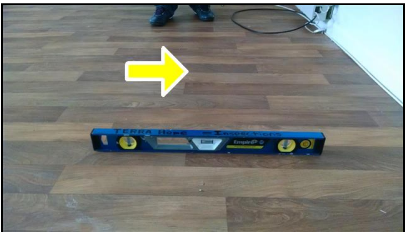
4.5 Item 14(Picture) 1st floor living room

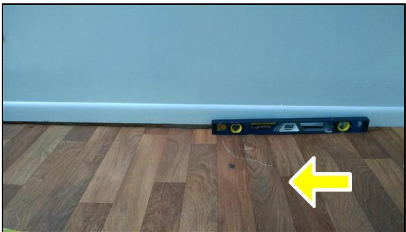
4.5 Item 15(Picture) 1st floor front bedroom

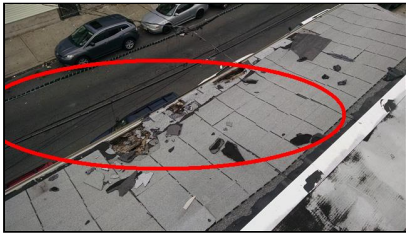
5.0 Item 1(Picture)

5.0 Observed on the flat roof in the rear of the house, the rolled asphalt roofing membrane had several blisters present. Blisters are typically created by voids resulting from improper adhesion during the application of the roofing membrane. If these blisters or the seams open up, water could enter the structure below. In addition, there were large holes in the shingle roof covering and decking on the front of the house. These open holes are letting water into the living space below potentially causing water damage. Recommend further evaluation of the entire roof by a qualified, licensed roofing contractor and repaired as needed.

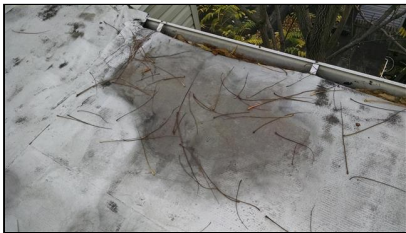
5.0 Item 4(Picture) Ponding water on flat roof

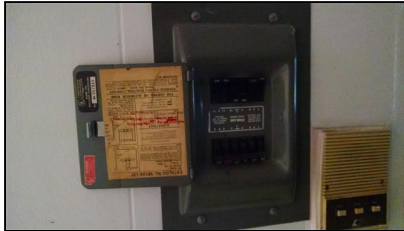
7.4 There were two Federal Pacific Electric Stab-Lok electric sub panels present in the 1st and 2nd floor apartments (one in each apartment) which is a safety concern. There are studies that show that some FPE circuit breakers are prone to problems that can lead to failures, lack of proper protection of circuits and other serious issues, including fire and electrocution. Due to the other electrical related issues observed in the house, I would recommend further evaluation of these sub panels as well as the entire electrical system by a qualified, licensed electrician. Additional information pertaining to these electric panels can be found at <http://www.ismypanelsafe.com/fpe.aspx> and [http://inspectapedia.com/fpe/FPE\\_Stab\\_Lok\\_Hazards.htm](http://inspectapedia.com/fpe/FPE_Stab_Lok_Hazards.htm).

7.4 Item 1(Picture) 2nd floor  
Federal Pacific sub panel

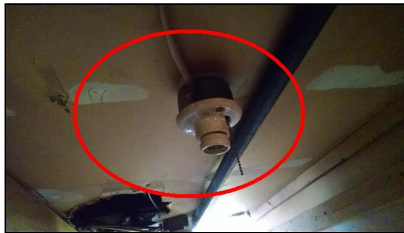
7.8 Item 1(Picture)

**7.8** Observed in the basement, there were numerous light fixtures that were not functioning and there was an outlet in which the front cover was loose. These are safety issues. Recommend further evaluation for repairs by a licensed contractor.

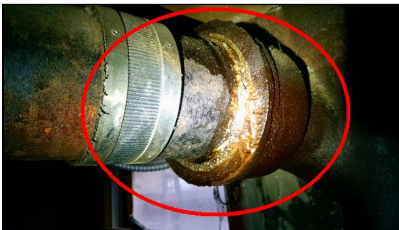
8.2 Item 1(Picture)

**8.2** The main cast iron DWV piping in the basement appeared to be leaking. This leak could allow sewer waste to drip onto the basement floor which is a health hazard. Recommend further evaluation for repairs by a licensed plumber.

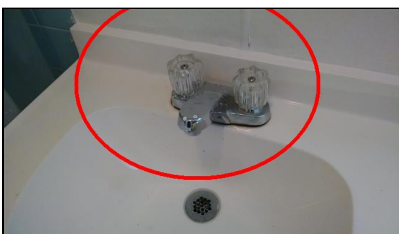
8.3 Item 1(Picture)

**8.3** The faucet on the 1st floor bathroom sink was not functioning properly. Turning it either way would turn the water on. Recommend further evaluation for repairs by a qualified, licensed plumber.

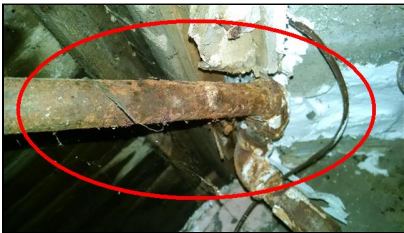
8.7 Item 1(Picture)

8.7 A small section of the gas supply piping on the top of one of the gas meters located in the front of the basement was extremely rusted. It is unknown how much of the sidewall of the pipe is rusted and it may be compromised. For safety purposes, I would recommend a further evaluation by a qualified, licensed plumber.

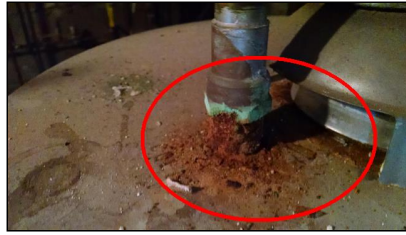
9.0 Item 2(Picture)

**9.0** (2) The water supply piping at the top of the water heater ending is serial #8103 was extremely rusted and deteriorated. This condition could result in water damage and/or a flooded basement. Recommend further evaluation of the entire water heater for repairs by a qualified, licensed plumber.

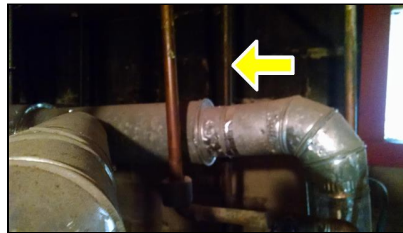
**9.1** The vent connectors on both of the water heaters are not properly screwed to the draft hoods on the top of the water heaters and are sloped downward. This is a safety issue as carbon monoxide could leak out and enter the basement space if the vent connector were to get knocked off the draft hood. In addition, the vent connectors appeared to be oversized for the draft hoods. They are not the proper size to fit on the top of the draft hoods. Recommend further evaluation for repairs by a qualified, licensed plumber.

9.1 Item 2(Picture) Vent sloped downward

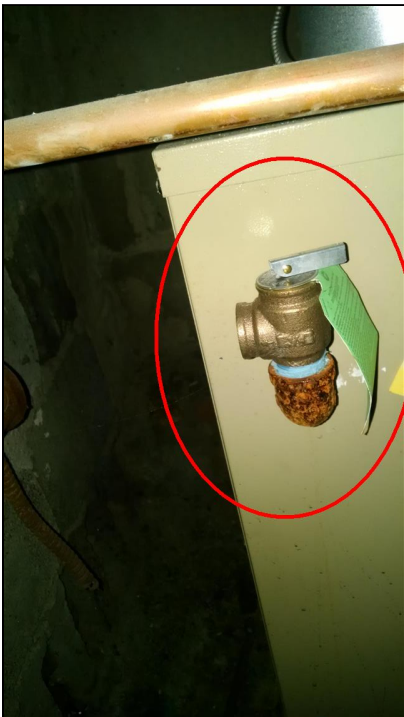
10.0 Item 2(Picture)

10.0 There was no discharge piping on the TPR (temperature pressure relief) valves on either of the two Weil-McLain boilers present in the basement. Proper discharge pipes are needed and should be within 6 inches from the basement floor. This is a safety issue as a person in the vicinity boilers could get scalded should a discharge situation occur. Recommend further evaluation for repairs by a qualified, licensed plumber.

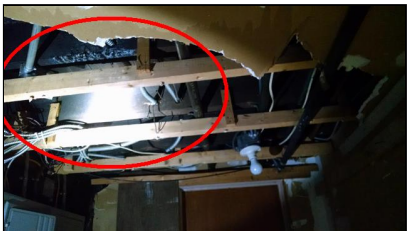
10.0 Item 3(Picture) Charred floor joists in front of basement

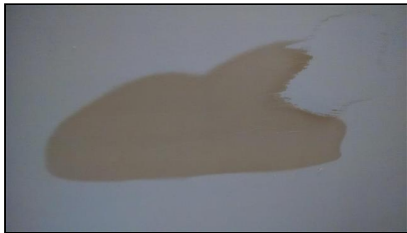
12.1 Item 1(Picture)

12.1 (1) Evidence of previous moisture intrusion was observed in the rear 2nd floor bedroom on the ceiling and rear wall. This area appeared to be dry at the time of the inspection. Consult with the owner/occupant to ascertain if any previous repairs were performed to rectify this situation and provide documentation if any is available. If this cannot be done or if this condition is still a concern to you, I would recommend a further evaluation be done by a qualified, licensed contractor.

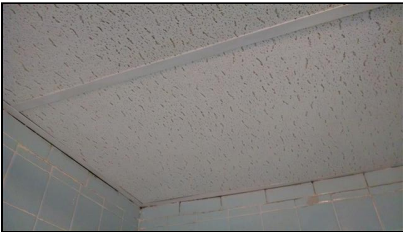
12.1 (4) There was a drop ceiling present in the 1st floor bathroom which covered the entire ceiling. This is an issue as the metal framing could rusted due to the moisture while taking a shower and also moisture could get trapped in the space above the drop ceiling and the 2nd floor subfloor. Mold could possibly form on the ceiling tiles as well as the space above the drop ceiling. There was no exhaust fan present in this bathroom. Recommend further evaluation for repairs by a qualified, licensed contractor.

12.1 Item 7(Picture) Drop ceiling in bathroom

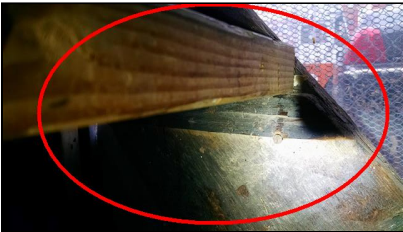
12.5 There were numerous issues observed pertaining to the basement staircase- 1) some of the wood structure was charred from a previous fire 2) the supporting wood supporting the stair treads was inadequate 3) the handrail was mounted too low and was missing the required balusters 4) the risers were opened and should be boxed in 5) the staircase itself was very narrow. These are safety issues and for safety, the needed repairs should be completed. Recommend further evaluation by a licensed contractor.

12.5 Item 2(Picture) Fire charred wood supporting stair treads

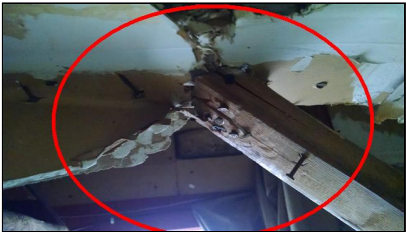
12.5 Item 3(Picture) Handrail loose and too low

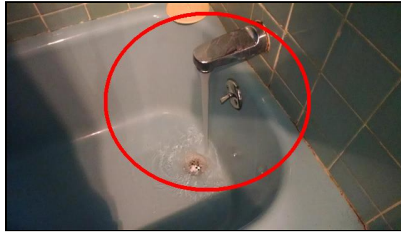
13.3 Item 1(Picture)

**13.3** The mechanical integrated tub stopper in the 2nd floor bathroom bathtub is inoperable. You will not have the ability to fill up the tub if you desired to do so. Recommend further evaluation for repairs by a licensed plumber.

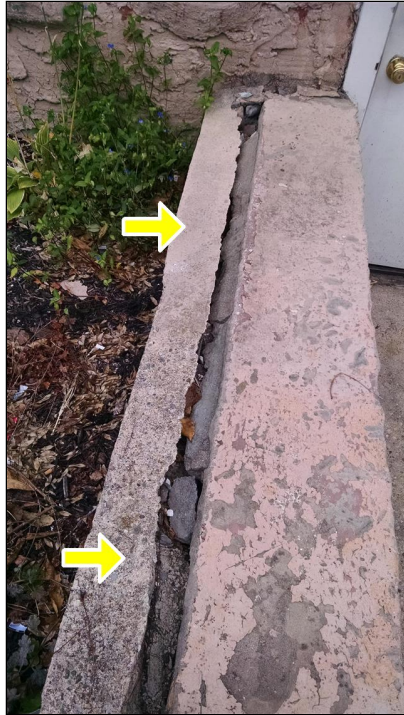
1.4 Item 1(Picture)

The front masonry retaining wall is extremely deteriorated. If not repaired, further deterioration of the retaining wall could occur. Recommend further evaluation for repairs by a qualified, licensed contractor.

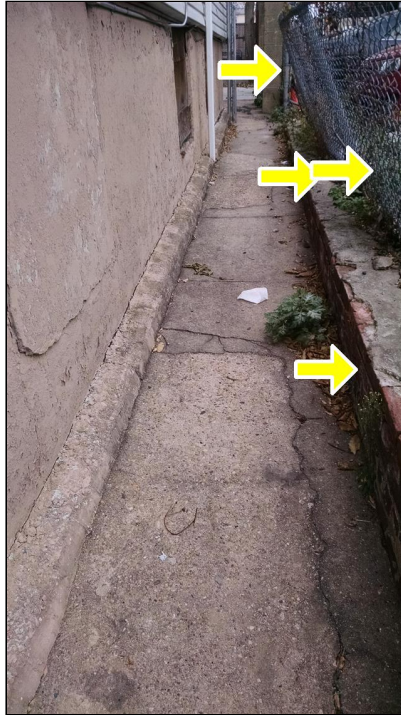
The retaining wall and the chain link fencing on the right side of the house is in need of repairs. The retaining wall is deteriorating and the fencing is damaged and leaning. Part of this may or may not be on your property. I would consult with your agent and also look on a survey of the property for reference. Recommend further evaluation for repairs if this is part on your property.

1.5 Item 1(Picture) Right side retaining wall and fencing is in need of repairs

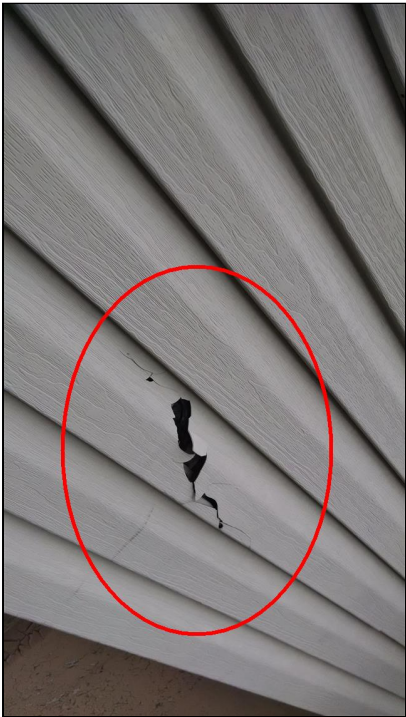
2.0 Item 1(Picture)

There were numerous small sections of vinyl siding that appeared to be damaged or missing on the front, right side and rear of the house. Further damage to the siding and deterioration of the structure behind the siding could occur if the needed repairs are not completed. In addition, in the rear where the vinyl siding is missing, you can see what appeared to be 3 different types of exterior cladding that was installed on the house over the years. The middle exterior cladding material is called fiber cement siding may contain asbestos fibers. Asbestos cement is a composite material consisting of Portland cement reinforced with asbestos fibers. Asbestos fiber cement siding has been known to have been used on homes built from the 1920's until the early 1970's. In 1973, the EPA banned the use of asbestos in the manufacturing of building products. Asbestos materials are considered safe by the EPA if they are not disturbed, torn, ripped, or damaged. No torn, ripped, or damaged fiber cement siding materials were observed. All of the suspect fiber cement siding except where it is visible in the rear and in the rear basement stairwell appears to be covered up by the vinyl siding that is on the house currently. Recommend further evaluation of all of the exterior siding on the house for repairs by a qualified, licensed contractor. If client has any concerns regarding asbestos materials, an asbestos testing lab should be consulted for further review to ensure safety prior to closing.

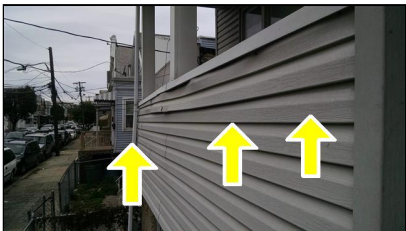
2.0 Item 4(Picture) Vinyl siding buckling on front porch

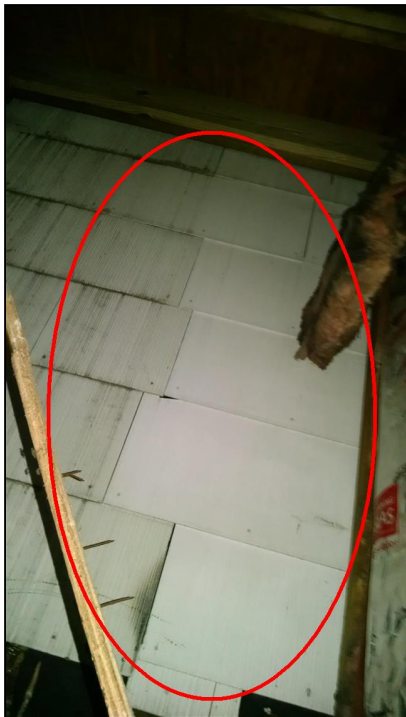
2.0 Item 5(Picture) Fiber cement siding visible in rear basement stairwell

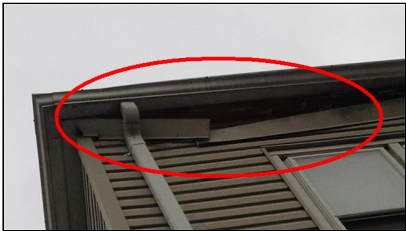
2.2 Item 1(Picture)

(1) There was a piece of aluminum soffit trim on the front of th house that was damaged. Recommend further evaluation for repairs by a licensed contractor.

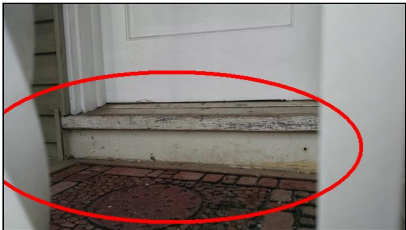
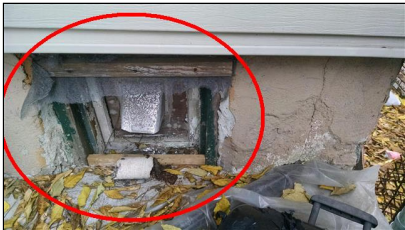
(2) The paint on numerous areas of the wood trim on the exterior of the house (doors, windows, etc.) as well as the some of the door jambs was peeling leaving the wood exposed to the elements. If not repaired, moisture damage and wood rot could occur. Recommend further evaluation of all of these areas for repairs by a qualified, licensed contractor.

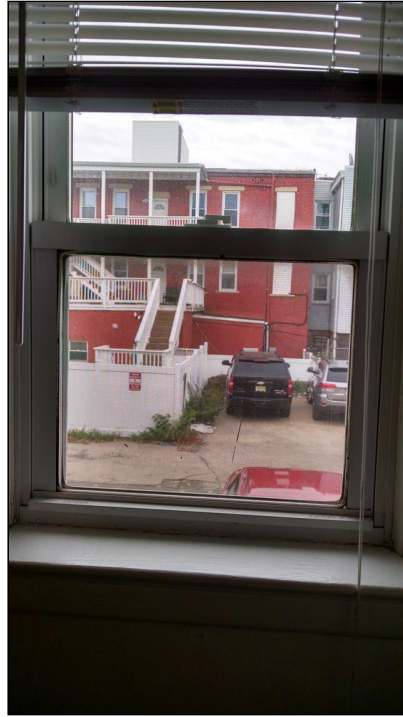
2.3 Item 1(Picture)

The window in the 1st floor bathroom was not functioning properly. The bottom window sash would slam down when you opened it. This is a safety issue and should be repaired. Recommend further evaluation for repairs by a licensed contractor.

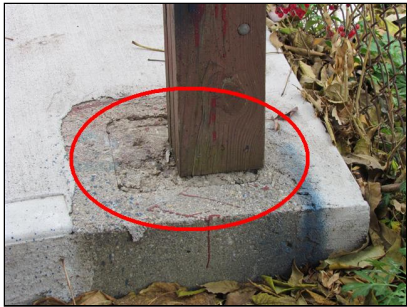
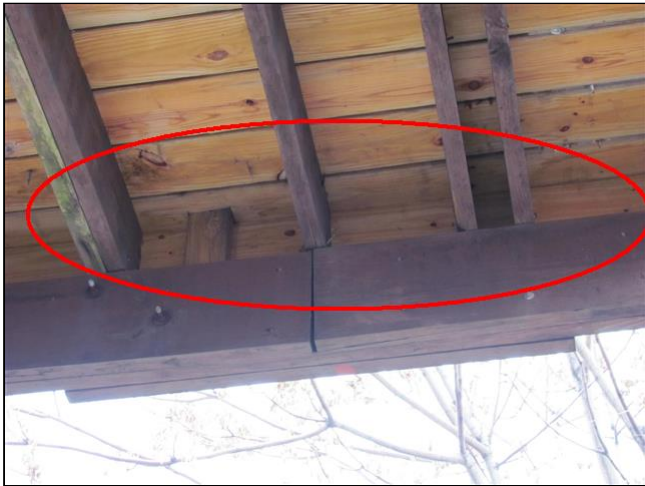
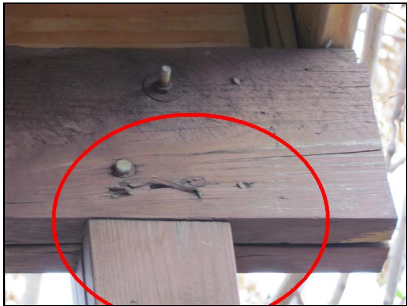
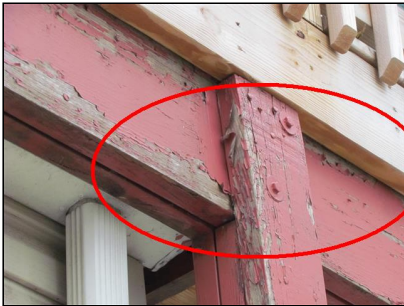
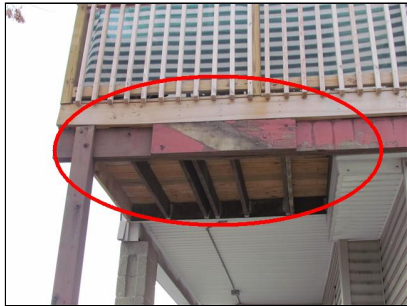
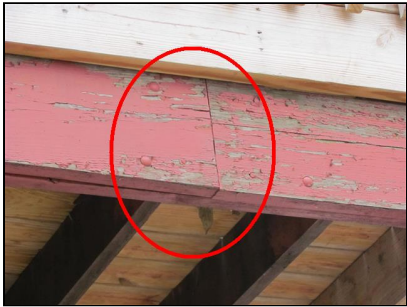
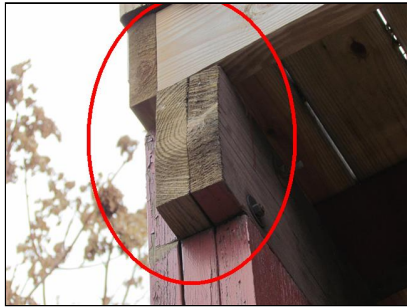
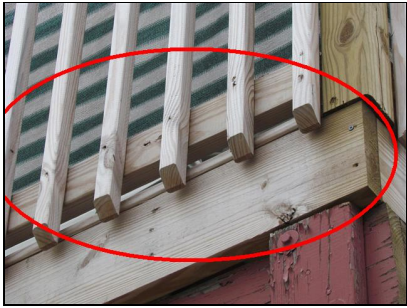
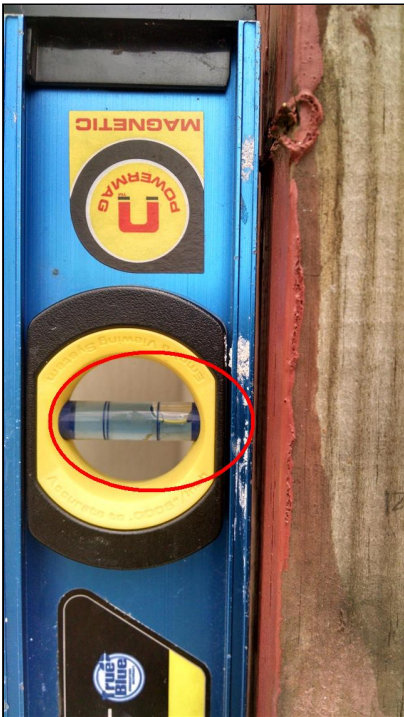
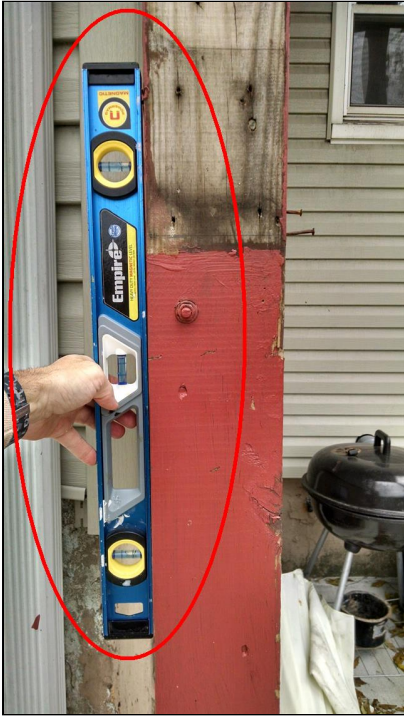
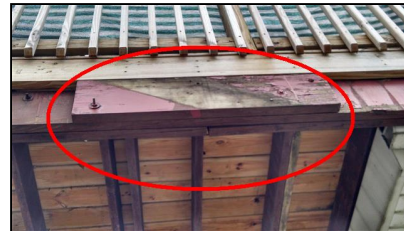
Numerous issues were observed pertaining to the rear deck...to name a few- 1) there are no support post to footing mechanical connectors 2) there are no support post to beam mechanical connectors 3) there are no beam to joist mechanical connectors 4) the entire guardrail assembly is extremely loose, not properly mechanically attached to the primary structure of the house and deck and is just overall poorly built 5) the main vertical support posts are made up of 3 framing member lag bolted together (these should be solid 6"x6" posts) 6) the two support posts on the right are not plum and are leaning 7) there are no lag bolts attaching the ledger boards to the primary structure of the house 8) no portion of a deck should be attached to any cantilevered portion of the house 9) there were two splices in the main support beams that did not have any support posts under them (any splices should have a support post underneath it). These are all safety and structural issues and with the guardrail being so loose, I would recommend not using this deck until the entire deck is further evaluated by a qualified, licensed contractor and the needed repairs are completed.

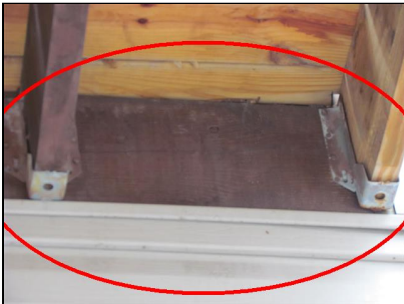
2.8 Item 12(Picture) No lag bolts

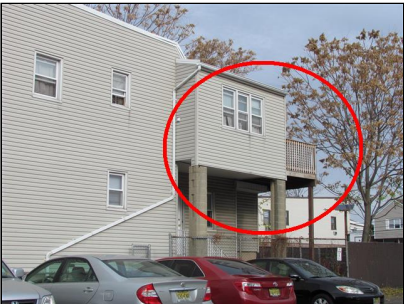
2.8 Item 13(Picture) Deck attached to cantilevered portion of the house

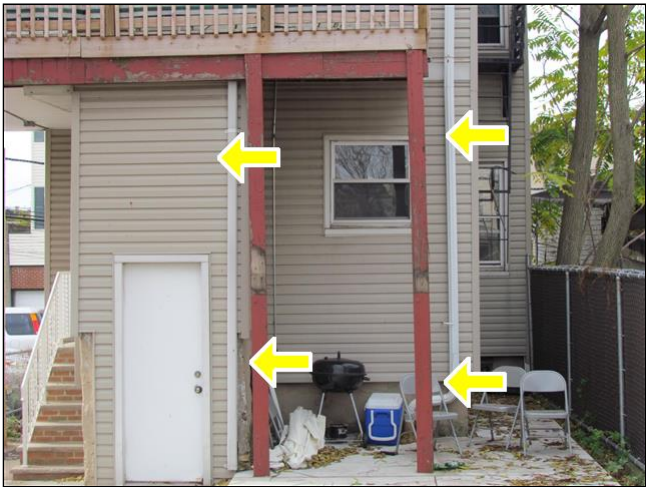
2.8 Item 15(Picture) Support posts leaning to the left

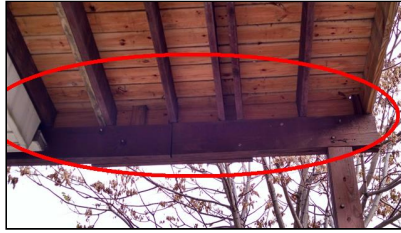
2.8 Item 18(Picture) No joist hangers

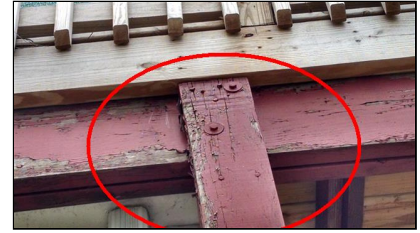
2.8 Item 19(Picture) No mechanical connectors

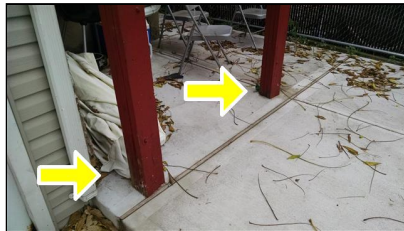
2.8 Item 20(Picture) No mechanical connectors

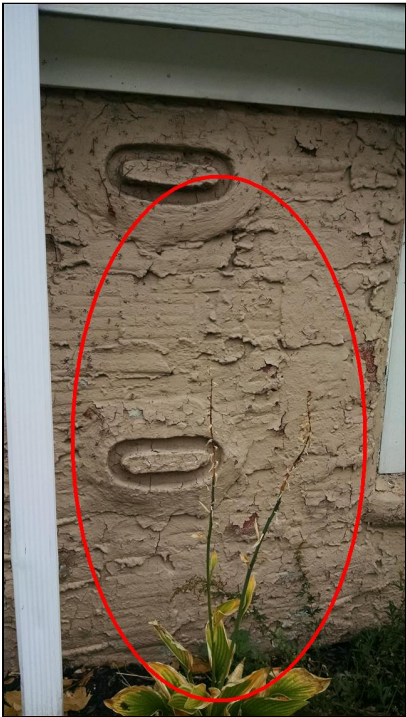
(1) Observed on the interior and exterior masonry foundation wall surfaces, there were several vertical cracks visible and the paint was peeling off of these surfaces in numerous areas. In addition, the parging on several areas of the interior and exterior foundation walls was cracked/missing/flaking off, portions of the basement concrete floor were cracked and portions of the brick foundation in the rear was deteriorated. Further deterioration of the foundation could occur if the needed repairs are not completed. Recommend further evaluation of the entire foundation (interior and exterior) for repairs by a qualified, licensed contractor.

4.0 Item 1(Picture) Peeling paint front

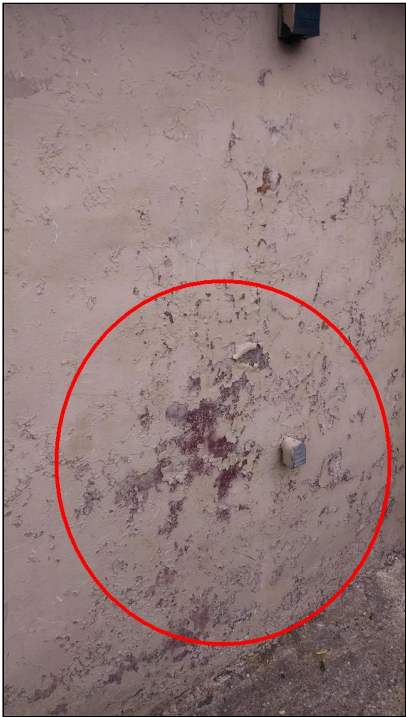
4.0 Item 2(Picture) Peeling paint left side

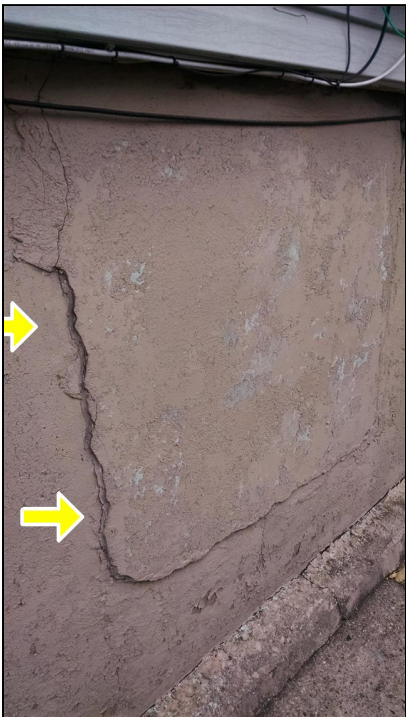
4.0 Item 4(Picture) Cracks on right side

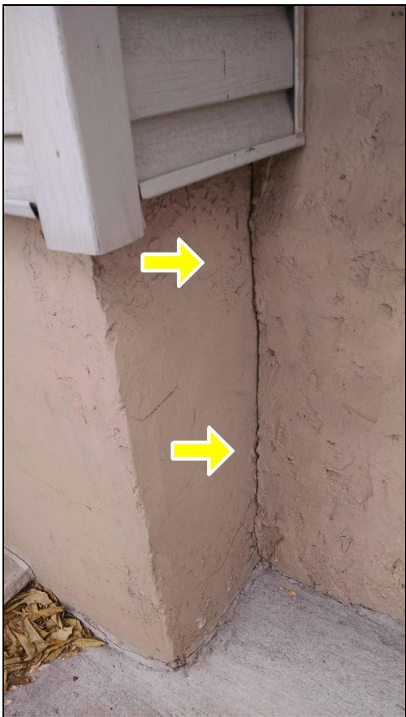
4.0 Item 5(Picture) Crack in rear

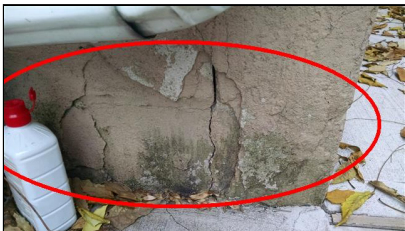
4.0 Item 6(Picture) Parging cracked in rear

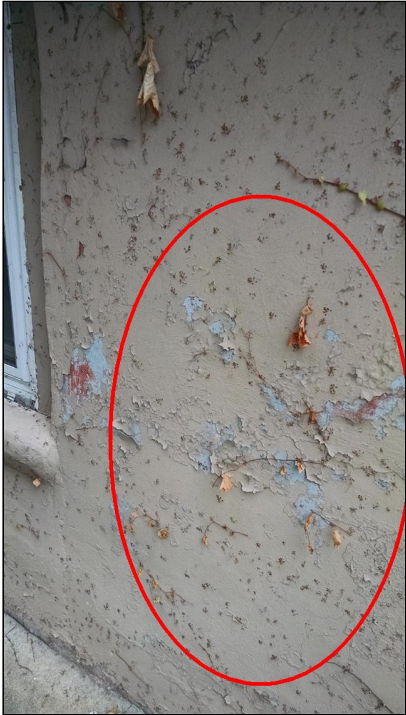
4.0 Item 8(Picture) Peeling paint left side

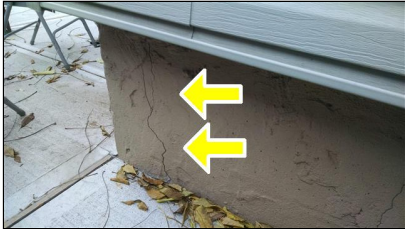
4.0 Item 9(Picture) Cracks in rear

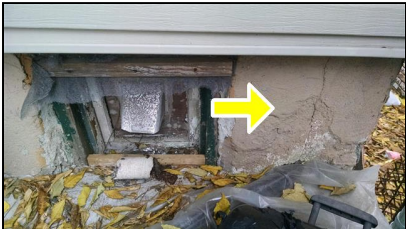
4.0 Item 10(Picture) Cracks in rear

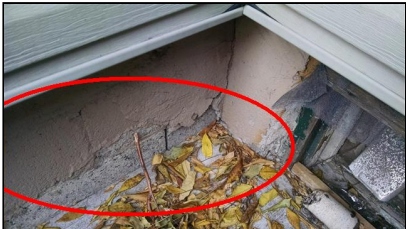
4.0 Item 11(Picture) Parging deteriorated in rear

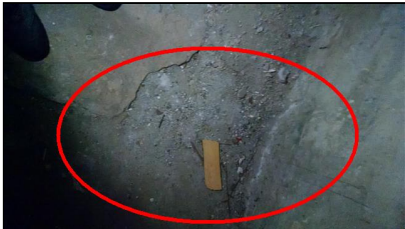
4.0 Item 12(Picture) Cracks in basement floor

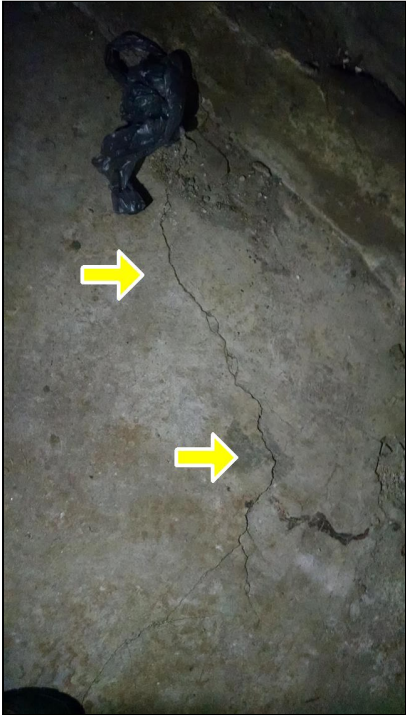
4.0 Item 13(Picture) Cracks in basement floor

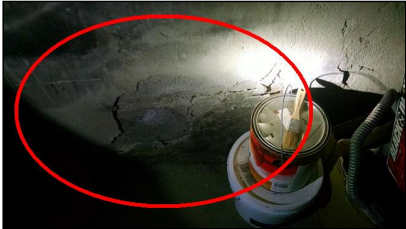
4.0 Item 14(Picture) Interior basement wall

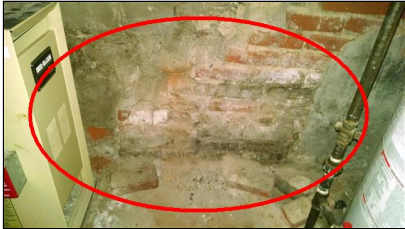
4.0 Item 15(Picture) Brick foundation wall in rear deteriorated- bricks laying on floor

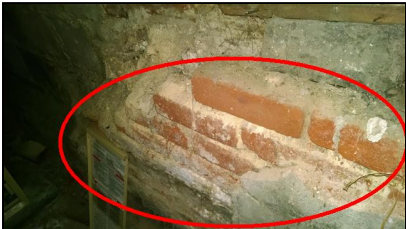
4.0 Item 16(Picture) Brick foundation in rear deteriorated

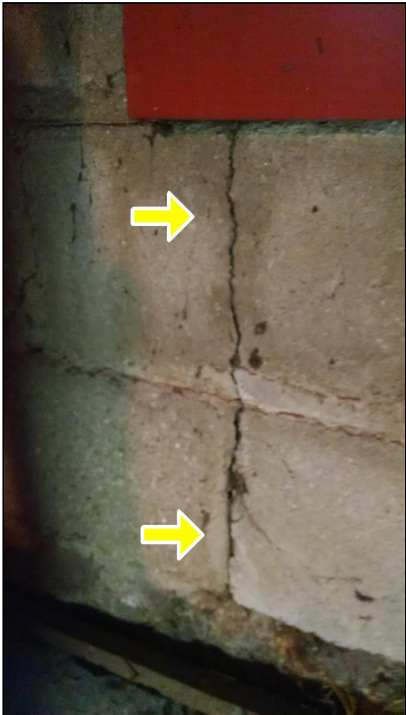
4.0 Item 17(Picture) Crack-interior right side basement wall

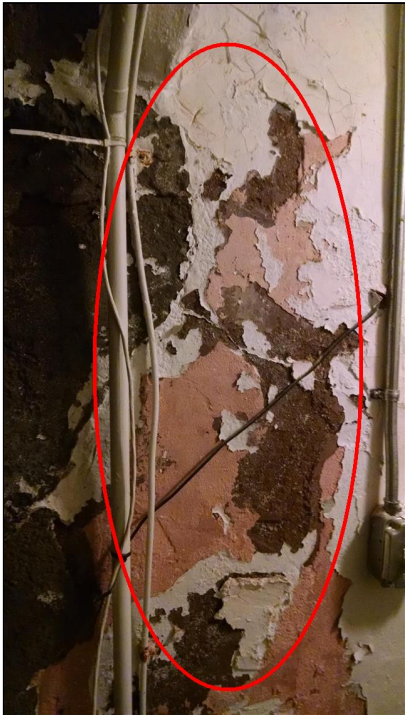
4.0 Item 18(Picture) Peeling paint and parging deteriorated in front basement

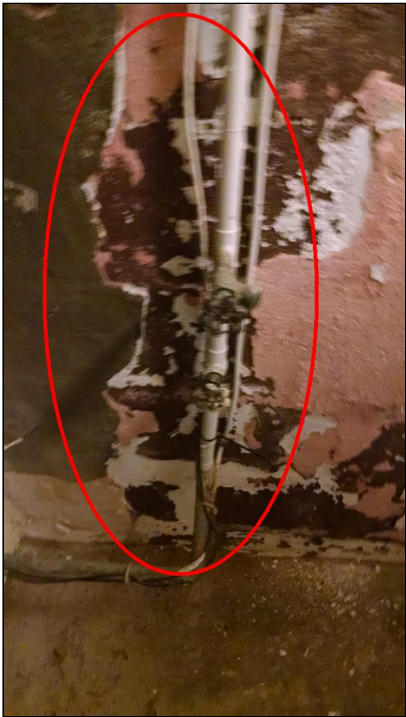
4.0 Item 19(Picture) Peeling paint and parging deteriorated in front basement

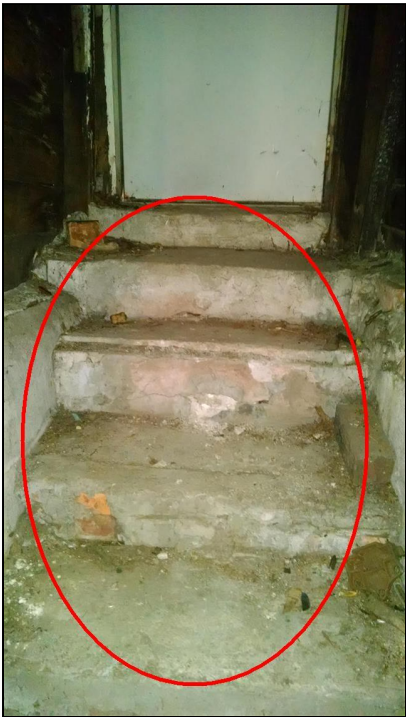
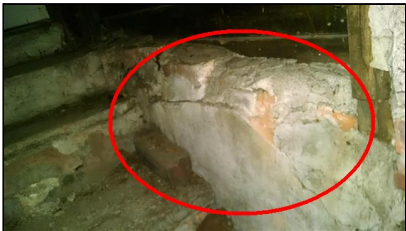
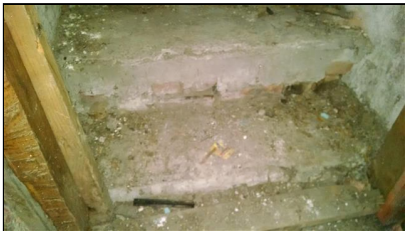
(2) The masonry staircase in the rear of the basement for the exterior rear door is severely deteriorated. Further deterioration of this staircase could occur if the needed repairs are not completed as well as this being a safety issue. Recommend further evaluation of the entire foundation (interior and exterior) for repairs by a qualified, licensed contractor.

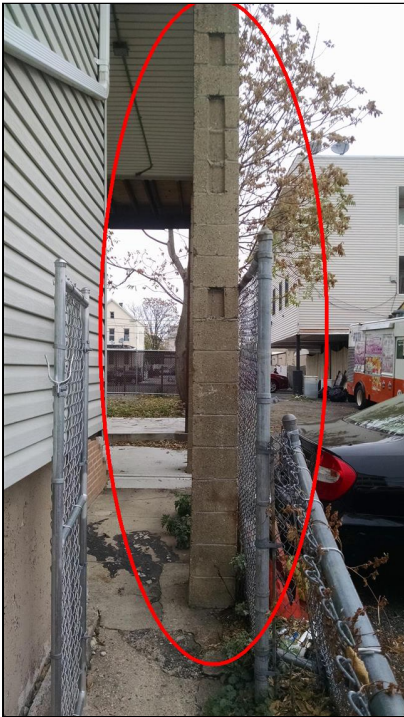
4.1 Item 1(Picture)

The front masonry support column supporting the cantilevered portion of the 2nd floor in the rear has a slight bow in the middle of it. Portions of it are not plumb and there is a crack in the mortar joint between the 4th and 5th blocks at the bottom. This is a safety concern as there may be some structural issues within the house that are causing the column to bow. In addition, just to bring this to your attention, there is no protection in place for these columns from the cars parking in the parking lot on the property to the right of the house. Due to the fire damaged structure that is still in place, the sloping floors and this issue, I would recommend further evaluation of the entire structure of the house for repairs by a qualified, licensed structural engineer.

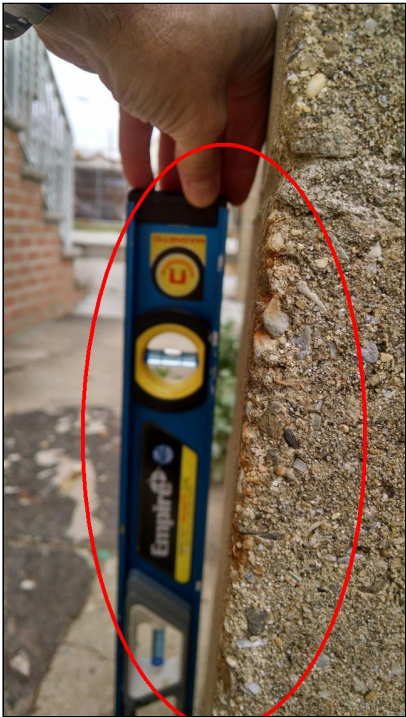
4.1 Item 2(Picture) Bottom of column not plumb

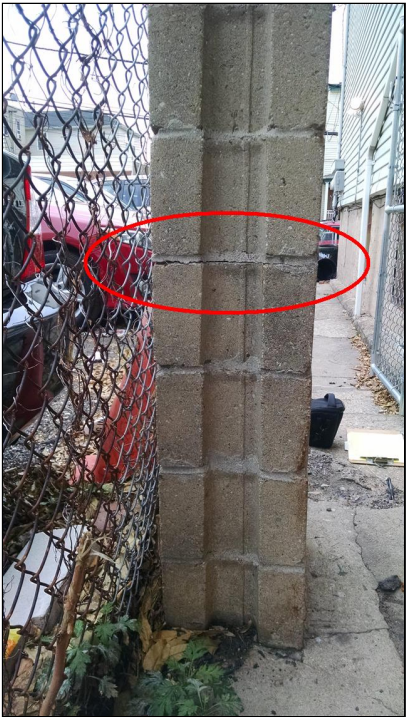
4.1 Item 3(Picture) Crack in mortar joint

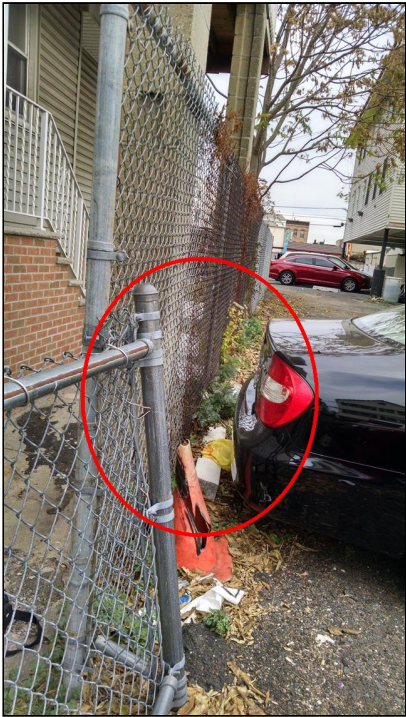
4.1 Item 5(Picture) Columns have no protection from cars parking in the parking lot on the right side of the house
