# Property Inspection Report

**Property Address:**  
65 West 1st Street  
Inspectionville NJ 76666

**Terra Home Inspections LLC**

<b>Date:</b> 9/16/2015	<b>Time:</b> 10:00am	<b>Report ID:</b> 20150288
<b>Property:</b> 65 West 1st Street Inspectionville NJ 76666	<b>Customer:</b> Tony Inspection	<b>Real Estate Professional:</b> Sally Realtor

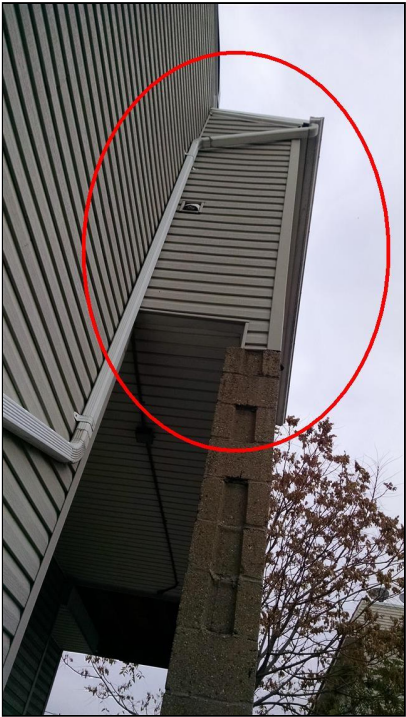
The front masonry support column supporting the cantilevered portion of the 2nd floor in the rear has a slight bow in the middle of it. Portions of it are not plumb and there is a crack in the mortar joint between the 4th and 5th blocks at the bottom. This is a safety concern as there may be some structural issues within the house that are causing the column to bow. In addition, just to bring this to your attention, there is no protection in place for these columns from the cars parking in the parking lot on the property to the right of the house. Due to the fire damaged structure that is still in place, the sloping floors and this issue, I would recommend further evaluation of the entire structure of the house for repairs by a qualified, licensed structural engineer.

4.1 Item 6(Picture) Columns supporting rear of house

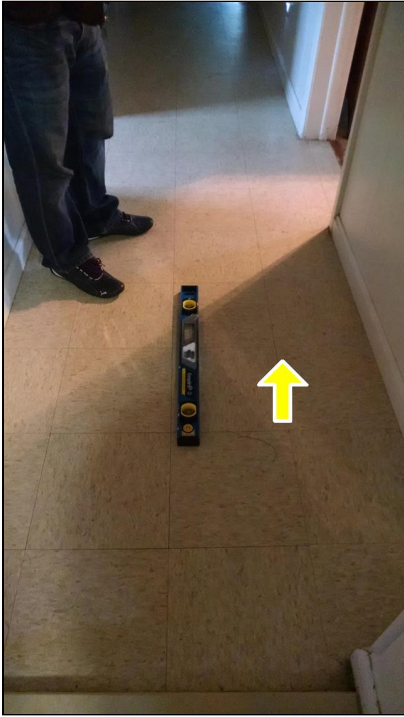
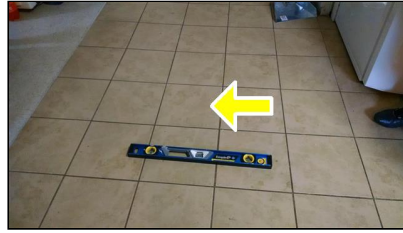
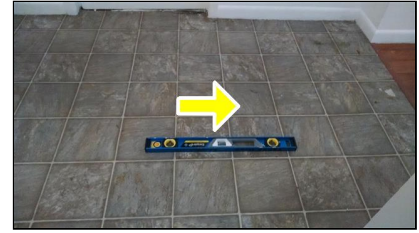
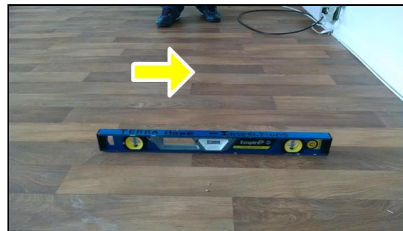
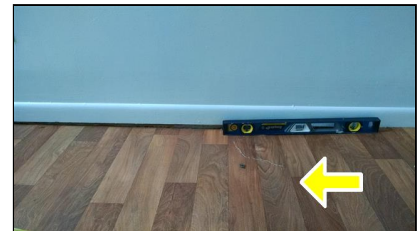
(2) There were numerous rooms in the house that had noticeable sloping floors present. The areas of concern are as follows- 1) the 2nd floor kitchen floor was sloped downward left to right 2) the 2nd floor hallway floor was sloped downward from the rear to the front 3) the 1st floor kitchen floor was sloped downward from the rear to the front and it had a noticeable hump in it on the left side 4) the 1st floor front bedroom floor was sloped downward from right to left 5) the 1st floor living room floor was sloped downward from the front to the rear. Due to the fire damaged structure that is still in place, the exterior masonry column issues and this issue, I would recommend further evaluation of the entire structure of the house for repairs by a qualified, licensed structural engineer.

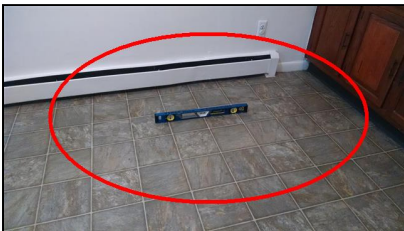
4.5 Item 13(Picture) Hump in 1st floor kitchen floor

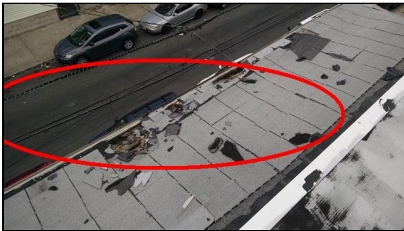
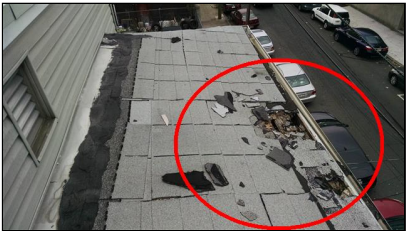
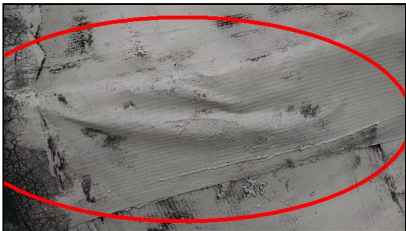
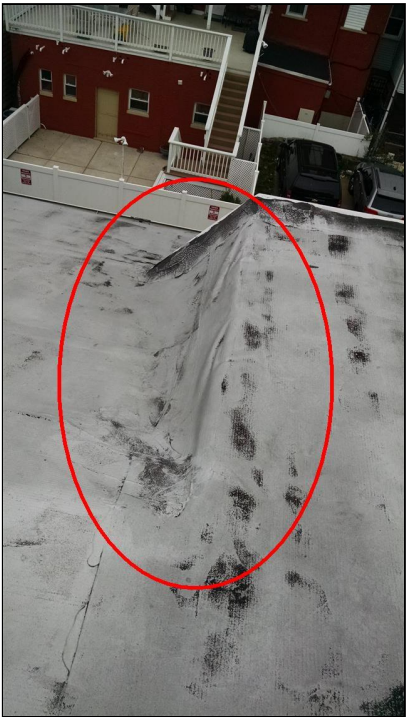
Observed on the flat roof in the rear of the house, the rolled asphalt roofing membrane had several blisters present. Blisters are typically created by voids resulting from improper adhesion during the application of the roofing membrane. If these blisters or the seams open up, water could enter the structure below. In addition, there were large holes in the shingle roof covering and decking on the front of the house. These open holes are letting water into the living space below potentially causing water damage. Recommend further evaluation of the entire roof by a qualified, licensed roofing contractor and repaired as needed.

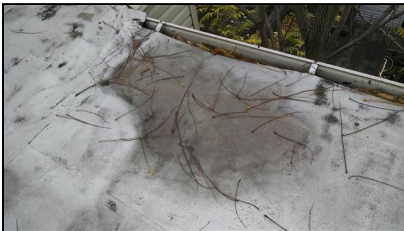
5.0 Item 4(Picture) Ponding water on flat roof

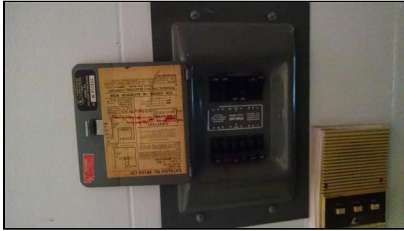
There were two Federal Pacific Electric Stab-Lok electric sub panels present in the 1st and 2nd floor apartments (one in each apartment) which is a safety concern. There are studies that show that some FPE circuit breakers are prone to problems that can lead to failures, lack of proper protection of circuits and other serious issues, including fire and electrocution. Due to the other electrical related issues observed in the house, I would recommend further evaluation of these sub panels as well as the entire electrical system by a qualified, licensed electrician. Additional information pertaining to these electric panels can be found at <http://www.ismypanelsafe.com/fpe.aspx> and [http://inspectapedia.com/fpe/FPE\\_Stab\\_Lok\\_Hazards.htm](http://inspectapedia.com/fpe/FPE_Stab_Lok_Hazards.htm).

7.4 Item 1(Picture) 2nd floor  
Federal Pacific sub panel

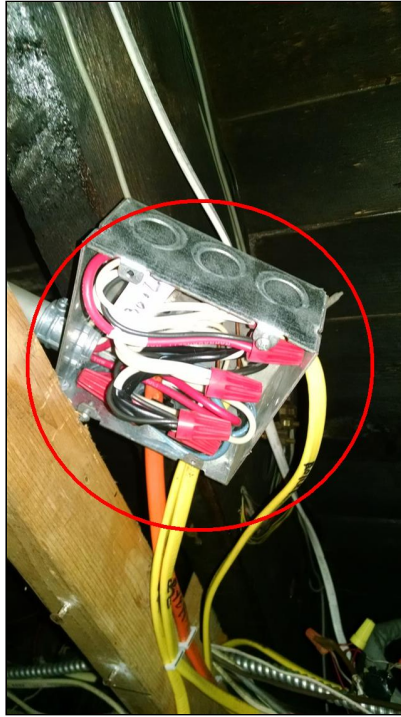
7.7 Item 1(Picture)

There were numerous electrical junction boxes observed in the basement area that didn't have the required cover plates on them. The cover plates are required in order to contain any arcing which would potentially cause a fire. If a wire is loose, the amperage will go up, which causes heat. This excessive heat is also capable of causing a fire. The idea is to keep all splices enclosed to reduce the risk of fire and to prevent damage to the wires due to accidental contact. Recommend further evaluation for repairs by a qualified, licensed electrician.

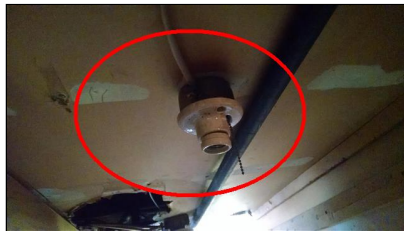
7.8 Item 1(Picture)

Observed in the basement, there were numerous light fixtures that were not functioning and there was an outlet in which the front cover was loose. These are safety issues. Recommend further evaluation for repairs by a licensed contractor.

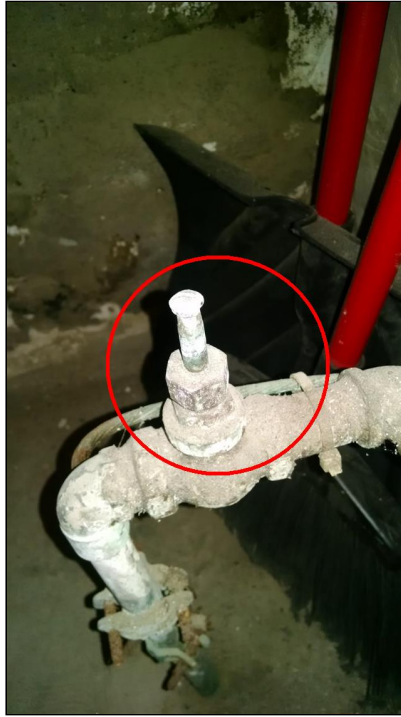
8.0 Item 1(Picture)

One of the main water supply shutoff valves located in the basement is missing the required handle. In the event of an emergency, this valve could not be closed. Recommend installing the required handle.

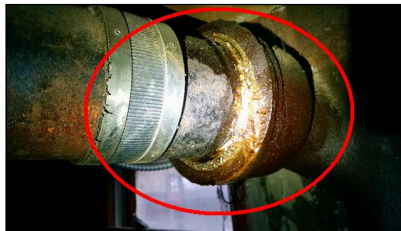
8.2 Item 1(Picture)

The main cast iron DWV piping in the basement appeared to be leaking. This leak could allow sewer waste to drip onto the basement floor which is a health hazard. Recommend further evaluation for repairs by a licensed plumber.

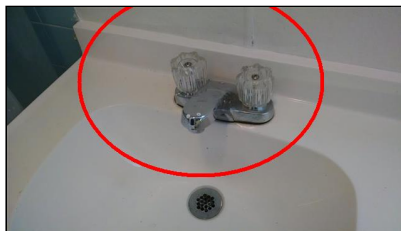
8.3 Item 1(Picture)

The faucet on the 1st floor bathroom sink was not functioning properly. Turning it either way would turn the water on. Recommend further evaluation for repairs by a qualified, licensed plumber.

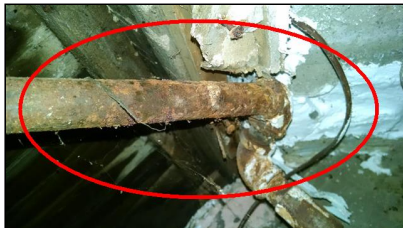
8.7 Item 1(Picture)

A small section of the gas supply piping on the top of one of the gas meters located in the front of the basement was extremely rusted. It is unknown how much of the sidewall of the pipe is rusted and it may be compromised. For safety purposes, I would recommend a further evaluation by a qualified, licensed plumber.

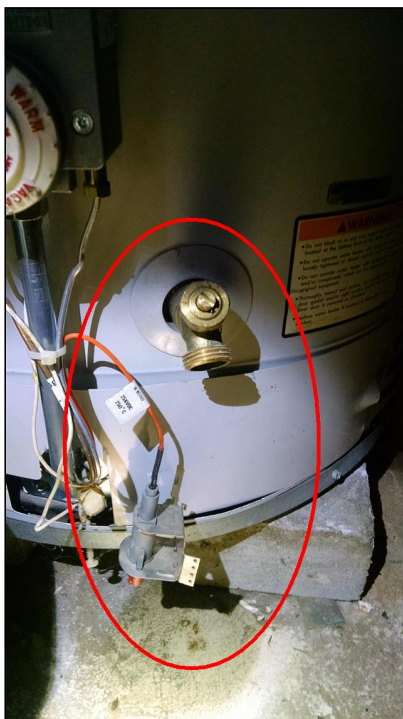
9.0 Item 1(Picture)

(1) There was a visible water leak at the drain valve at the bottom of the water heater ending in serial #6100. This leak is it were to become worse, could result in water damage and/or a flooded basement. Recommend further evaluation of the entire water heater for repairs by a qualified, licensed plumber.

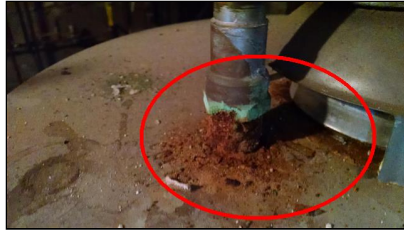
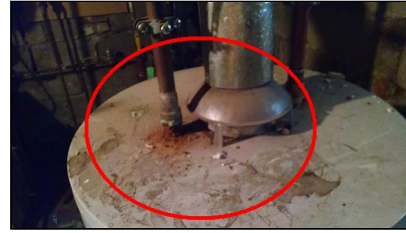
(2) The water supply piping at the top of the water heater ending is serial #8103 was extremely rusted and deteriorated. This condition could result in water damage and/or a flooded basement. Recommend further evaluation of the entire water heater for repairs by a qualified, licensed plumber.

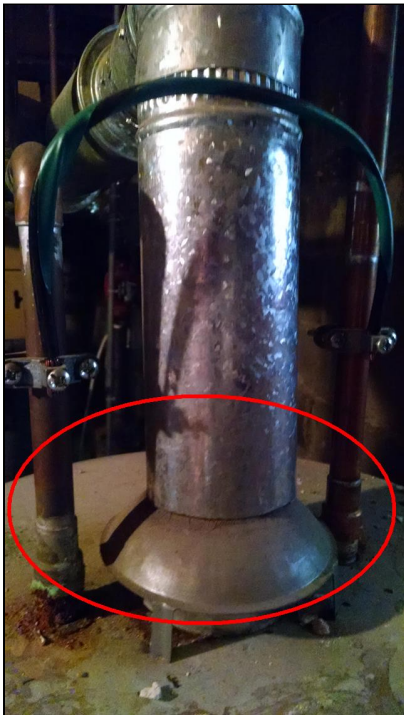
The vent connectors on both of the water heaters are not properly screwed to the draft hoods on the top of the water heaters and are sloped downward. This is a safety issue as carbon monoxide could leak out and enter the basement space if the vent connector were to get knocked off the draft hood. In addition, the vent connectors appeared to be oversized for the draft hoods. They are not the proper size to fit on the top of the draft hoods. Recommend further evaluation for repairs by a qualified, licensed plumber.

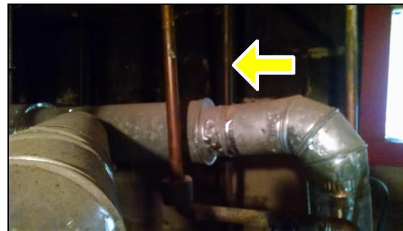
9.1 Item 2(Picture) Vent sloped downward

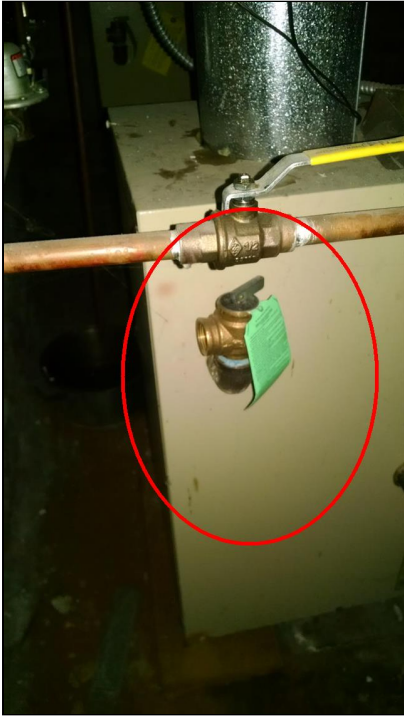
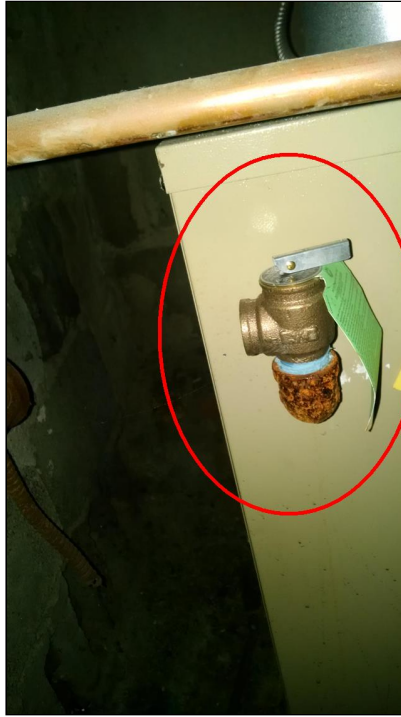
There was no discharge piping on the TPR (temperature pressure relief) valves on either of the two Weil-McLain boilers present in the basement. Proper discharge pipes are needed and should be within 6 inches from the basement floor. This is a safety issue as a person in the vicinity boilers could get scalded should a discharge situation occur. Recommend further evaluation for repairs by a qualified, licensed plumber.

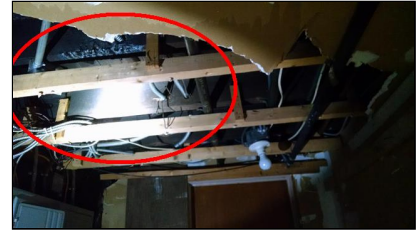
(1) There appeared to have been a fire in the basement at one time. There was numerous areas of the 1st floor wood structure (the sections that weren't covered up with drywall in the basement), basement stairs and walls and other areas of the basement that were charred/fire damaged. Also, as viewed from the inside of the 1st floor bathroom, there were sections of the right side exterior wall above the drop ceiling that were charred. Since most of the basement ceiling is covered with drywall as well as the 1st floor living space and the rest of the house, the extent of the fire damage to the structural framing members could not be determined. All this charred wood is a concern, as the fire may have compromised the structural integrity of the structural framing members and the foundation that is still in place. Recommend further evaluation of these areas by a qualified, licensed contractor.

10.0 Item 3(Picture) Charred floor joists in front of basement

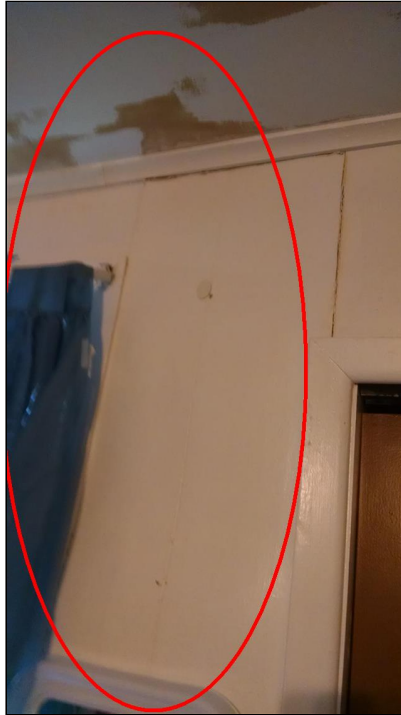
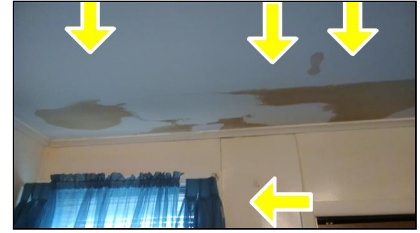
(1) Evidence of previous moisture intrusion was observed in the rear 2nd floor bedroom on the ceiling and rear wall. This area appeared to be dry at the time of the inspection. Consult with the owner/occupant to ascertain if any previous repairs were performed to rectify this situation and provide documentation if any is available. If this cannot be done or if this condition is still a concern to you, I would recommend a further evaluation be done by a qualified, licensed contractor.

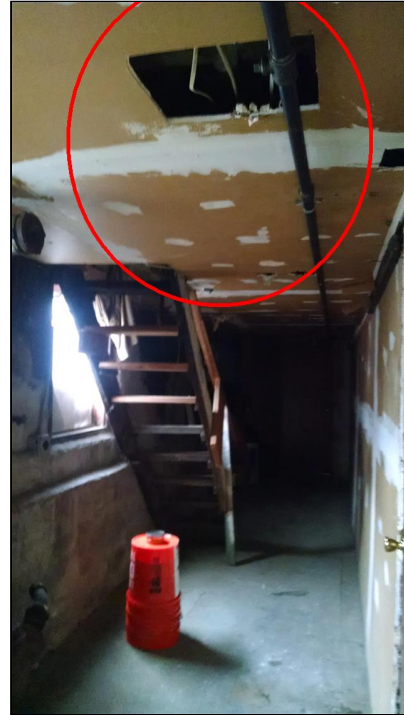
(3) There were numerous sections in the basement that was missing drywall on the ceiling. The basement ceiling should be 100% sealed up to provide the proper fire protection for the basement living space as well as the units above. Recommend further evaluation of all of the ceiling and wall surfaces for repairs by a qualified, licensed contractor.

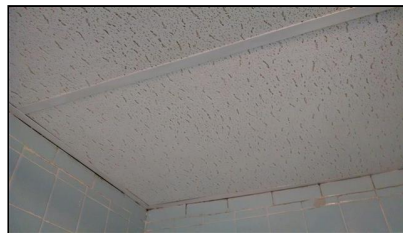
(4) There was a drop ceiling present in the 1st floor bathroom which covered the entire ceiling. This is an issue as the metal framing could rusted due to the moisture while taking a shower and also moisture could get trapped in the space above the drop ceiling and the 2nd floor subfloor. Mold could possibly form on the ceiling tiles as well as the space above the drop ceiling. There was no exhaust fan present in this bathroom. Recommend further evaluation for repairs by a qualified, licensed contractor.

12.1 Item 7(Picture) Drop ceiling  
in bathroom**12.5 Stairways, Steps, Railings****Repair/Replace**

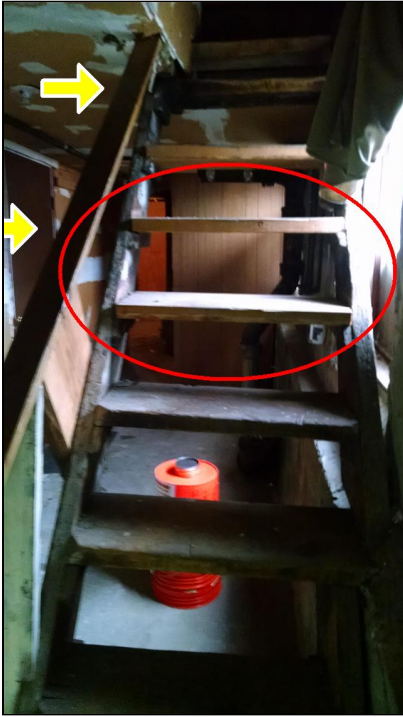
There were numerous issues observed pertaining to the basement staircase- 1) some of the wood structure was charred from a previous fire 2) the supporting wood supporting the stair treads was inadequate 3) the handrail was mounted too low and was missing the required balusters 4) the risers were opened and should be boxed in 5) the staircase itself was very narrow. These are safety issues and for safety, the needed repairs should be completed. Recommend further evaluation by a licensed contractor.

12.5 Item 1(Picture) Open risers, handrail too low and no balusters

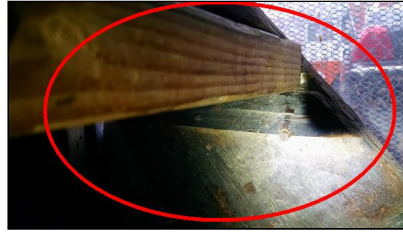
12.5 Item 2(Picture) Fire charred wood supporting stair treads

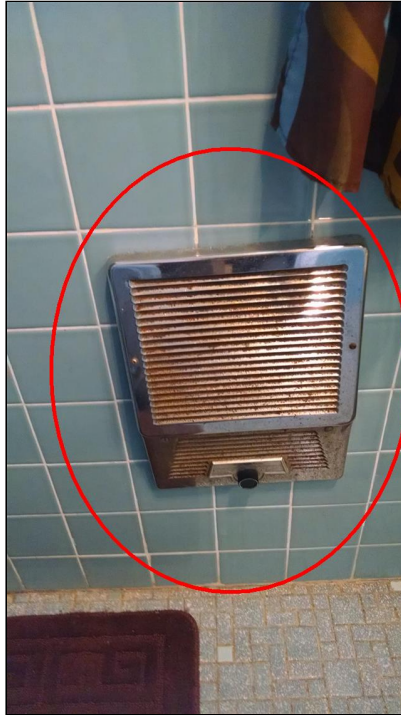
13.0 Item 1(Picture)

There was what appeared to be a wall mounted electric heater present between the shower and the toilet in the 2nd floor bathroom. This is a safety issue as this heater is very close to an open water source and it is not appear to be GFCI protected. For safety, GFCI protection is required in all areas within a close proximity of a water source. A ground fault circuit interrupter (GFCI) is a device (outlet or circuit breaker) that shuts off an electric power circuit when it detects that current is flowing along an unintended path, such as through water or a person. It is used to reduce the risk of electric shock. They can also prevent fires, like when a live wire touches a metal conduit. For safety purposes, I would recommend a further evaluation of this heater for GFCI protection to be done by a qualified, licensed electrician.

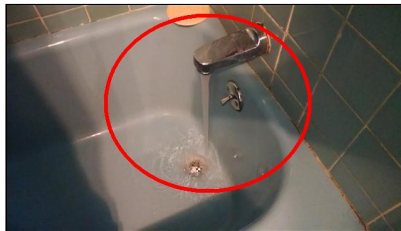
13.3 Item 1(Picture)

The mechanical integrated tub stopper in the 2nd floor bathroom bathtub is inoperable. You will not have the ability to fill up the tub if you desired to do so. Recommend further evaluation for repairs by a licensed plumber.

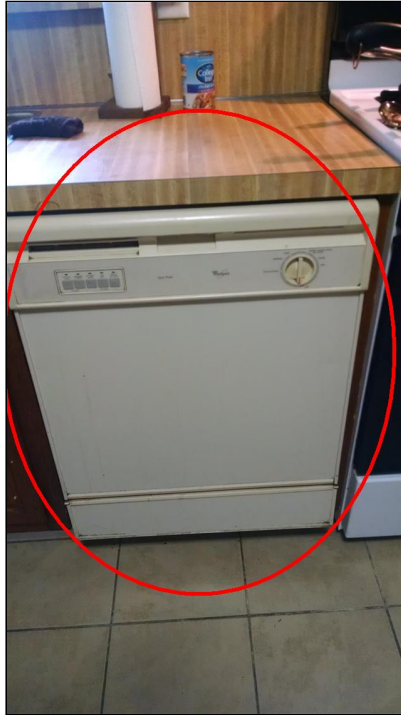
14.5 Item 1(Picture)

The dishwasher present in the 2nd floor kitchen was not functioning when tested. Recommend further evaluation for repairs by a qualified, licensed appliance repair professional.

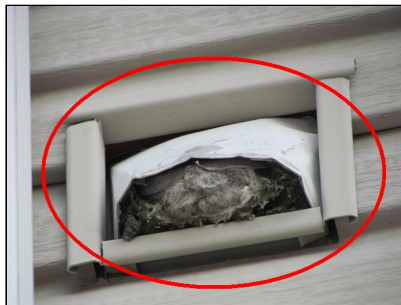
15.4 Item 1(Picture)

The dryer vent for the 2nd floor dryer appears to be clogged. This is a fire hazard and it may also effect the performance of the clothes dryer. Recommend further evaluation for repairs by a licensed contractor.
