Inspection Report

Property Address:
513 Moore Street
San Marcos TX 78666

PROPERTY INSPECTION REPORT

By: Chad Garrett 6785 / Austinspect 5/30/2014

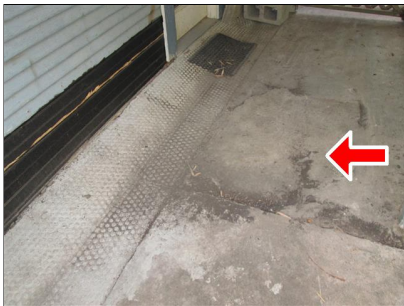
B. Item 1(Picture)

(1) Water ponds at various areas around home. Improve drainage as needed so that water flows away from the structure

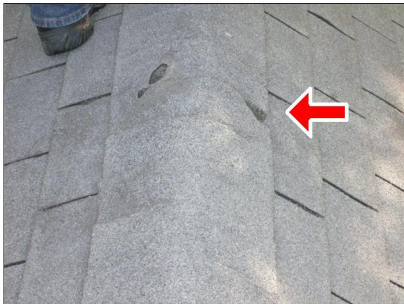
C. Item 2(Picture)

- (1) The roof is older. Shingles are raised in various areas
- (2) Rubber seal around service mast needs replacement

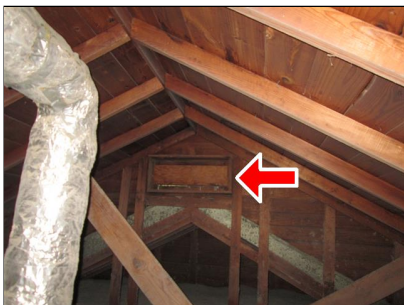
(4) there is no attic ventilation. Install ventilation per todays standards

D. Item 3(Picture) sealed gable vent

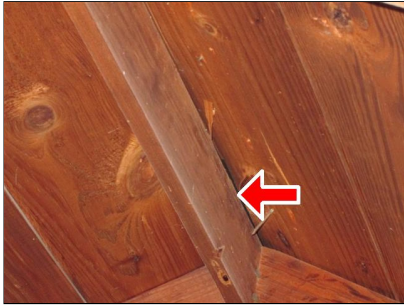
D. Item 4(Picture)

(5) Ridge beam should be the same size/thickness as the roof rafters. This is a current code standard. The roof and structure were performing as intended at the time of inspection

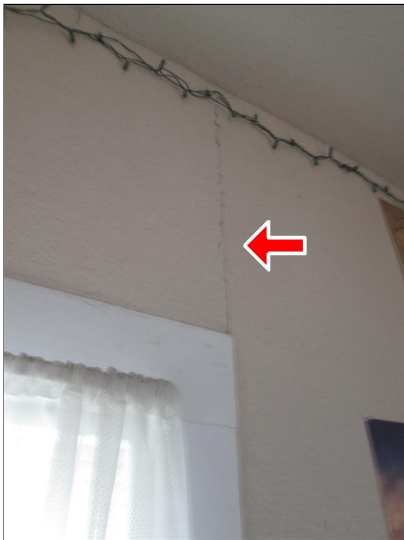
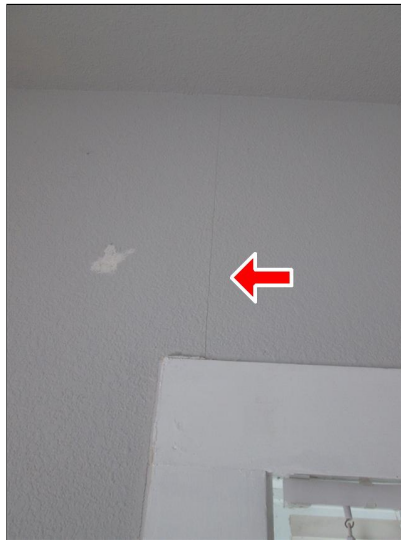
(1) Settlement at various wall areas

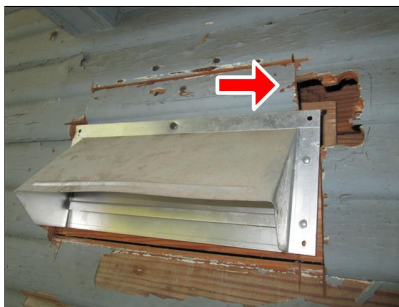
E. Item 8(Picture) around stove top vent

(6) seal all wall penetrations

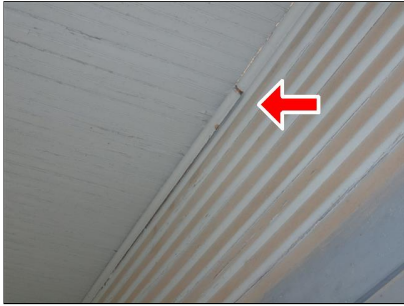
E. Item 9(Picture)

(7) exterior siding is damaged at base in some areas

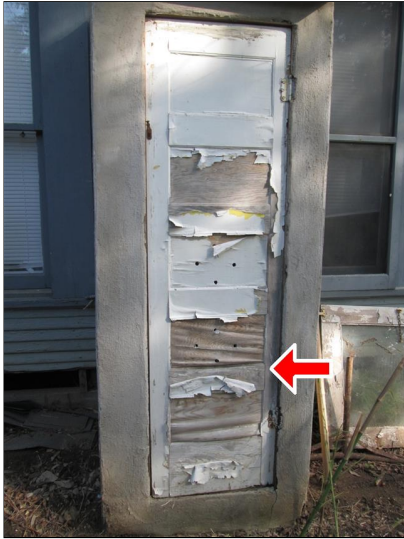
G. Item 1(Picture)

- (2) no dead bolt at front door
- (3) rear door dead bolt is inoperable
- (4) front door has been pried open at some point and door is damaged in striker area

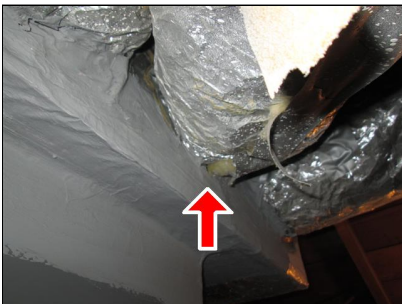
C. Item 2(Picture)

(3) some ducting does not appear to be properly sealed

(2) clean and seal return plenum

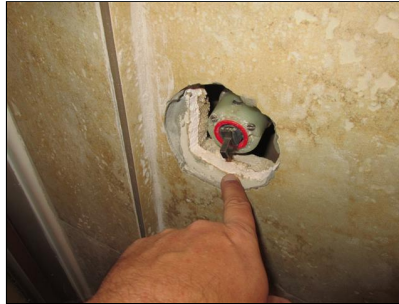
A. Item 4(Picture)

(7) hot and cold water is reversed at front bathroom shower. hot should be left
