# Property Inspection Report

56 Inspection Place

Property NJ 08000

## Terra Home Inspections LLC

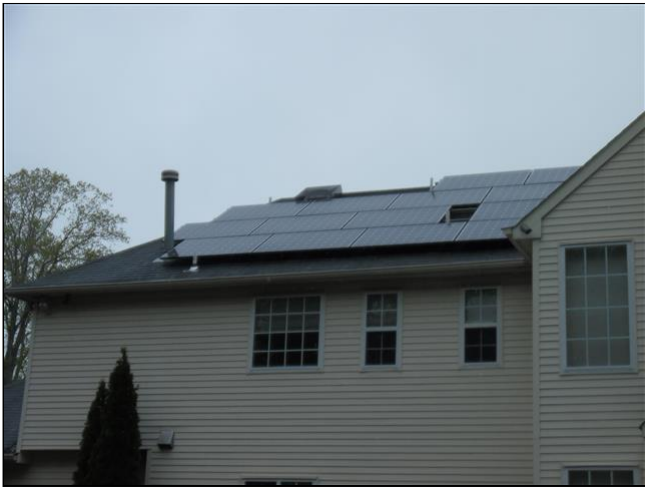
Solar panels on rear roof plane

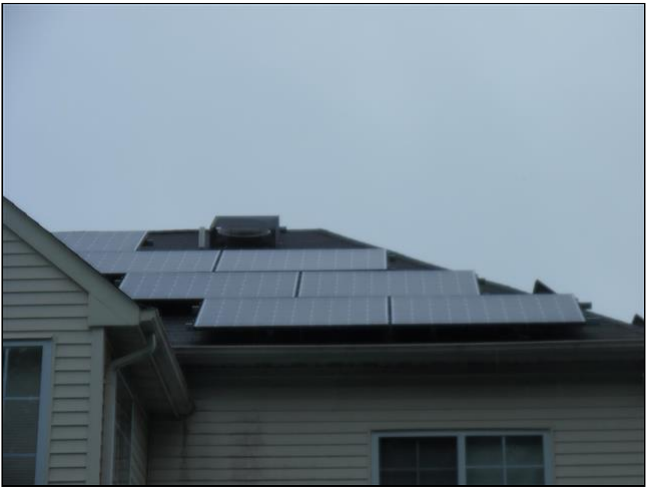
Solar panels on rear roof plane

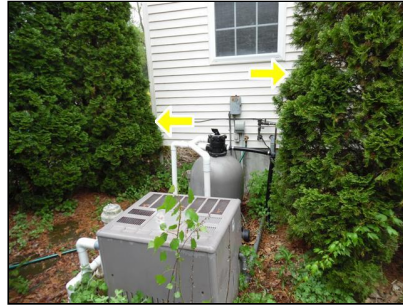
1.3 There was some vegetation observed near or touching the exterior of the house. This vegetation at full growth should be kept at least a foot (preferably 18 inches) from house siding and windows. Keep trees away from foundation and the roof. Vegetation in contact or proximity to the house can provide pathways for wood destroying insects, as well as abrade and damage siding, screens and roofs. Recommend trimming back the vegetation near the exterior of the house.

1.3 Item 2(Picture) Trim back

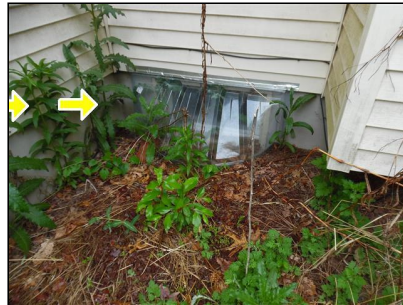
1.3 Item 4(Picture) Trim back
