Report: 2658 sheridan road

Confidential Inspection Report 2658 Sheridan Road Evanston, IL 602201

March 31, 2016

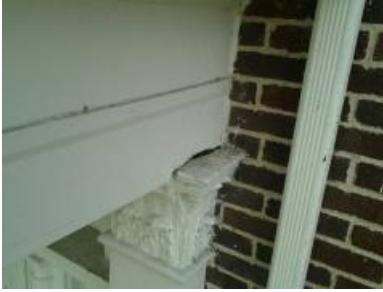
Column to the right of the front door needs to be caulked at the top.

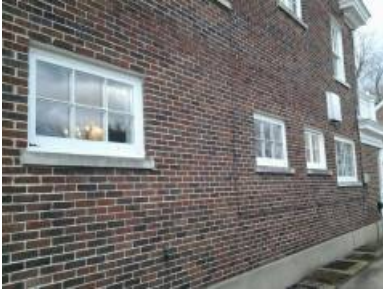
Exterior Windows:

The original wood windows need glazing and paint touchup.

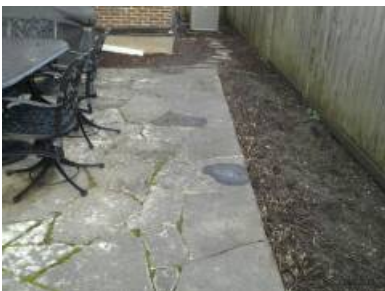
Attention Needed - Some flagstones are loose and needs adjustment.

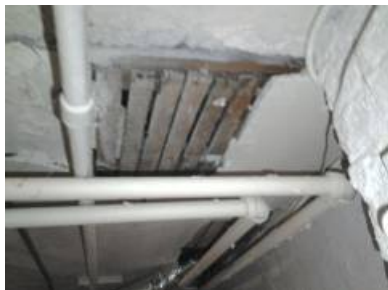
Attention Needed - The interior exposed foundation walls appear to need attention to prevent further deterioration.

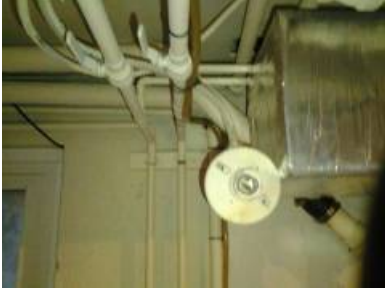
Interior of Basement

Ceiling light needs to be secured to ceiling.

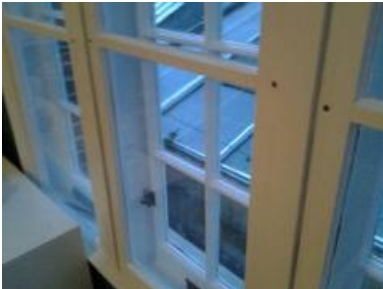
All the windows are screwed shut in the playroom.

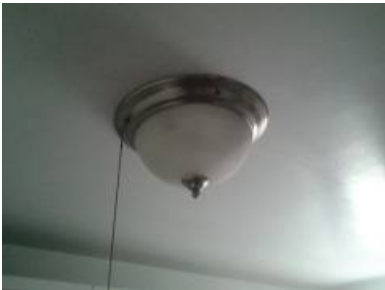
The light in the kitchen doesn't work.
