HOME INSPECTION

1234 Main Street
Beaverton, OR 97005

Buyer Name
07/14/2024 9:00AM

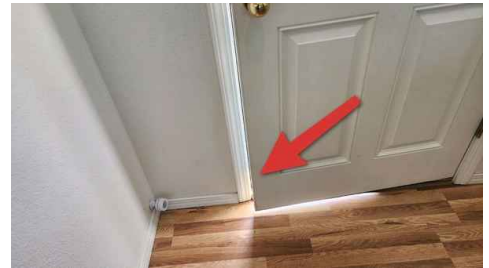
RUBBING ON FRAME

The door is rubbing on the frame/threshold and needs to be adjusted for ease of use.

Sticky

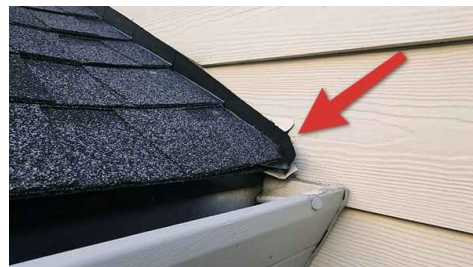
KICK OUT FLASHING

Adequate kick out flashing should be installed where the roof meets the house so water is less likely to run down between the gutter and the wall, eventually causing damage to the structure. It is supposed to be 4" long and 4" high. You have it installed above the front entrance but it is too small.

Too small

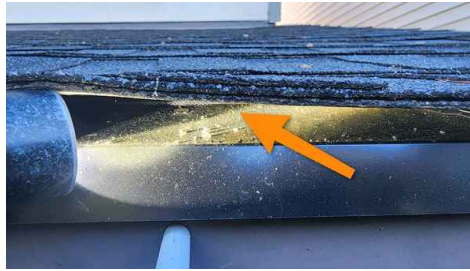
The roofing membrane underlayment is supposed to be installed on top of the drip edge flashing and not below. This may cause moisture intrusion and potential damage to the sheathing. A repair would be difficult and it is best to monitor those areas and have it done correctly when the roof is being replaced.

Underlayment below flashing

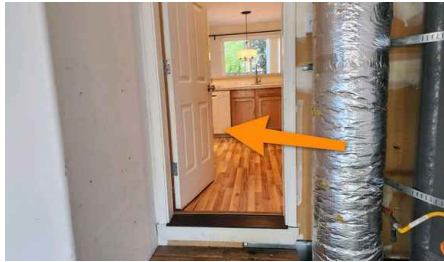
Consider upgrading

Consider installing a self closing mechanism for safety.

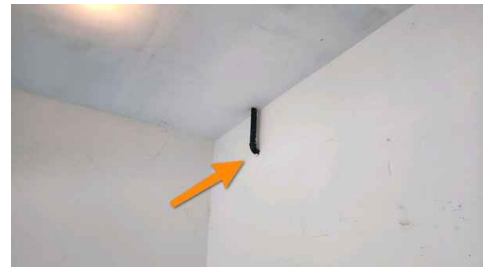
GARAGE WALL

An ABS drain pipe penetrates through the ceiling and wall in the garage. Walls between the garage and living space need to have a 20-minute fire separation in case a fire starts in the garage. There is a fire rated foam available which might be installed behind the wall so the penetration meets the current requirements but this cannot be verified. To be on the safe side, you could always build a drywall box around the drain for maximum protection.

ABS pipe

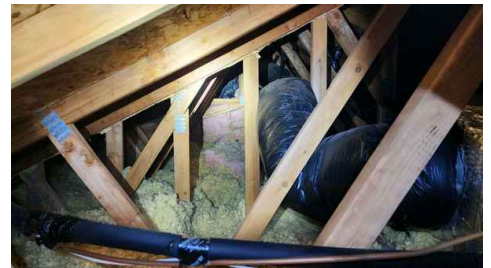
INSULATION

Due to insulation I was not able to safely inspect all of the attic. Stepping down the insulation negatively effects the energy rating as well. There may also be wiring below the insulation that could be damaged, potentially posing a fire hazard.

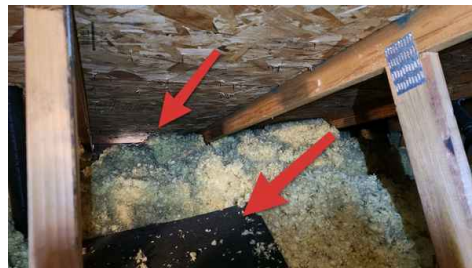
The soffit vents are covered or blocked which limits airflow and is conducive to mold growth. I suggest adding baffles and/or moving the insulation to provide better insulation in the attic. A baffle is missing on at least one of them near the entry.

Attach baffle

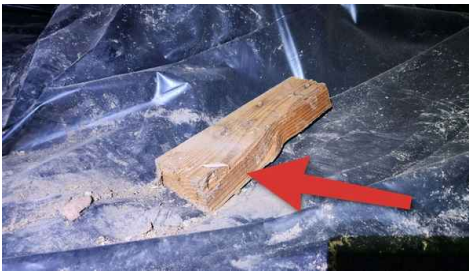
Remove

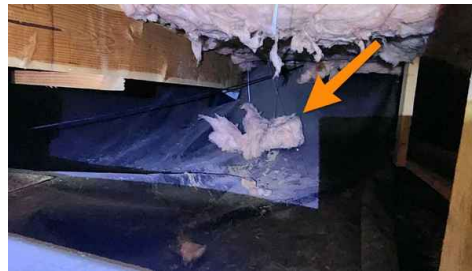
Remove insulation

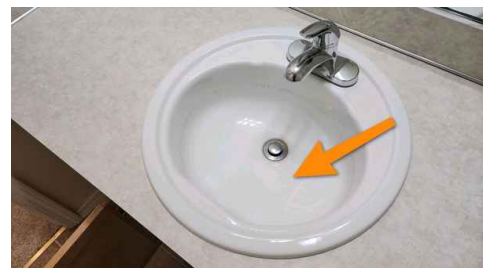
Metal sink

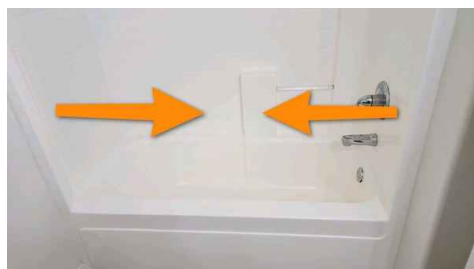
Consider installing a glass door

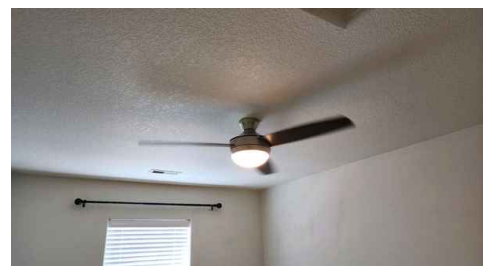
The remotes for the ceiling fans are in the kitchen drawer. They were tested and working at this time.

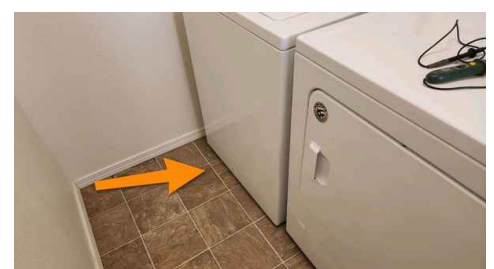
Consider adding a pan

Consider installing a pan underneath the washing machine to prevent potential damage to the floor in case of a leak.
