Country Club Ridge Condominiums

Level 1 Reserve Study

Report Period – 01/01/2021 – 12/31/2021

Executive Summary – Country Club Ridge Condominiums – ID # 18677

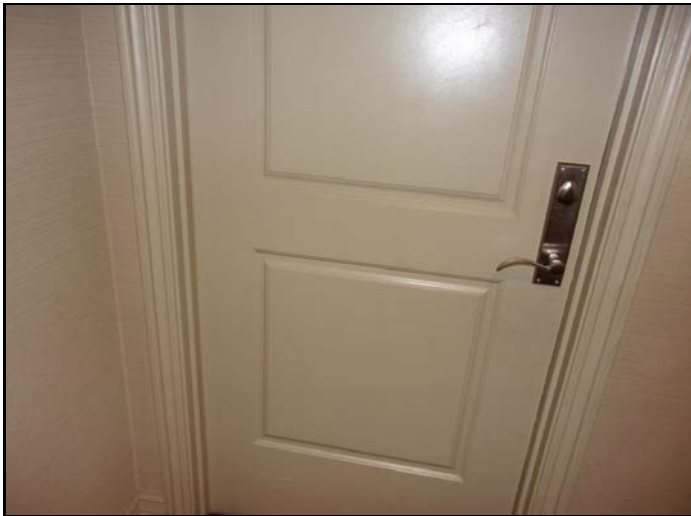
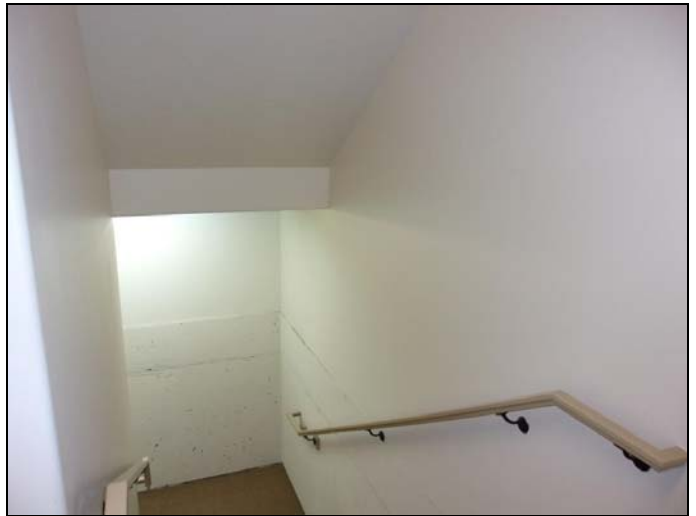
Comp #: 216 Interior Surfaces - Repaint

Location: **Building Interior**

Quantity: **Approx 21,120 Sq.ft.**

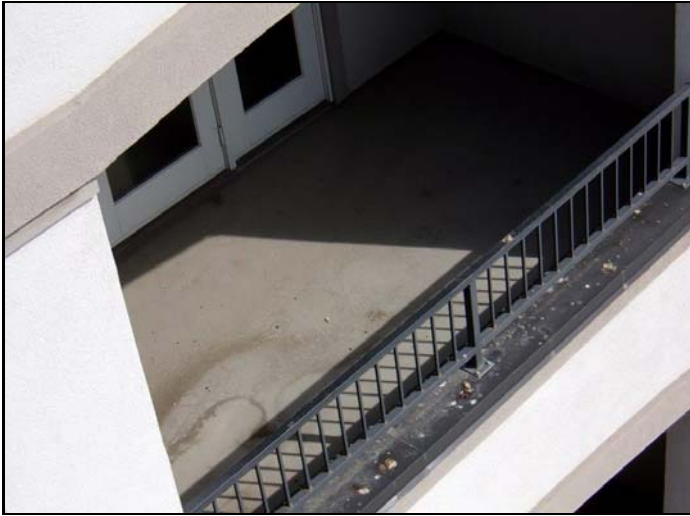
Comp #: 604 Decks - 2009 - Resurface

Location: Unit Decks

Quantity: Approx 6,520 Sq.ft.

Unable to inspect this component at the time of the site visit. Research with the client reveals this component is in good condition. We recommend funding to resurface this component approximately every 15 - 20 years. Remaining life based on current age.

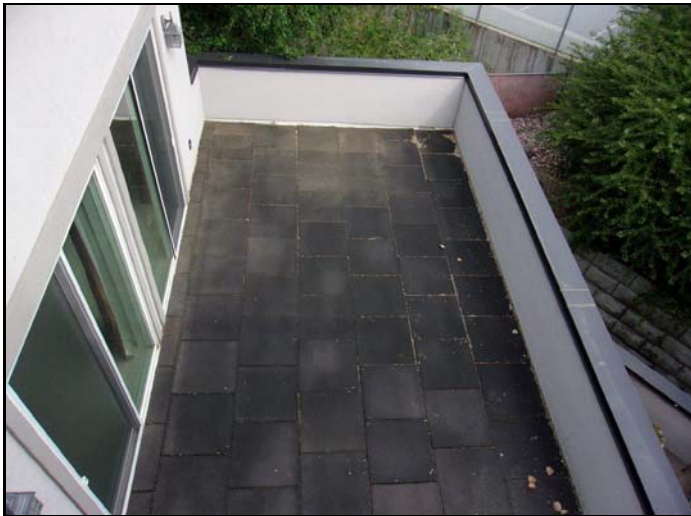
Comp #: 604 Decks - 2019 - Resurface

Location: **Unit Decks**

Quantity: **Approx 830 Sq.ft.**

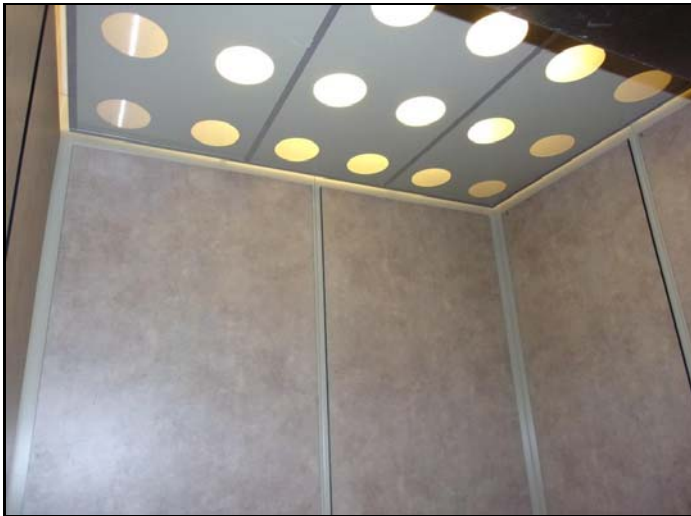
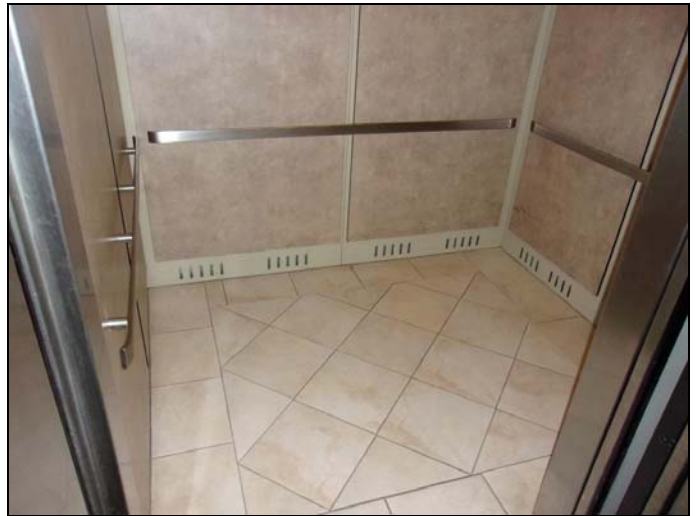
Comp #: 709 Elevator Cabs - Remodel

Location: **Building Interior**

Quantity: **(2) Elevator Cabs**

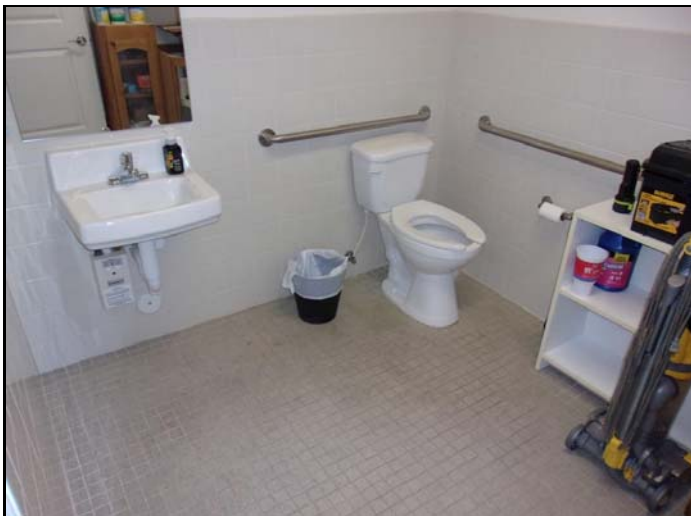
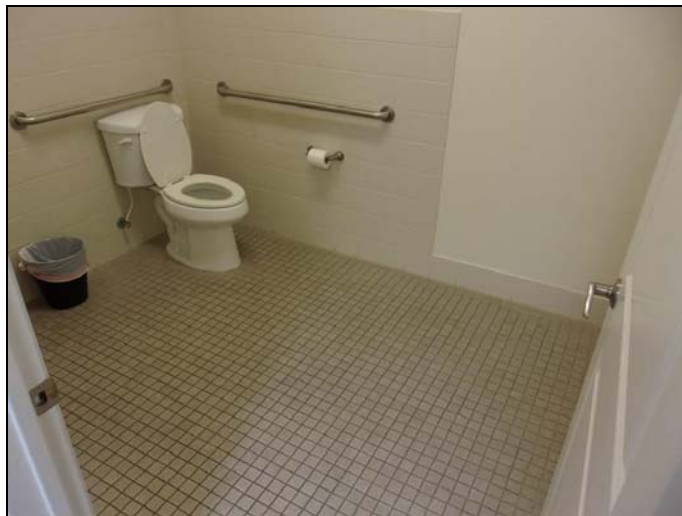
Comp #: 1413 Restrooms - Remodel

Location: **Building Interior**

Quantity: **(3) Restrooms**

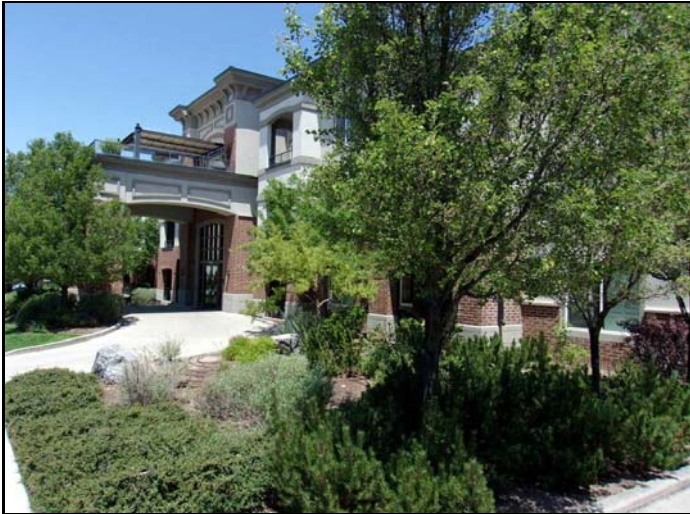
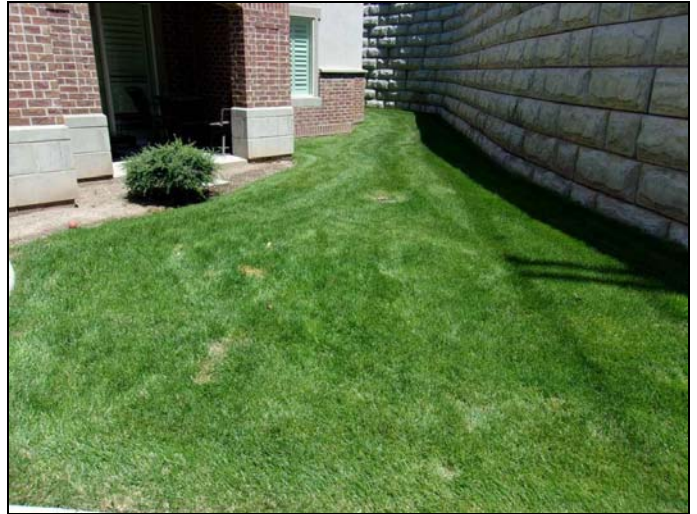
Comp #: 1812 Landscaping & Irrigation System - Renovate

Location: **Common Area**

Quantity: **Minimal Sq.ft.**
