Confidential Inspection Report
12345 Sample Way.
Sample AZ 12345

October 12, 2012

Prepared for:
Sample Inspection

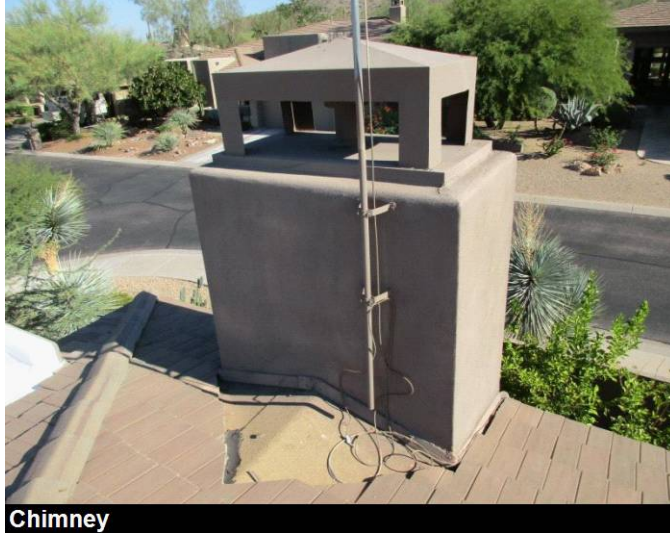
Chimney

In good condition. Spark arrester/rain cap noted.

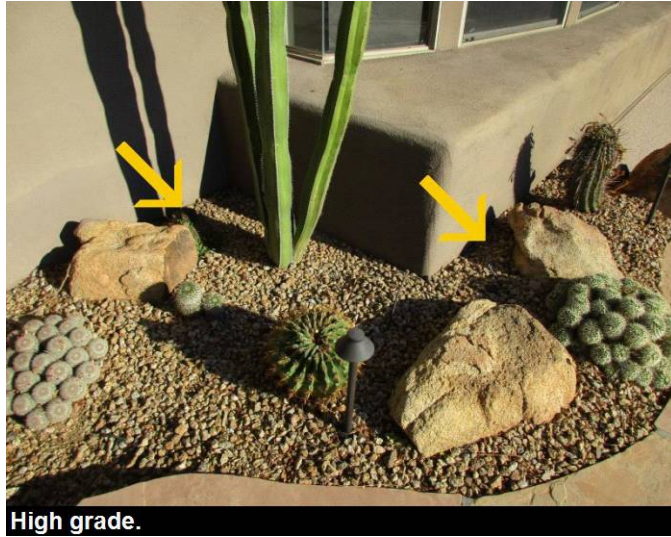
- 3.7 SITE: Flat site.
3.8 CONDITION: Grading at house is in generally good condition with the following noted exception (s):
**Recommend lowering soil/gravel below siding at the southeast house.
Grade should be 6 inches below any stucco or wood materials to prevent pest intrusion.**

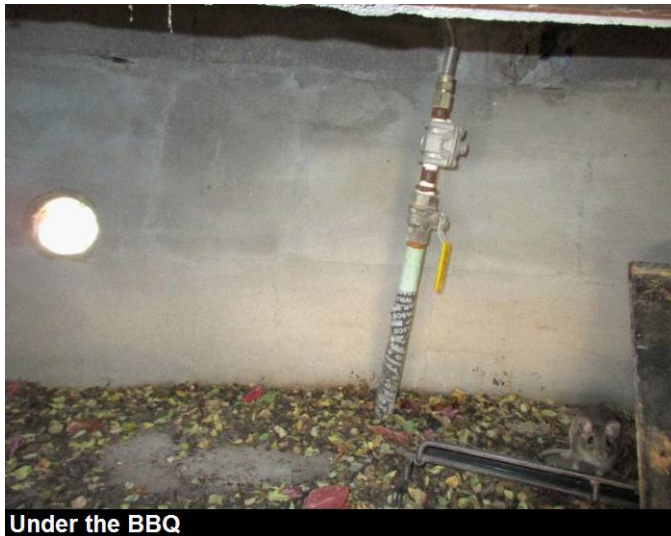
Under the BBQ

Gas type BBQ, Gas Line type
BBQ is in generally good condition with the following noted exception (s):
a) Inoperable burners / valves. This is an older BBQ. Recommend replacing the BBQ.
b) Igniter failed when tested. Recommend Repair.

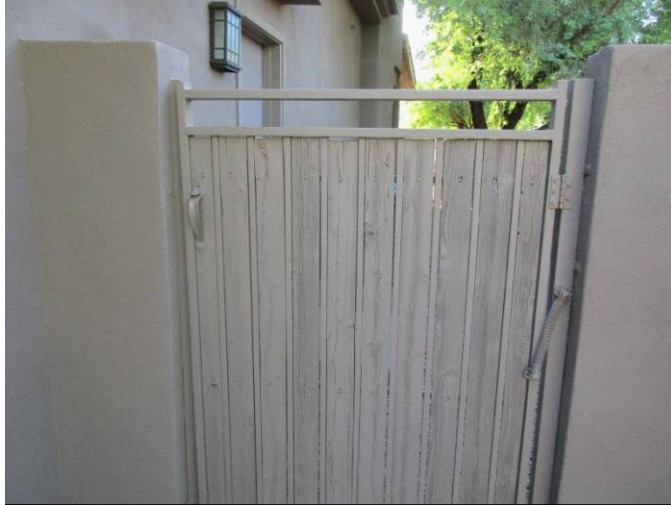
Gate.

Gate(s) in generally good condition with the following noted exception (s):

Recommend repairing gate latch to self close/latch. Child pool safety concern.

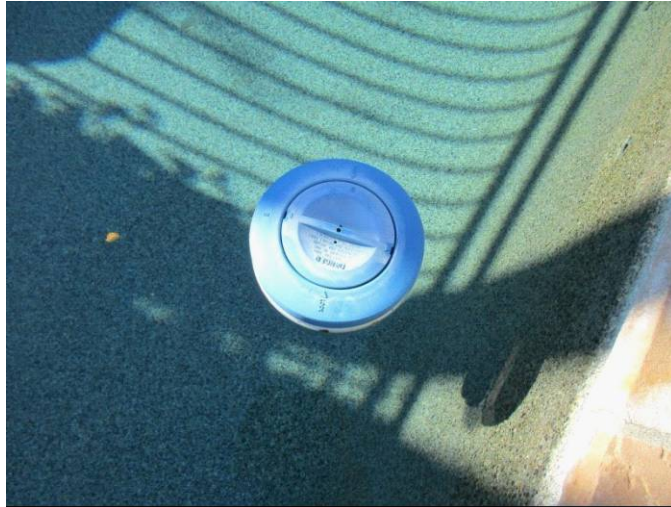
Floating chlorinator,

Observed in generally good condition with the following noted exception(s):

Recommend reviewing with seller prior to close, repair / replace as needed.

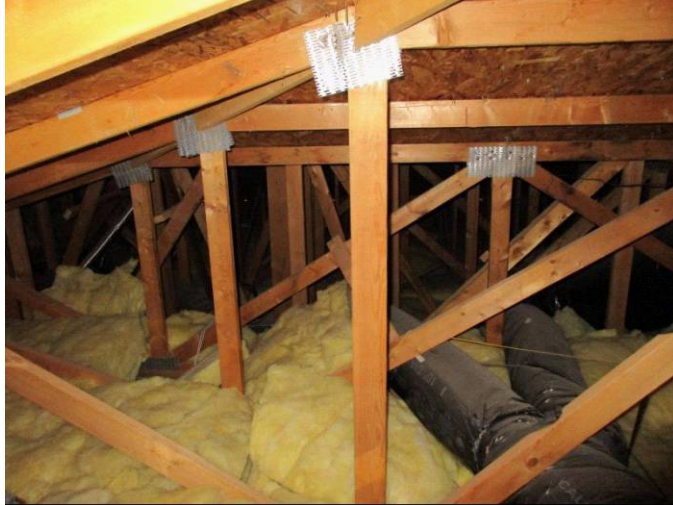
Dead mouse noted in the attic. Unable to determine if there are more, or active mice in the attic.

Recommend contacting a licensed pest control specialist for remediation.

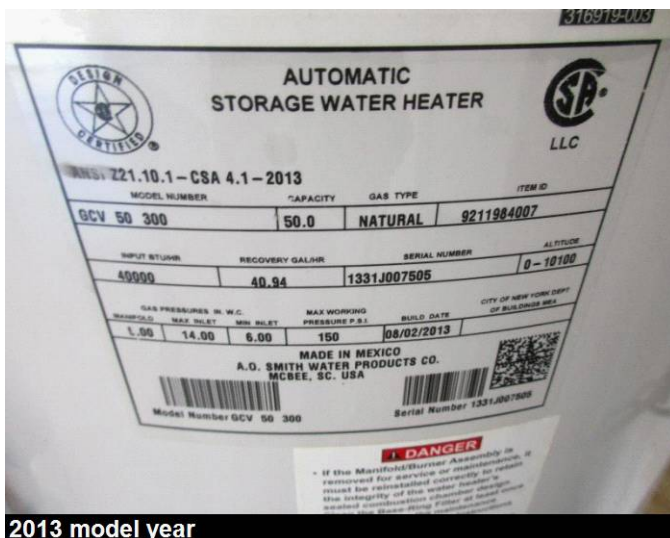
2013 dated Unit. 2 years old.
Industry average life for a gas water heater is 7- 10 years.

2013 model year

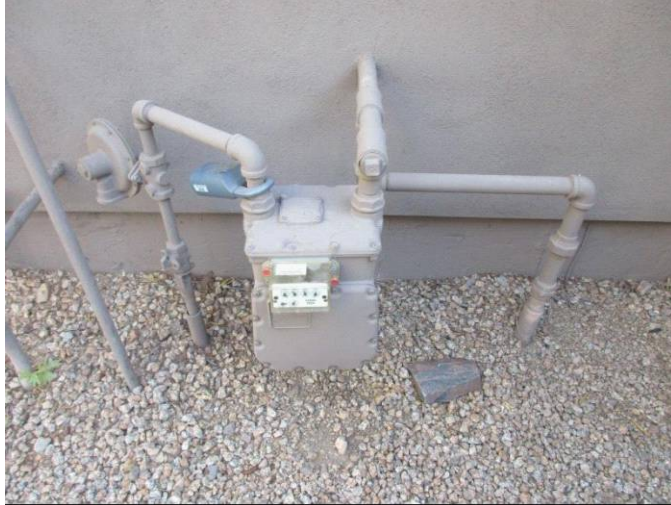
Gas meter noted in good condition.
Gas appliances at this location are;
1) Gas fired furnace(s) in the attic
2) Gas water heater
3) Gas dryer
4) Gas range/cooktop
5) Gas fireplace
6) Gas BBQ
7) Gas pool heater.

Gas meter.

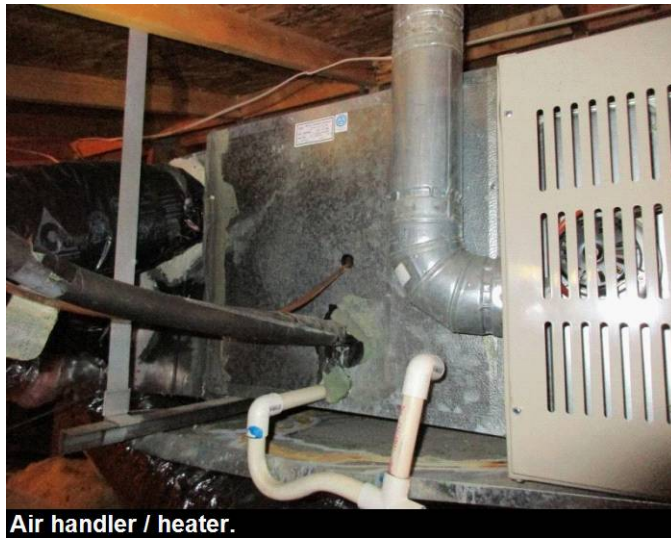
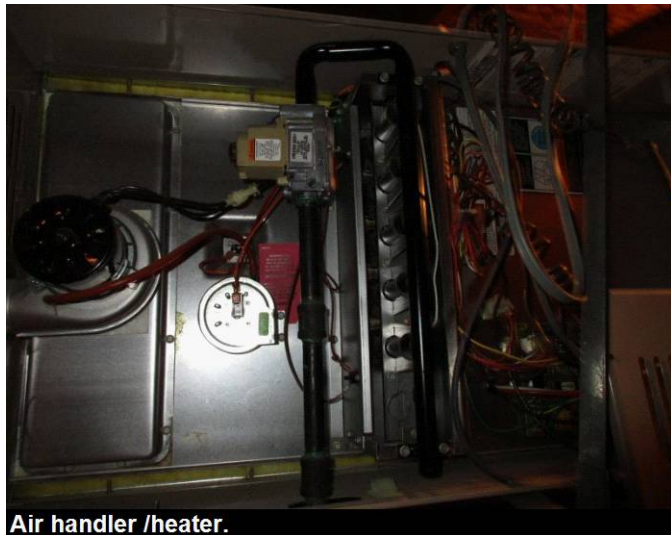
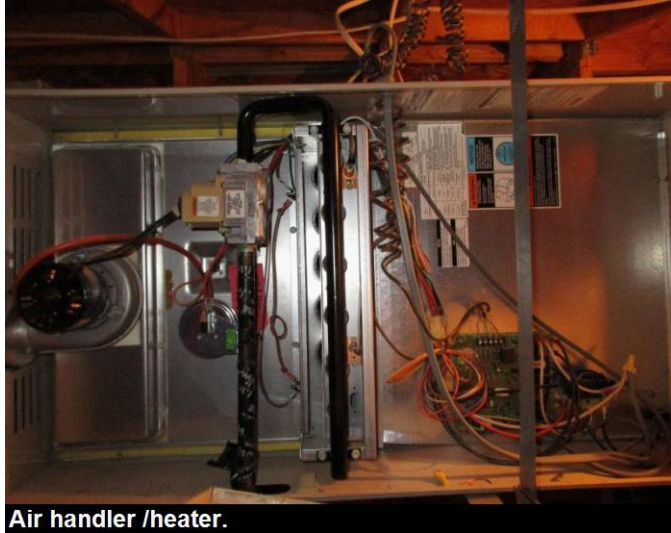
Air handler /heater.

Attic with drip pan observed in good condition (the northernmost unit).

Rust noted at the south units drip pan indicating past leakage.

Recommend reviewing history of area with seller including any past service/repair.

Recommend further evaluation. Repair may be required by licensed HVAC contractor.

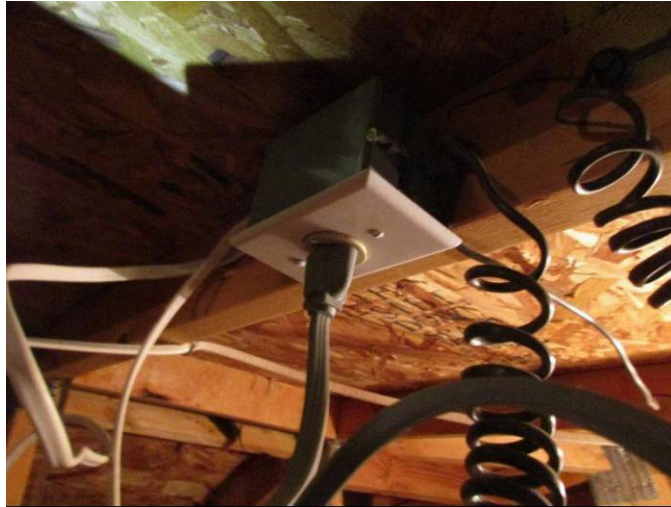
Electrical disconnect (both same)

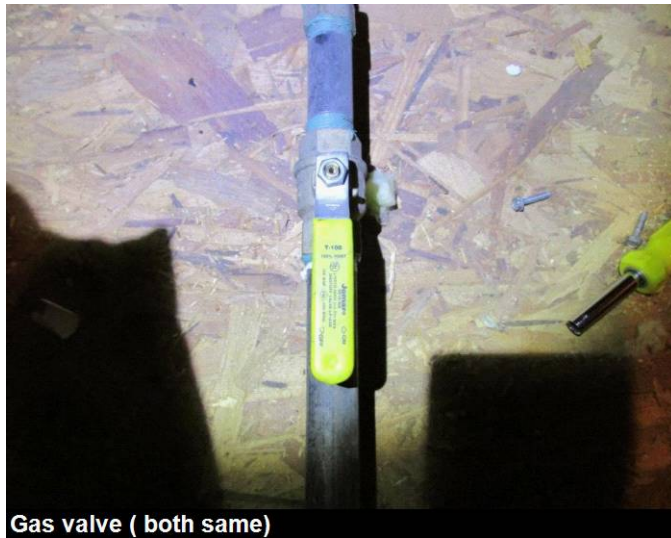
Gas valve (both same)

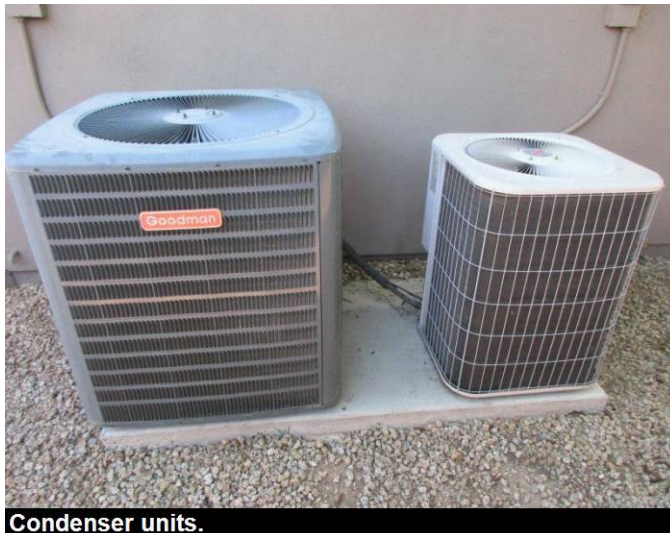
Condenser units.

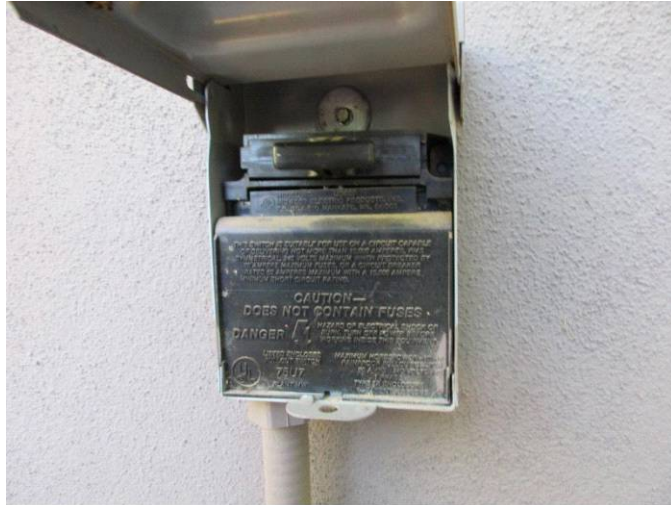
220 Volt, Electrical disconnect present and appears to be in good condition.

Electrical disconnect (both same)

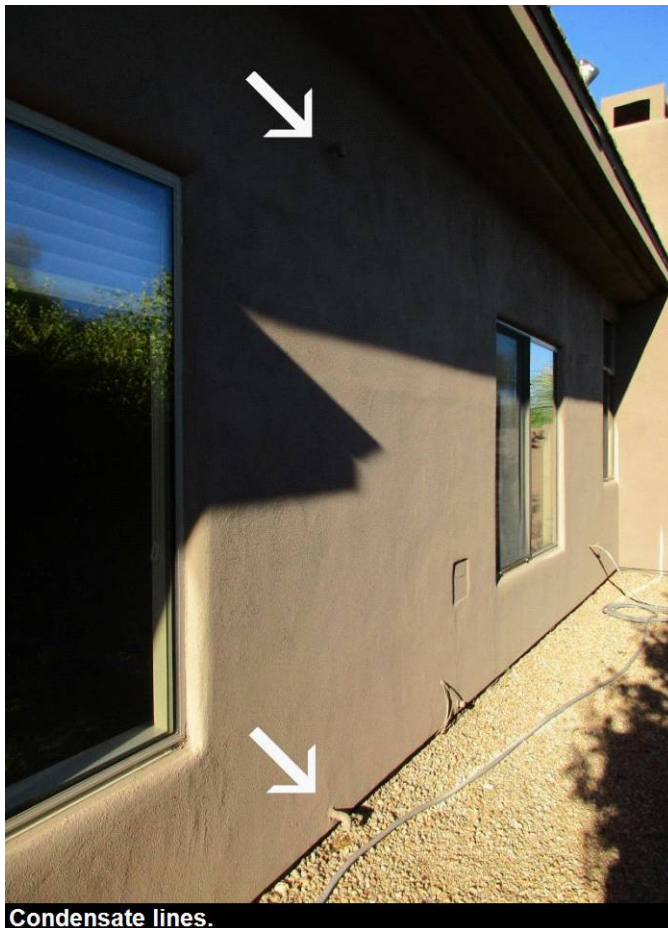
Condensate drain line (CDL) installed. In good condition. No damage or deterioration observed.

Condensate lines.

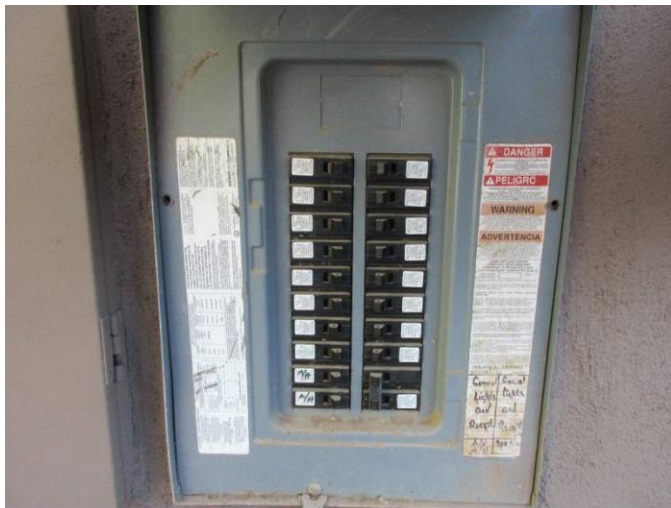
Sub panel

Circuit and wire sizing correct so far as visible, Grounding system is present. Observed in good condition

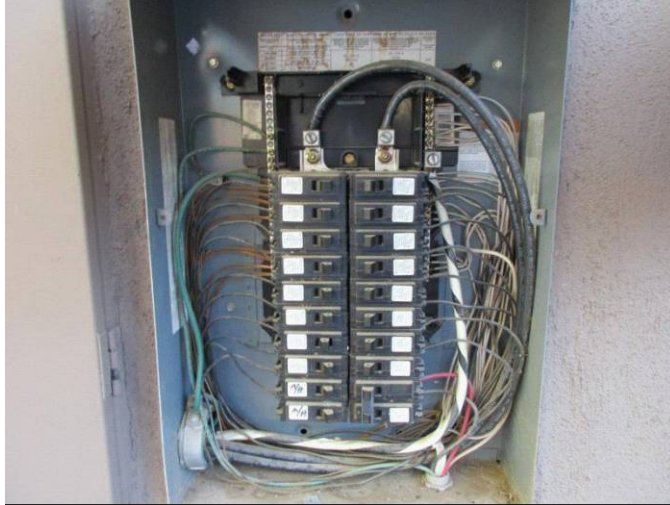
Sub panel (interior)

Panels are without the benefit of complete labeling. Safety concern. Recommend complete labeling.

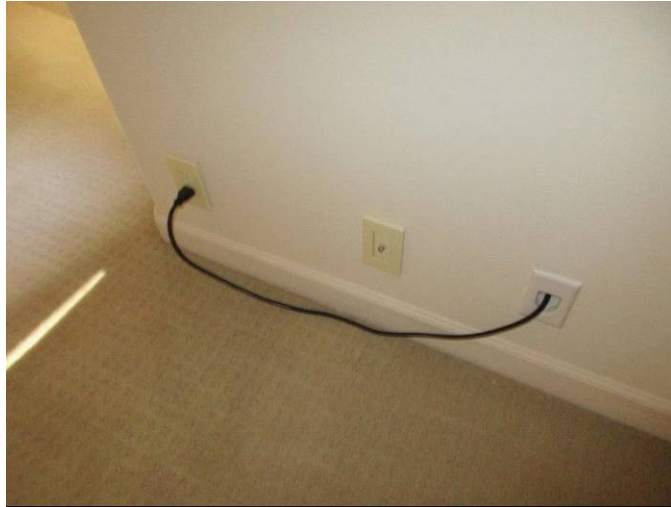
c) There is an electrical cord in the wall at the master bedroom, this is an improper installation. Unable to see the cord inside of the wall (and its condition).

Cord in the wall.

Recommend repairs.

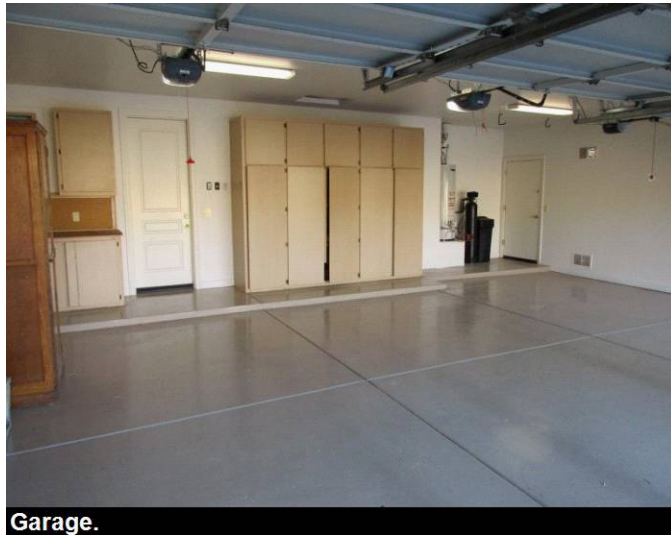
Garage.

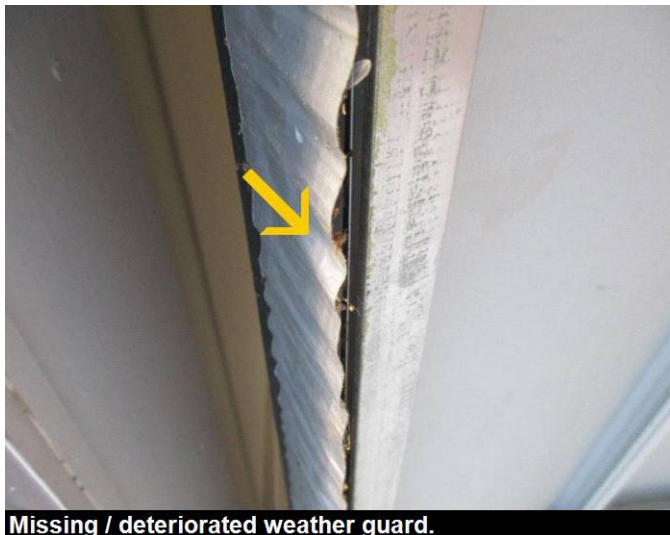
10.8 CONDITION: Automatic door openers tested operational (north and center door openers).
a) The southern most opener would make a slipping / grinding sound when in operation. The belt may be too loose, unable to fully determine this. We recommended further review and evaluation by a qualified and/or licensed garage door contractor . Repair as required.

b) Automatic object reverse feature is not operational at the south and north door openers. (should reverse with 25 lbs of resistance)
Note: All overhead doors should have a fully operational auto-reverse function. Recommend repair/adjustment of this automatic door opener safety feature.
 -Walk through sensors tested operable.
 Door(s) are in generally good condition with the following noted exception(s):

c) Rubber weather guard is missing/deteriorated at the bottom of garage door at the north door.
Recommend repair to prevent water and/or pest intrusion.

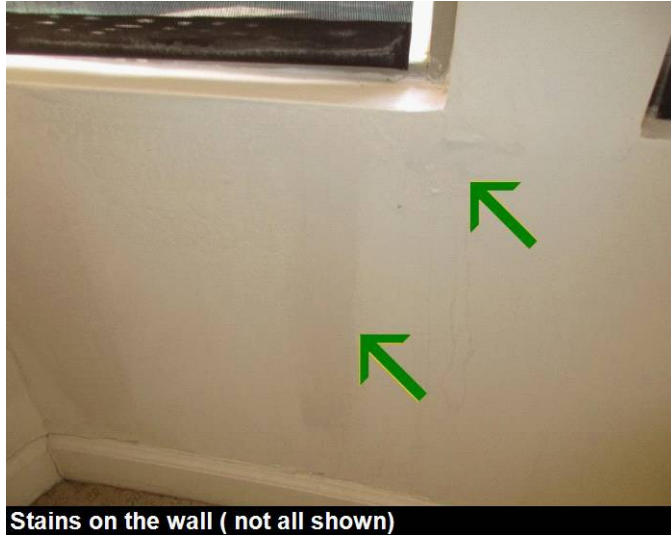
- 11.4 TYPE & CONDITION: Steel frames Single hung glass (slides up & down) and fixed type windows.
All insulated windows observed to be in good condition with no damage noted to vacuum seal. Insulated glass panes
All accessible windows were tested and found to be in generally good condition with the following noted exceptions:
The northeast window at the master bedroom may have leaked onto the wall during rains. Unable to determine if this has been repaired (appears to have newer caulking on the interior side of the window). Recommend reviewing history of past repairs including cause with the seller. Further repair as needed.

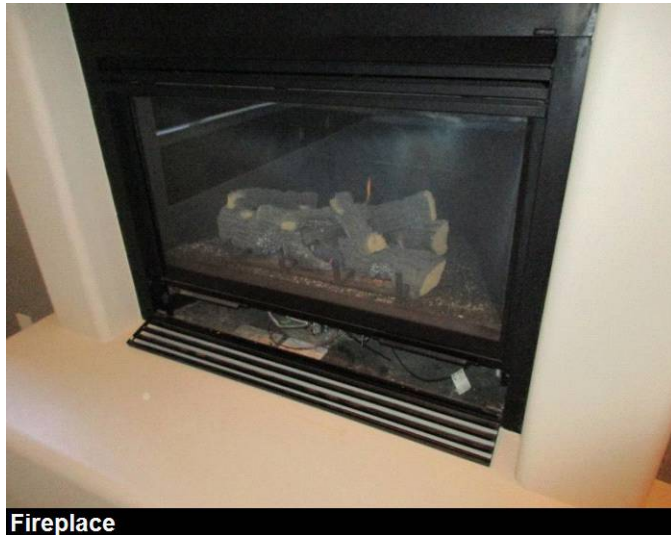
Prefabricated metal, GAS only. Gas tested operable. No damper is installed
Tested operable and in good condition.

Fireplace

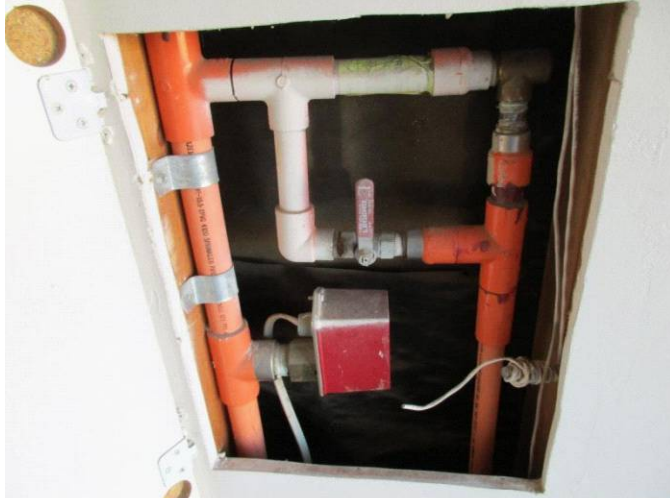
Fire sprinkler controls

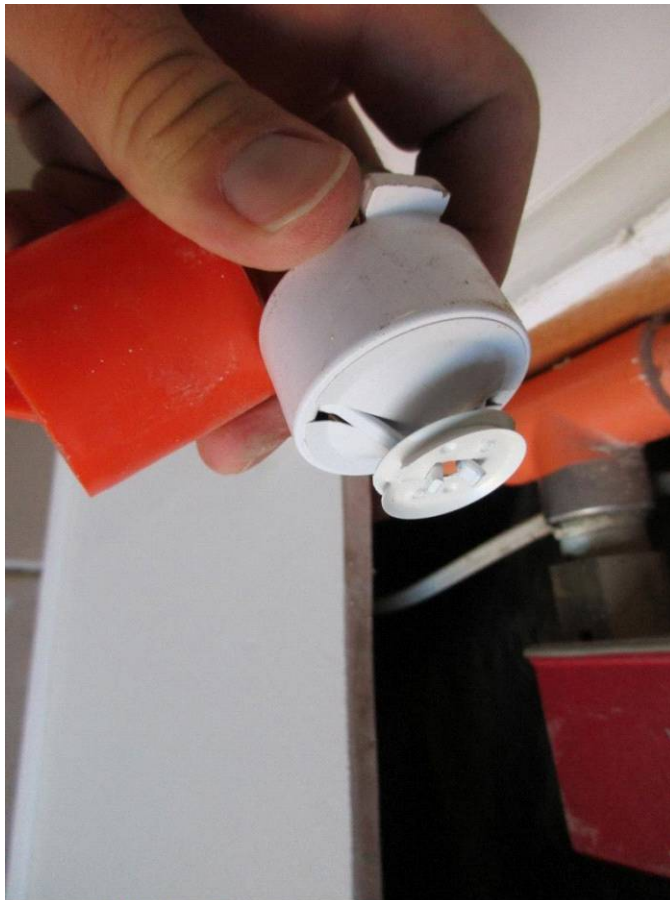
Fire sprinkler head.

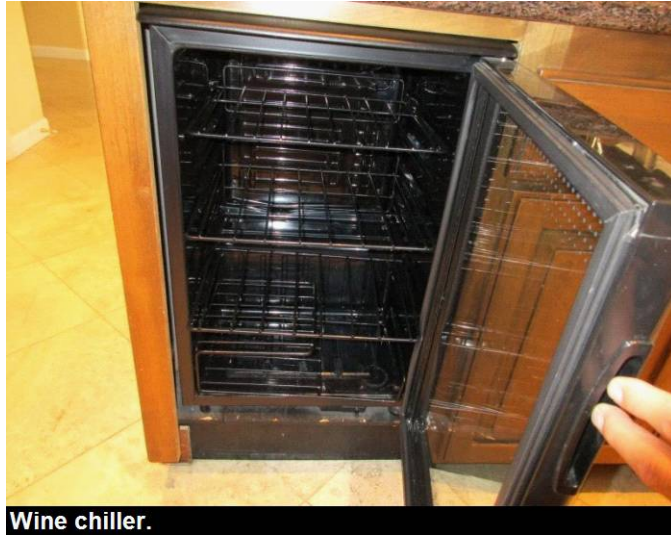
Refrigerator unit operating at the time of the inspection.
Note: 1- Do not test or determine cooling efficiency of unit.
Note: 2- Do not pull out refrigerator to view behind because of possible damage to flooring.
Dispenses water & ice.
The wine chiller in the kitchen is operable and in good condition.
The ice maker / dispenser did not operate and may be broken. Recommend Repair.

Wine chiller.
