Thursday, May 28, 2015

IM Buyer  
1 Seller Lane  
Anywhere, NY 11563

### **REPORT SUMMARY**

# GENERAL INFORMATION

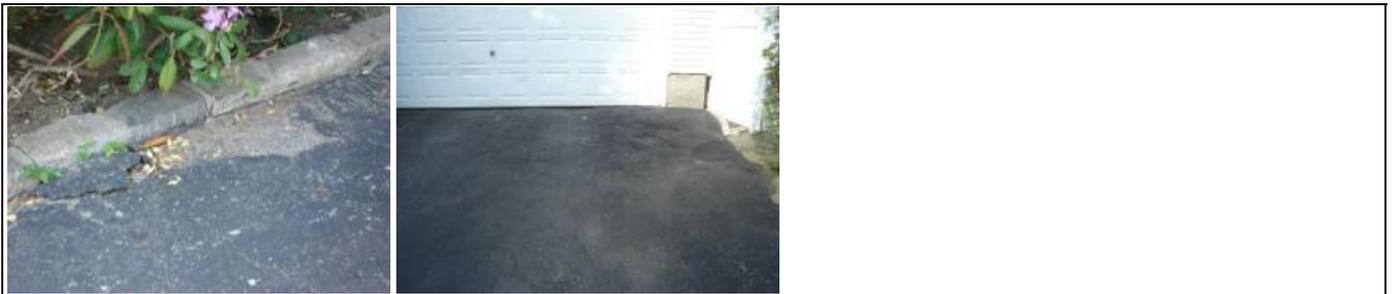
**2.9 Driveway Condition:**

The driveway surface material is in functional condition with only normal deterioration noted.

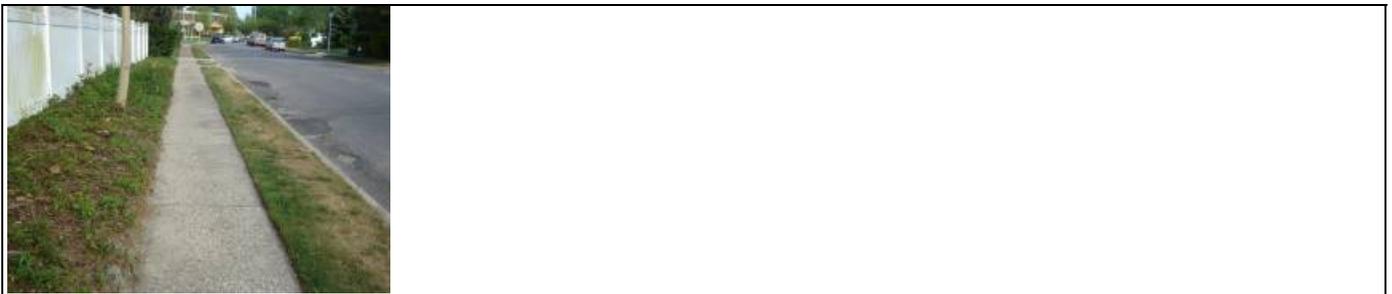
**2.11 Walkway Condition:**

The walkway surface material is in functional condition with only normal deterioration noted.

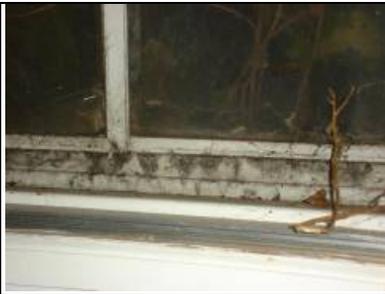
**3.17 Basement Windows:**

There are basement level windows. The windows as installed appear to be functional. The installed windows are above grade, and no leakage problems are anticipated. **Attention Needed** - The ground level in the bottom of the window wells needs to be lowered by digging out the soil to help prevent water from entering the windows or rotting the window framing.

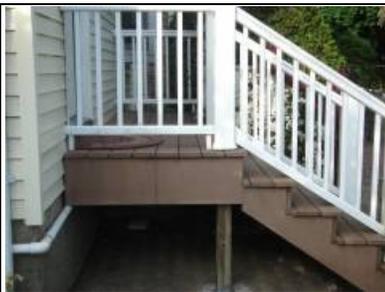
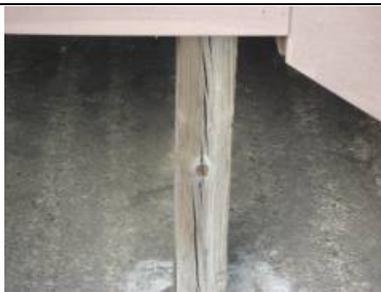
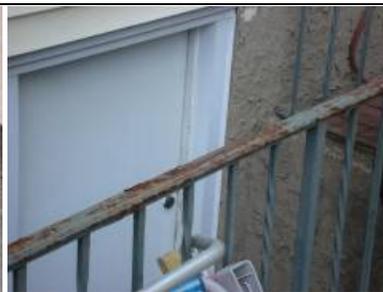
**3.19 Staircase Condition:**

There are handrails solidly attached and in useable condition. The staircase to the basement level appears functional. Hand rails are heavily weathered and should be maintained to prevent further deterioration. Rear entry steps appears functional; Support post is weathered and should be maintained to prevent further deterioration.

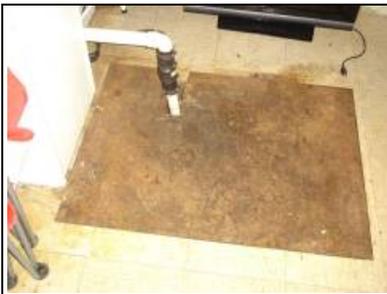
**3.34 Sump Pump Noted:**

Yes. The pump appears functional.

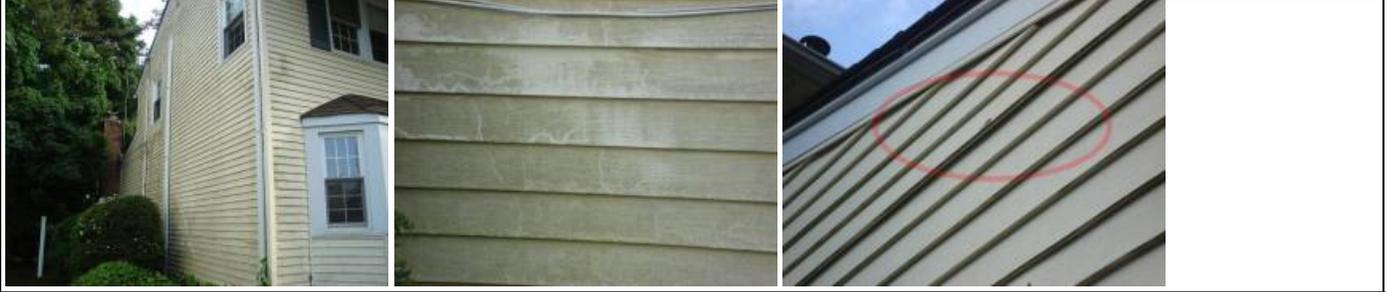
### 5.2 Exterior Siding Materials:

The siding is in serviceable condition. Weathering is noted on siding mainly on the left front of residence. **Attention Needed** - The exterior siding material or finish is in a condition that requires minor repair to prevent further deterioration. Some sagging is evident on rear extension.

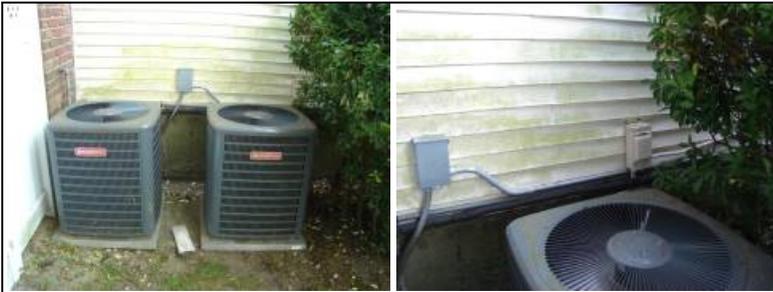
#### 6.1 Model/ Serial Number/ Size:

System is Goodman Manufacturing brand. Serial number is 0706619773 The typical service life for an AC unit is 12 - 15 years.  
Current age: July 2006  
Model # GSC130361DE.

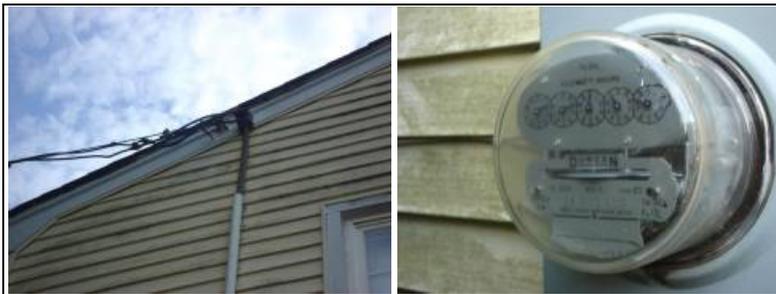
### 7.1 Type & Condition:

Overhead, 120/240 Volt, Circuit breakers, Appears serviceable.

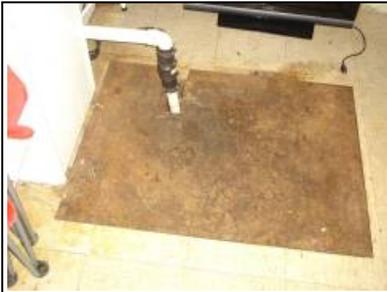
**8.23 Sump Pump:**

Yes - The sump pump installed is functional. The presence of a sump pump does not indicate there is a need for it. This inspection does not verify the existence of or effectiveness of any subslab or perimeter drainage system.

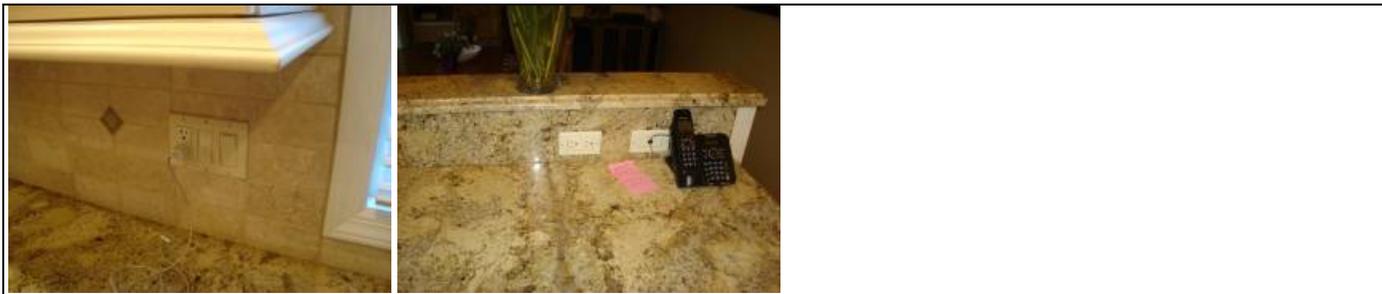
The outlets tested in the kitchen are correctly wired and grounded. As a whole, outlets throughout the room are in serviceable condition.

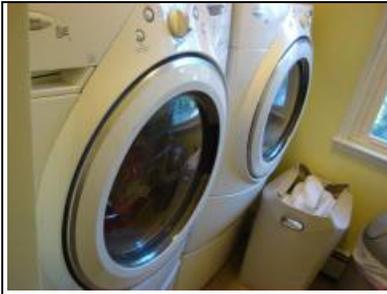
#### 10.7 Washer & Dryer

A washer and dryer are installed. Testing of either is not included as a part of this inspection.

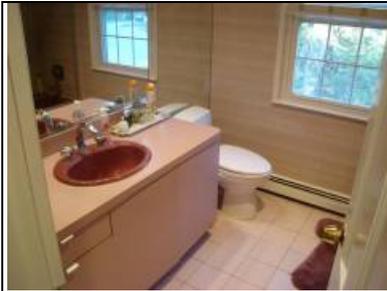
### 11.2 Basin and Drain Fixture:

The basin and drainage fixture appear to be fully functional.

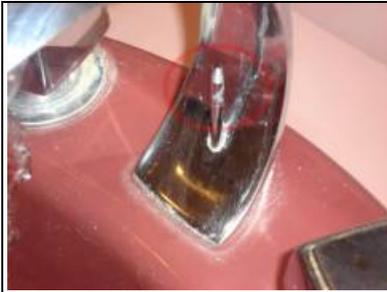
### 11.3 Faucet and Supply Lines:

Faucets and supply lines appear functional.

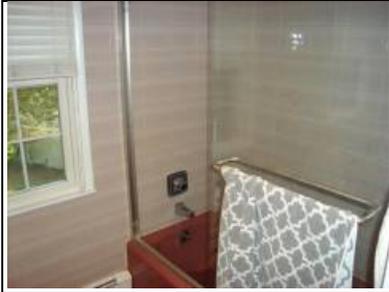
**11.10 Glass Tub/Shower Door:**

Yes. Safety Glass? - There is a set of sliding glass doors installed. I was not able to determine if they are made of safety glass.

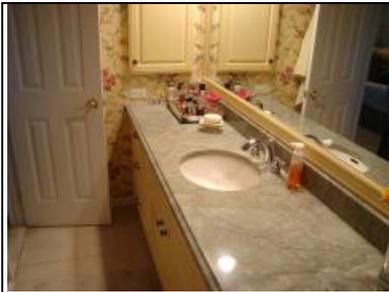
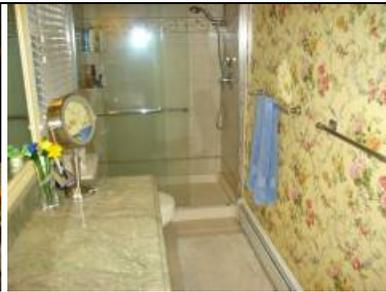
**11.18 Vanity Cabinet:**

The vanity cabinet and top in this bathroom are functional.

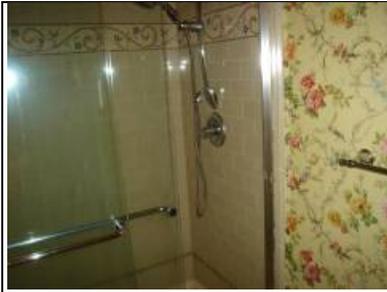
**11.27 Glass Tub/Shower Door:**

Yes.

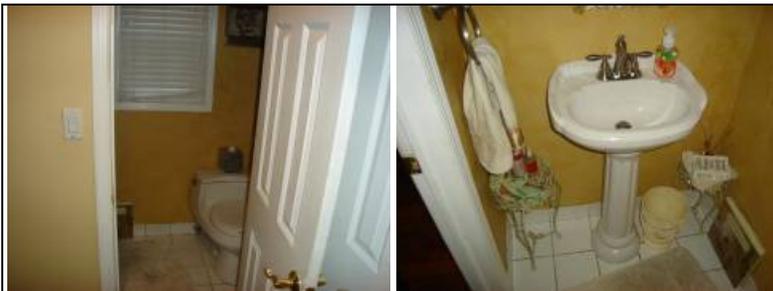
**11.34 Vanity Cabinet:**

The vanity cabinet and top in this bathroom are functional.

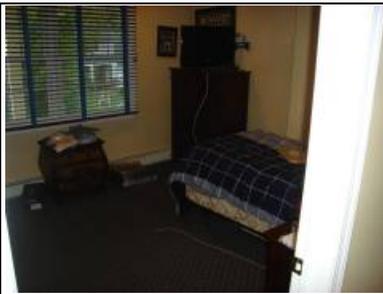
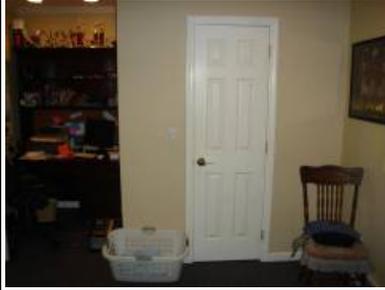
#### 12.9 Entry Door:

The entry door to this bedroom is functional.

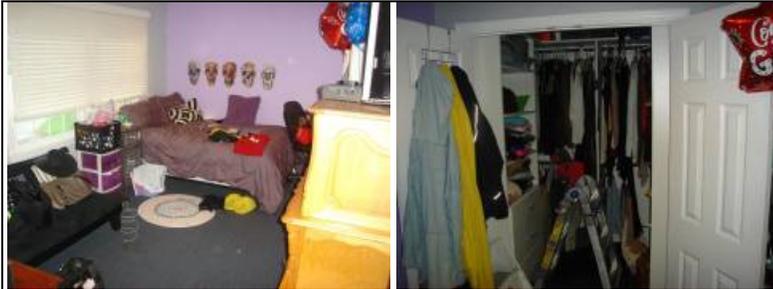
The entry door to this bedroom is functional.

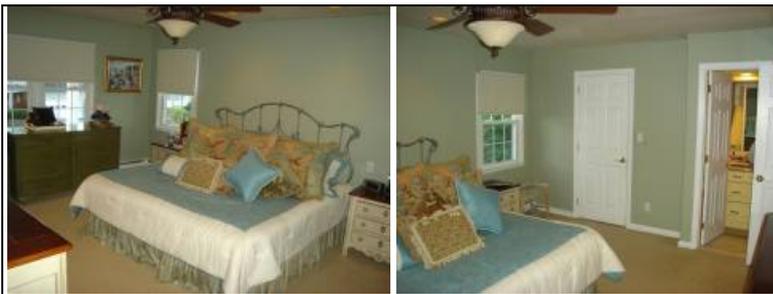
**12.35 Master Bedroom:**

The entry door to this bedroom is functional.

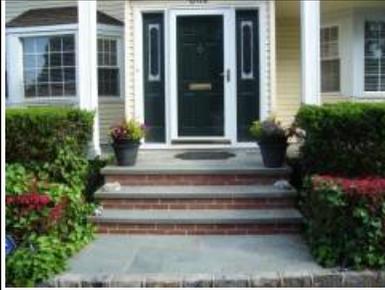
#### 13.2 Front Entry Door:

The main entry door to the structure is in functional condition.

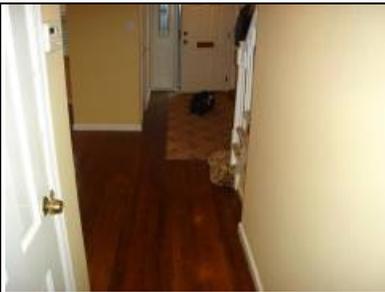
#### 13.5 Main Hallway:

The main hallway walls and floor are without significant issues.

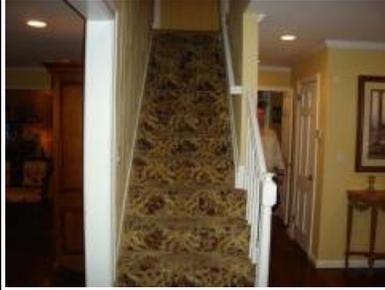
#### 13.7 Main Staircase:

The main staircase is appropriately installed.

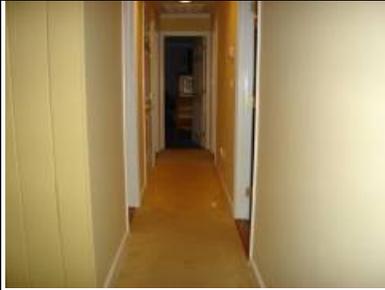
**13.8 Upper Level Hallway:**

The upper level hallway walls and floor are without significant issues.

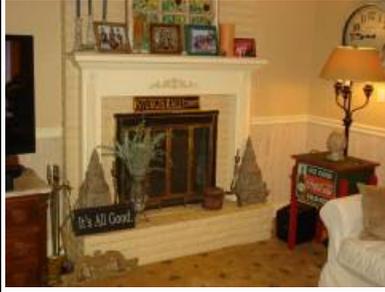
**13.17 Fireplace:**

Yes - There is a fireplace in this room. It has a satisfactory visual appearance. An inspection was completed on the fireplace. It is under the Structural Section.

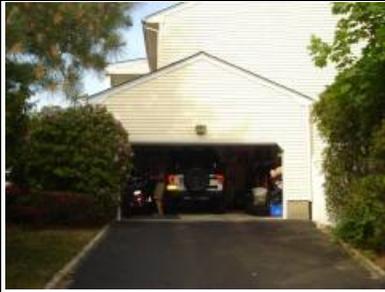
### 14.1 Garage Type

The garage is attached.

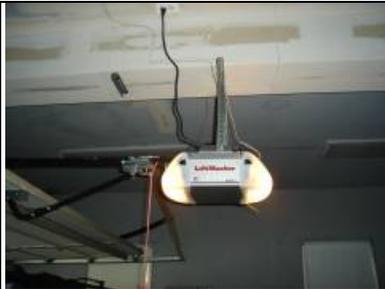
### 14.5 Automatic Overhead Door Opener:

The overhead door opener appears to function appropriately.
