### Architectural and Structural Needs Assessment The Towers, 1110 3rd Avenue North Fargo, North Dakota Issued: May 15, 2018

Re: Architectural and Structural Needs Assessment for The Towers Condominium

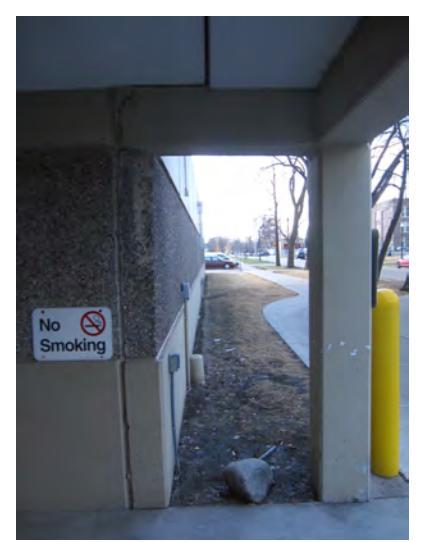
Precast column and beam on the west side of the north entrance.

**Precast Concrete Beams** The exposed precast concrete beams in the parking garage appear to be generally good condition. The precast beam running north and south on the west side of the north entrance has a diagonal crack above the bearing point on the south end. This is likely due to settlement of the precast column on the north end. This crack is not a structural concern, but it should be patched or caulked to prevent water infiltration.

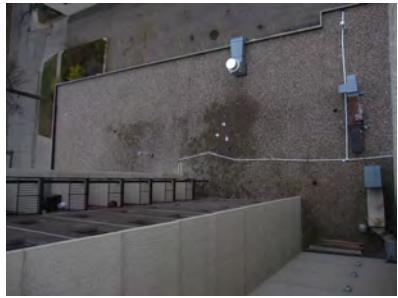
Southeast corner of the garage roof.

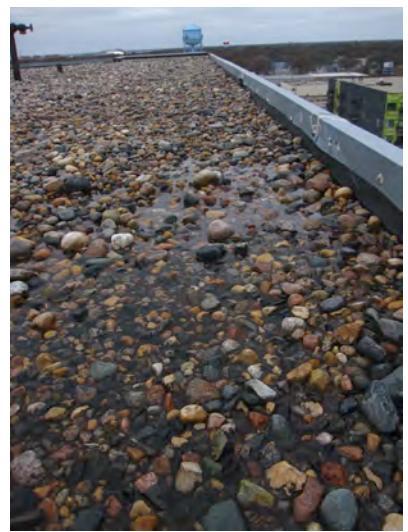
Ponding water in southeast corner of the east tower roof hours after a rain event.

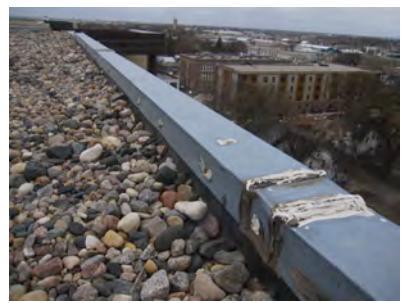
Original flashing at the 9<sup>th</sup> Floor Roof.

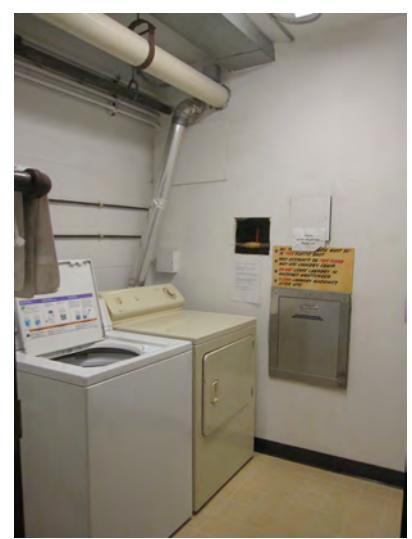
Access panel needed at 9<sup>th</sup> Floor Laundry Room.

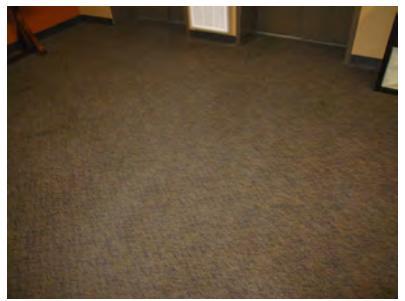
Carpet at garage level elevator lobby.

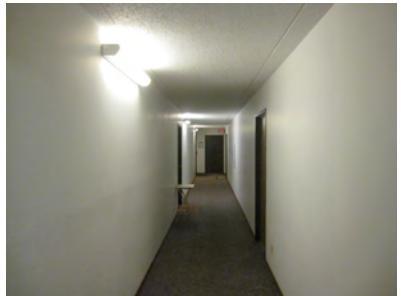
Typical corridor at Floors 1-9.

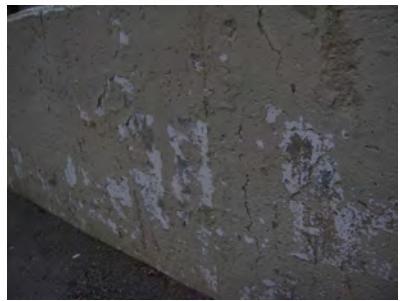
Pealing paint at southwest planter.

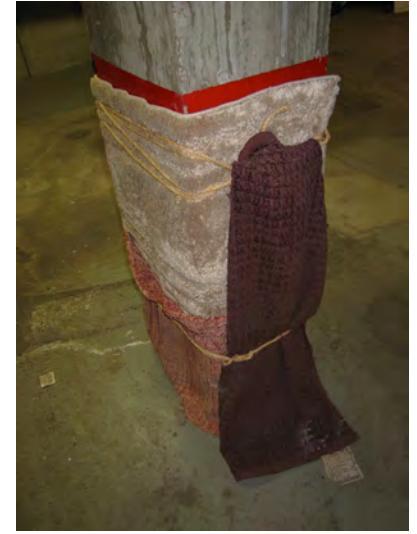
Car door protection at concrete column.

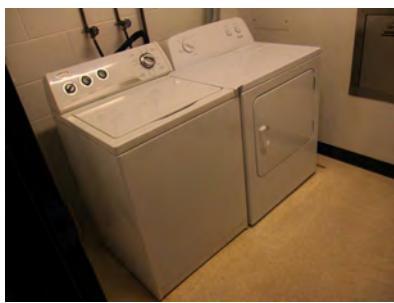
Typical washer and dryer.

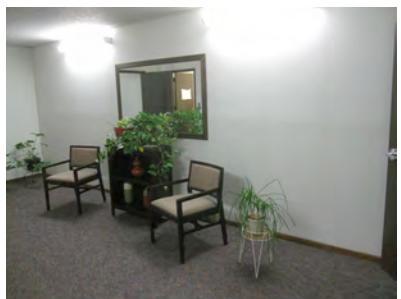
Elevator lobby furniture

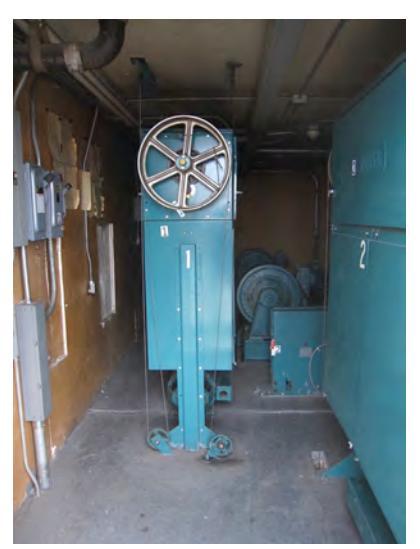
Elevator equipment in the penthouse.

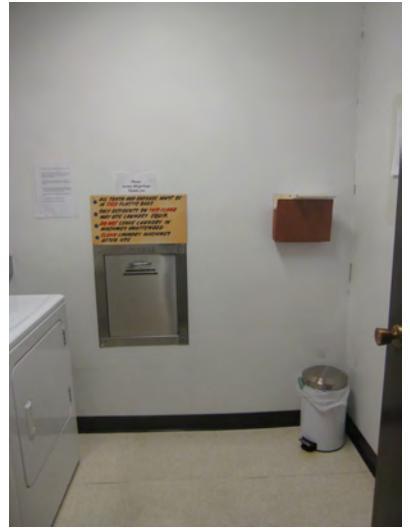
Typical trash chute.
