# Spring Creek Horse Palace Feasibility Study

Elko, Nevada  
October 14, 2016

# INTRODUCTION

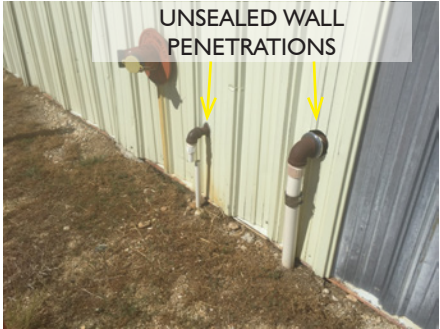
UNSEALED WALL PENETRATIONS

**Wall Penetrations:** Numerous wall penetrations for mechanical equipment are not flashed and sealed properly. It is recommended that these openings be flashed and sealed when the siding is repaired or replaced and sealed.

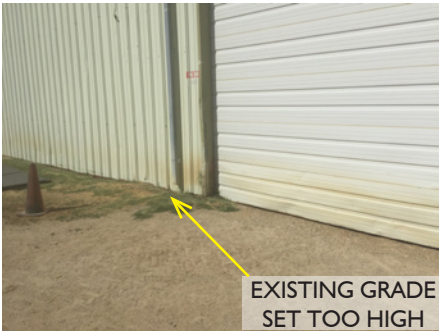
EXISTING GRADE SET TOO HIGH

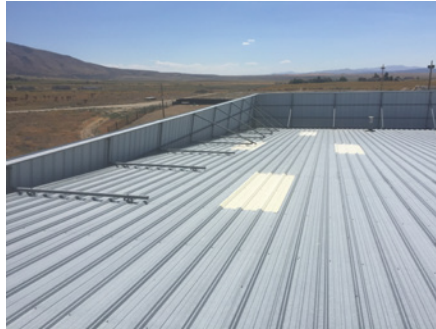
LOOSE ROOF PANEL LAP

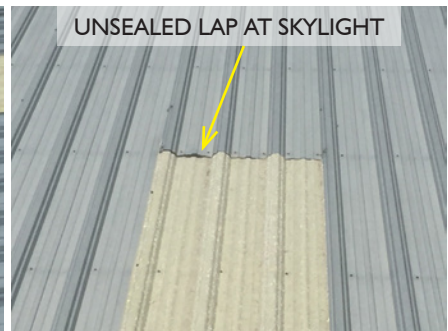
UNSEALED LAP AT SKYLIGHT

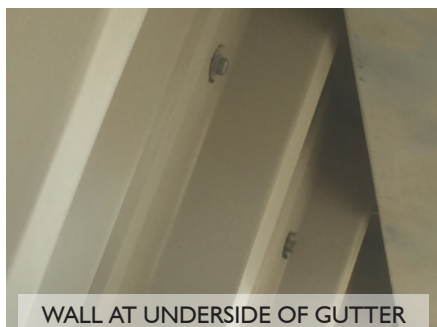
WALL AT UNDERSIDE OF GUTTER

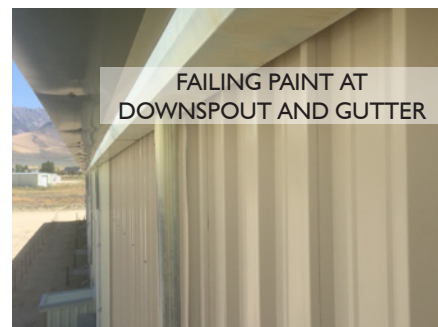
FAILING PAINT AT  
DOWNSPOUT AND GUTTER

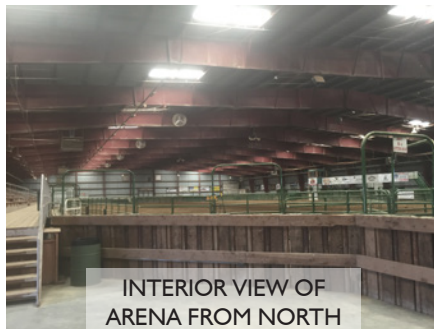
INTERIOR VIEW OF  
ARENA FROM NORTH

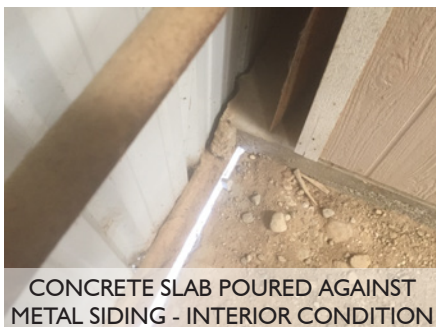
CONCRETE SLAB POURED AGAINST  
METAL SIDING - INTERIOR CONDITION

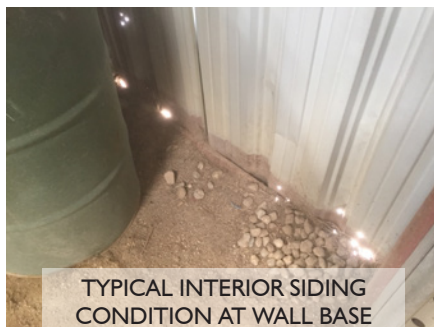
TYPICAL INTERIOR SIDING  
CONDITION AT WALL BASE

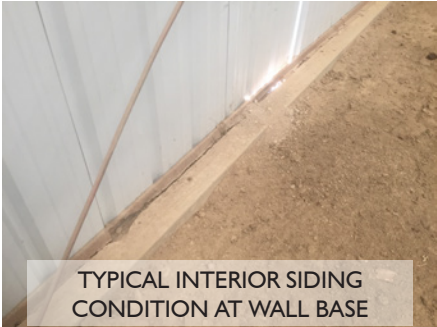
TYPICAL INTERIOR SIDING  
CONDITION AT WALL BASE

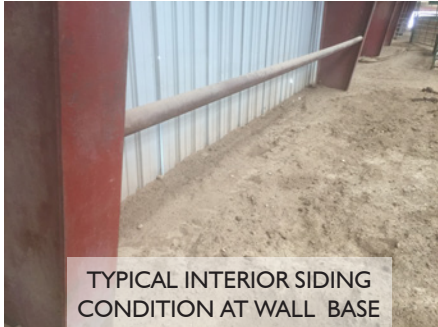
TYPICAL INTERIOR SIDING  
CONDITION AT WALL BASE

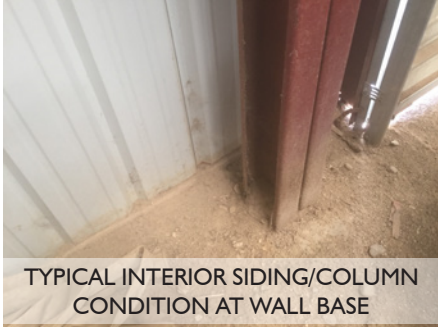
TYPICAL INTERIOR SIDING/COLUMN  
CONDITION AT WALL BASE

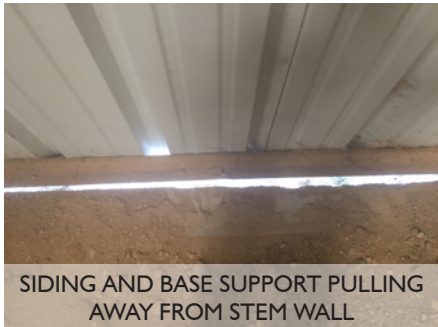
SIDING AND BASE SUPPORT PULLING  
AWAY FROM STEM WALL

It is Lochsa's recommendation that any wall panels or door jams experiencing deterioration or rusting be repaired or replaced. Wall panels on the northeast side of the building should be replaced to be flush with the stem walls as originally intended. It is also recommended that all panel joints, penetrations, and doors be properly sealed to prevent the potential of additional water intrusion. Steel columns showing signs of deterioration or rusting are recommended to be cleaned down to the base metal by the use of scrubbing or pickling and repainted to prevent further deterioration and extend the life of the structural system.

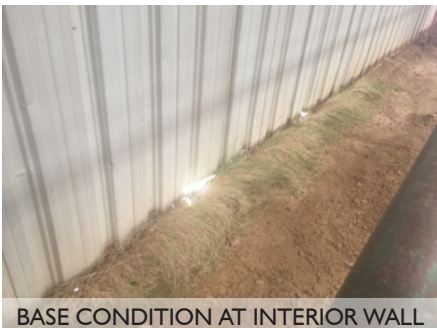
BASE CONDITION AT INTERIOR WALL
