MINIMUM INSPECTION PROCEDURAL GUIDELINES FOR BUILDING ELECTRICAL RECERTIFICATION

Table with 1 column and 13 rows containing structure details: a. Name on Title: Village at Dadeland Condominiums (K), b. Street Address: 7400 SW 82nd St. Miami, Florida 33143, c. Legal Description: Village at Dadeland Condominiums, d. Owner's Name: Village at Dadeland Condominiums, e. Owner's Mailing Address: 7400 SW 82nd St. Miami, Florida 33143, f. Folio Number of Property on which Building is Located: 30-4035-047-XXXX, g. Building Code Occupancy Classification: R2 - Residential, h. Present Use: Condominium, Residential, i. General Description, Type of Construction, Size, Number of Stories, and Special Features. Additional Comments: The condominium building was built in 1970. The 4-story twenty-four unit building at the Village at Dadeland Condominium has an approximate footprint of 175ftx50ft. Building 7400 is 1 of 2 buildings that comprise the VILLA "K" area of the community. Buildings 7410 and 7400 are linked at their east and west ends respectively and have an approximate combined footprint of 350ftx50ft. Two stair/elevator towers are located on their south front elevation and provide access to

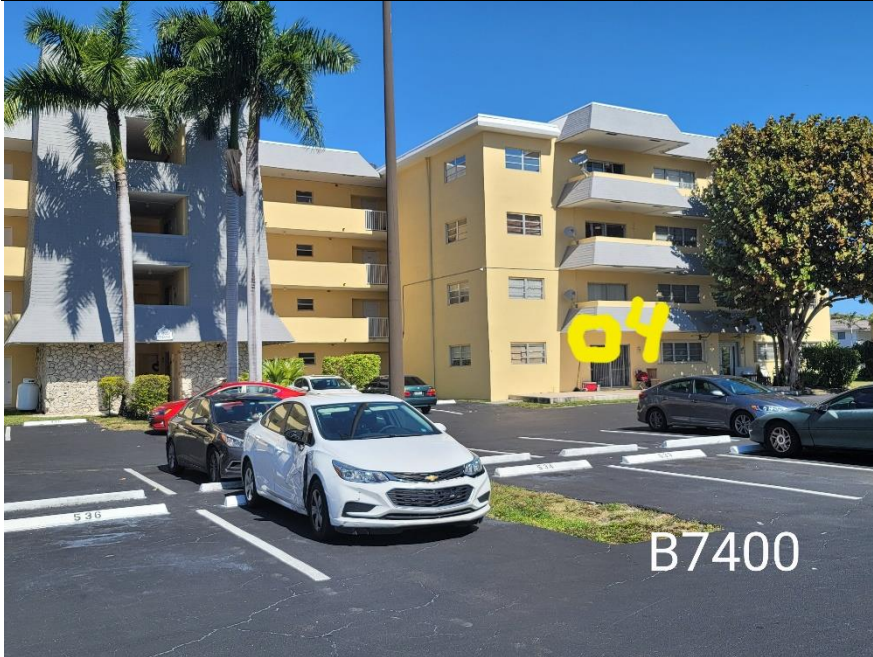
Photo #1:

Front elevation of building
7400
