Treasure State Acres Road Maintenance Plan

DRAFT 2015 REPORT

**Lewis & Clark County
Public Works Department
and
Treasure State Acres Homeowners Assoc.**

Robert Peccia & Associates
Helena & Kalispell, Montana
RPA Project: 14513.000

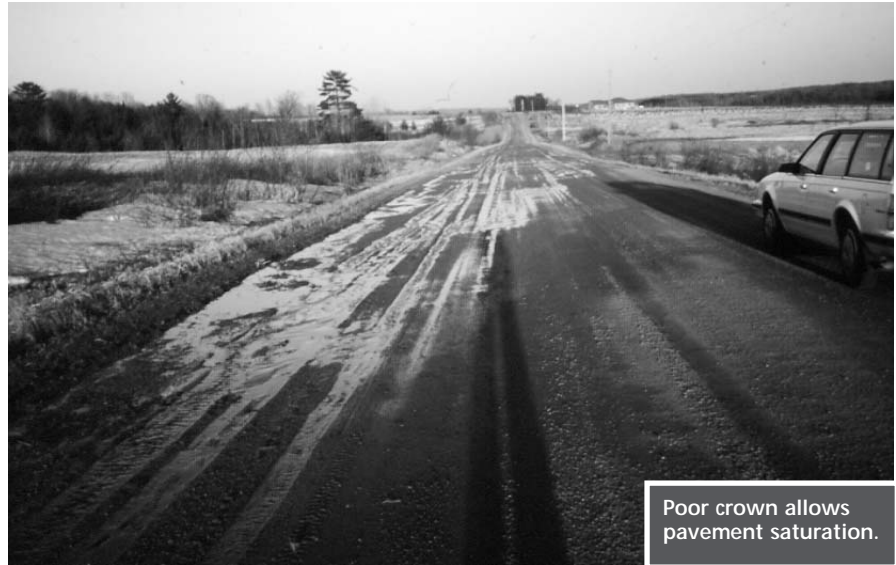
Poor crown allows pavement saturation.

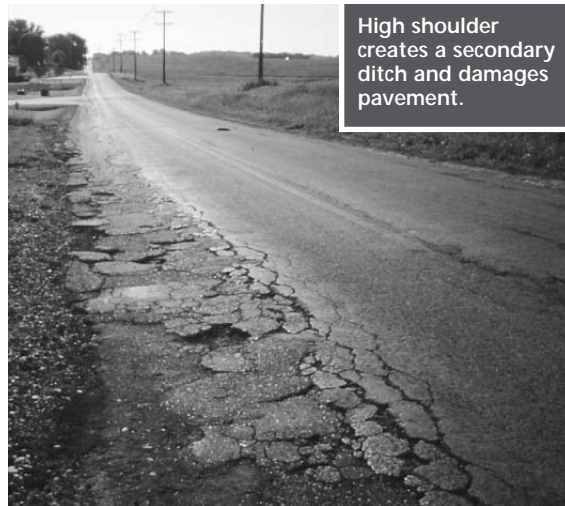
High shoulder creates a secondary ditch and damages pavement.

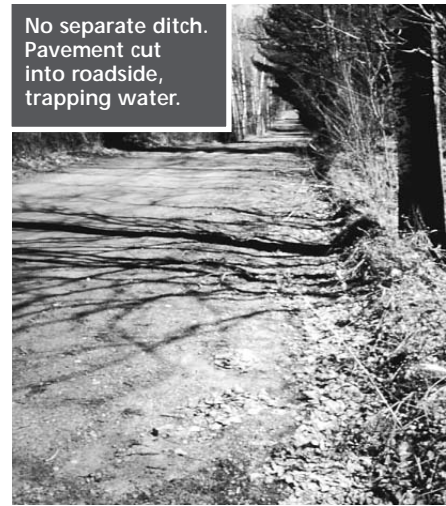
No separate ditch. Pavement cut into roadside, trapping water.

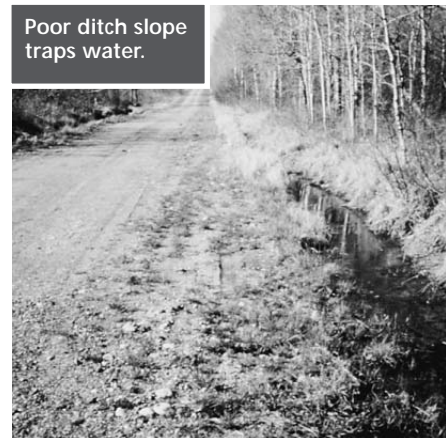
Poor ditch slope traps water.

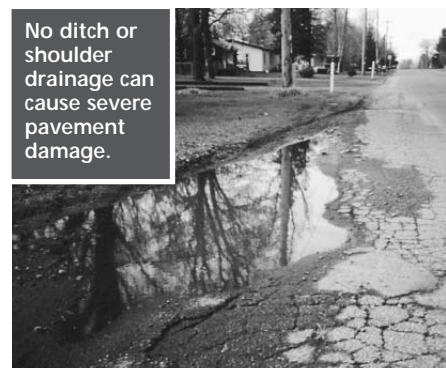
No ditch or shoulder drainage can cause severe pavement damage.

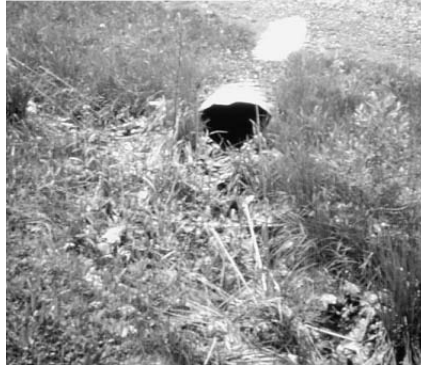
Culvert lacks proper cover. No end treatment. Ditch cleaning needed.

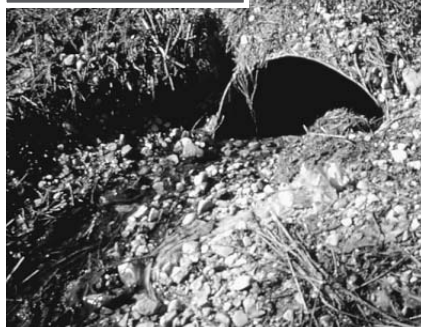
Pipe cleaning required. Determine source of silt and correct to prevent future problems.

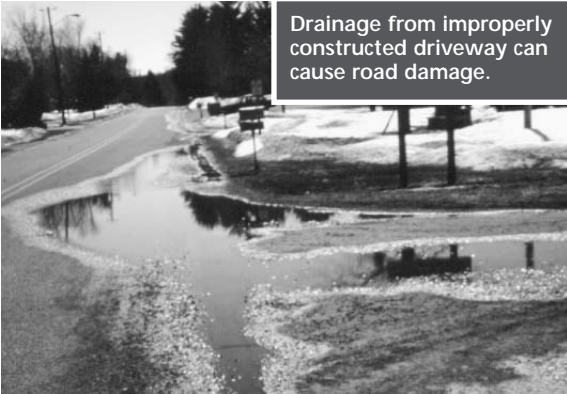
Drainage from improperly constructed driveway can cause road damage.

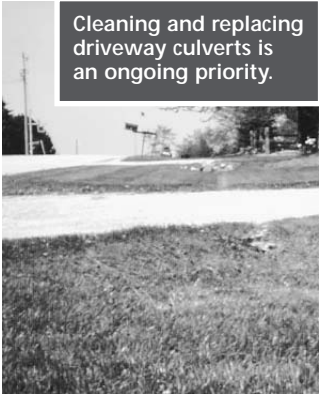
Cleaning and replacing driveway culverts is an ongoing priority.

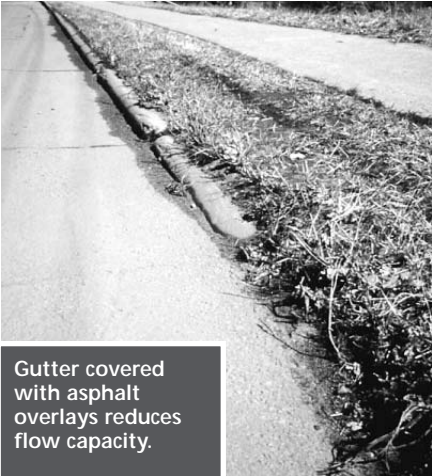
Gutter covered with asphalt overlays reduces flow capacity.

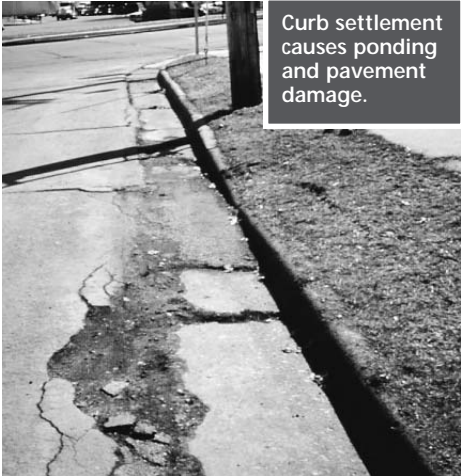
Curb settlement causes ponding and pavement damage.

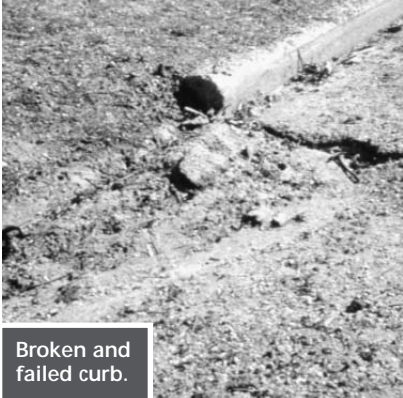
Broken and failed curb.

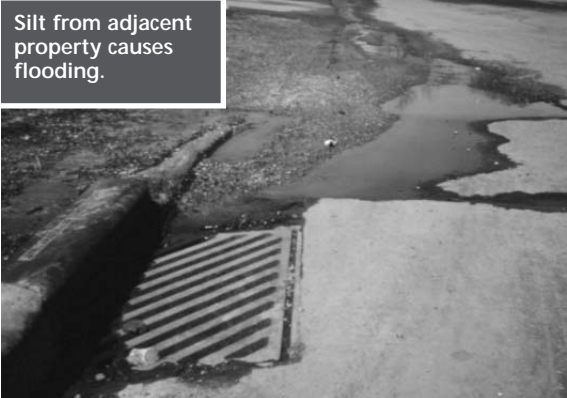
Silt from adjacent property causes flooding.

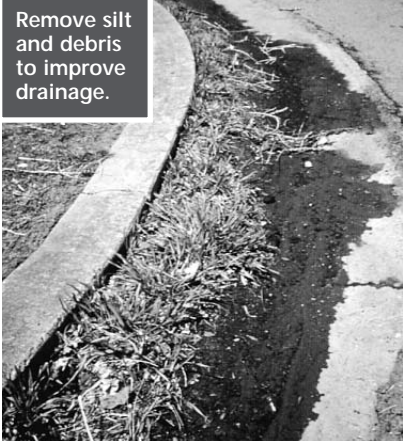
Remove silt and debris to improve drainage.

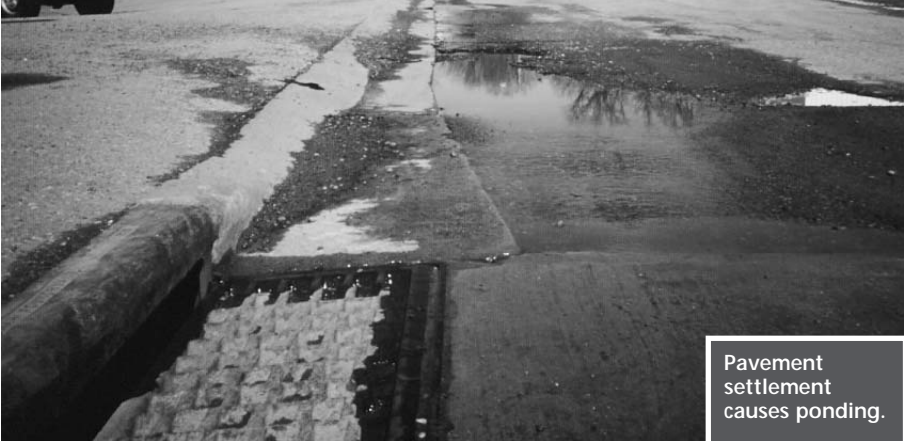
Pavement settlement causes ponding.

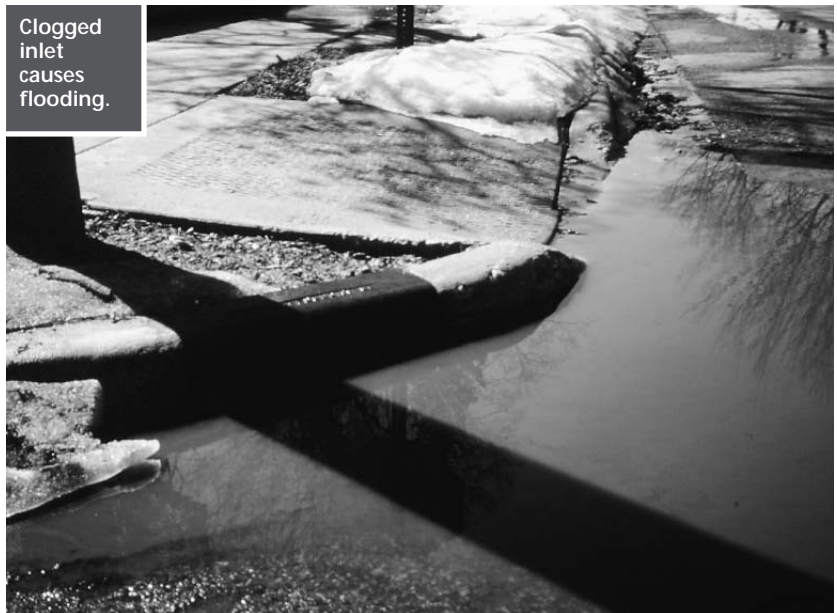
Clogged inlet causes flooding.

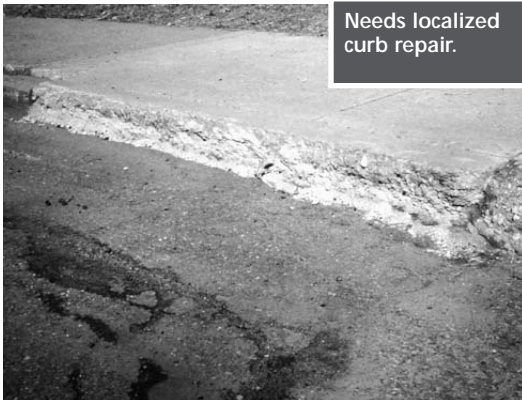
Needs localized curb repair.

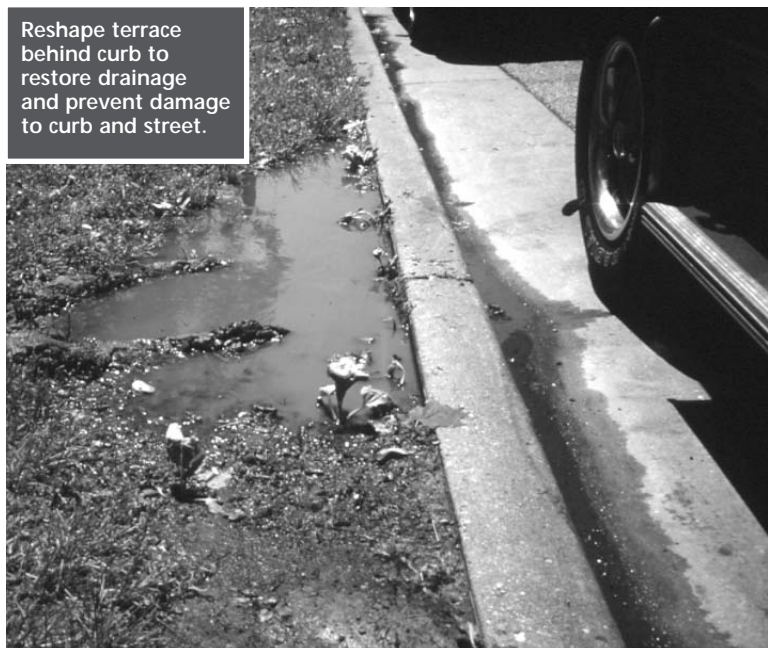
Reshape terrace behind curb to restore drainage and prevent damage to curb and street.

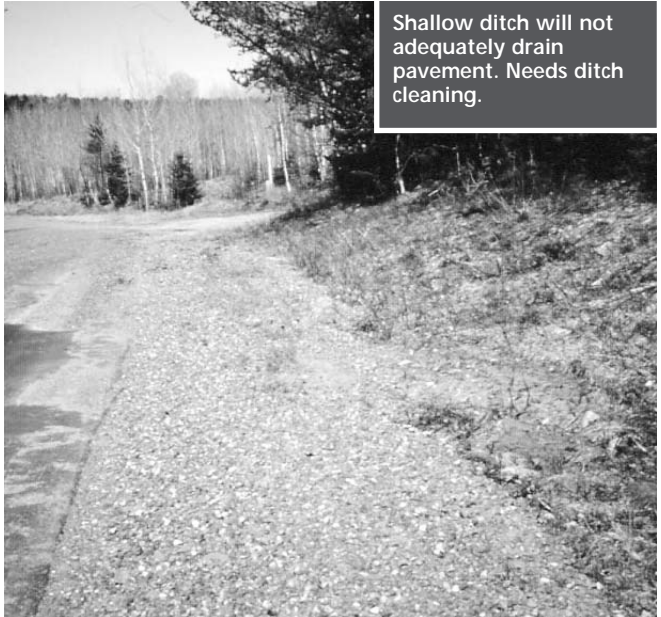
Shallow ditch will not adequately drain pavement. Needs ditch cleaning.

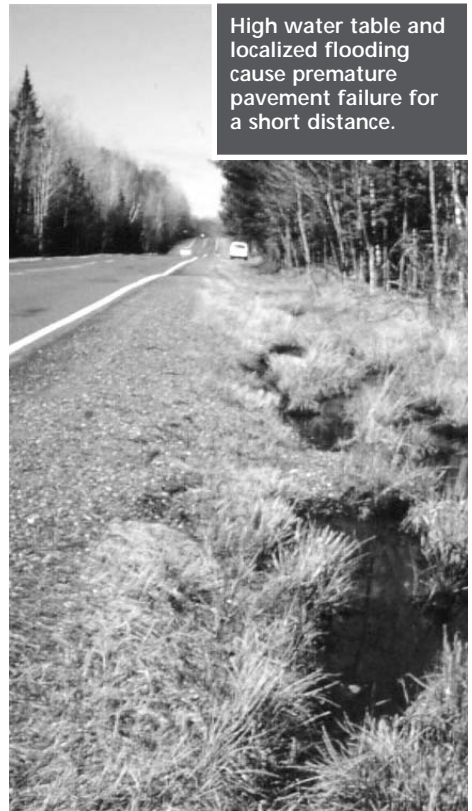
High water table and localized flooding cause premature pavement failure for a short distance.

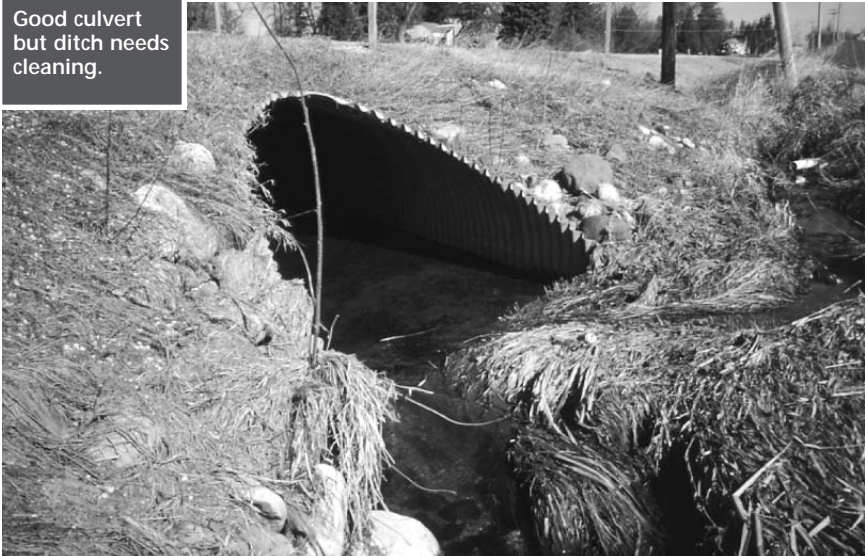
Good culvert but ditch needs cleaning.

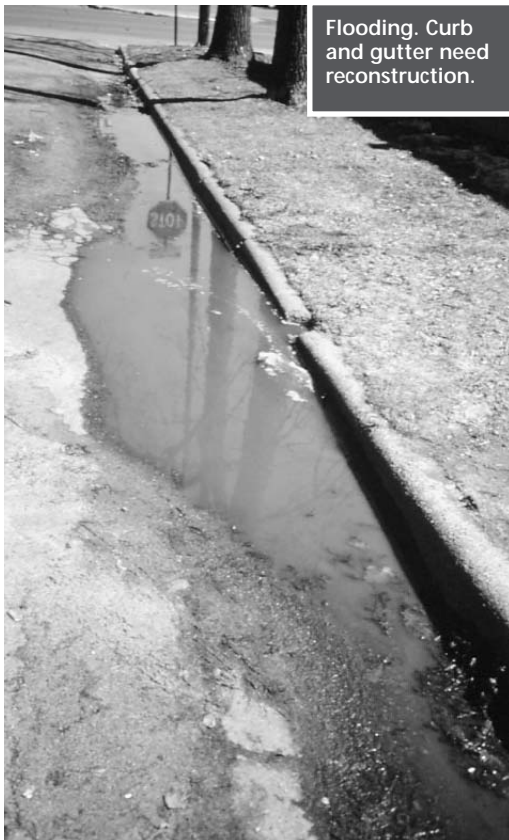
Flooding. Curb and gutter need reconstruction.

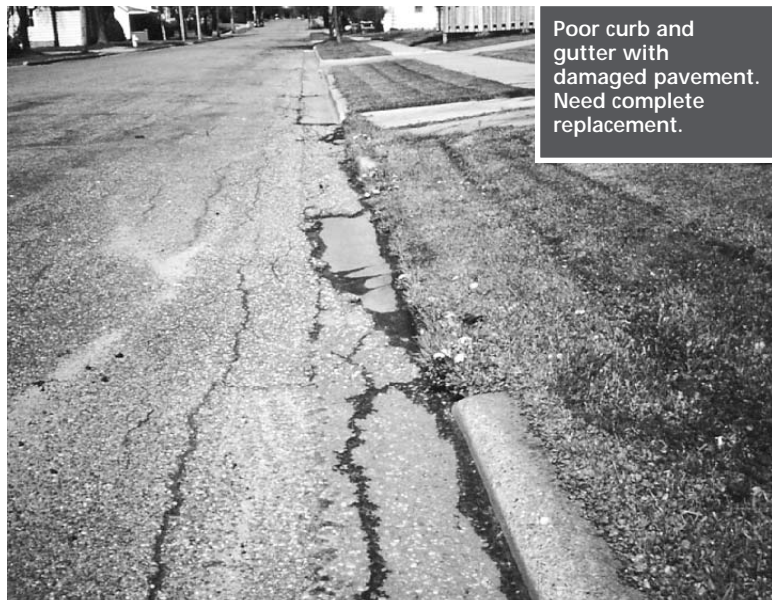
Poor curb and gutter with damaged pavement. Need complete replacement.

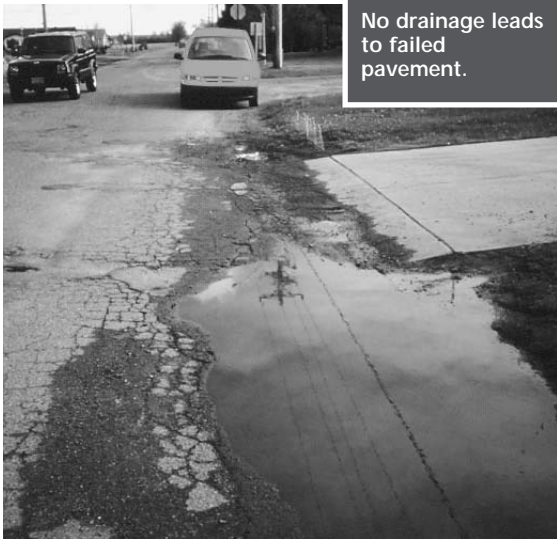
No drainage leads to failed pavement.

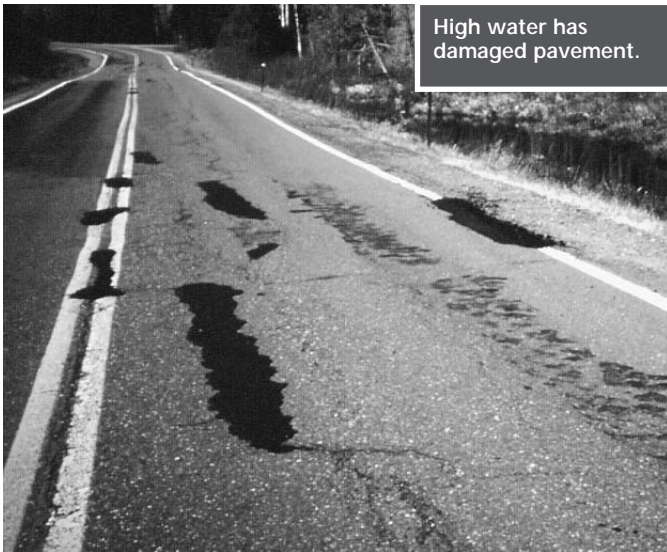
High water has damaged pavement.

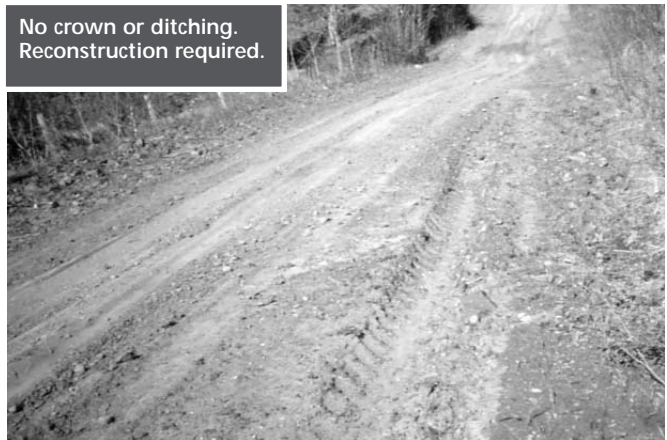
No crown or ditching. Reconstruction required.

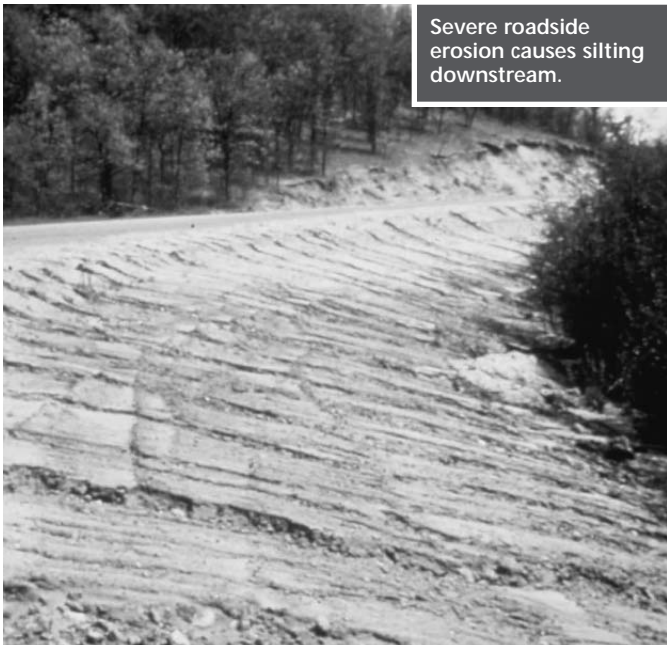
Severe roadside erosion causes silting downstream.

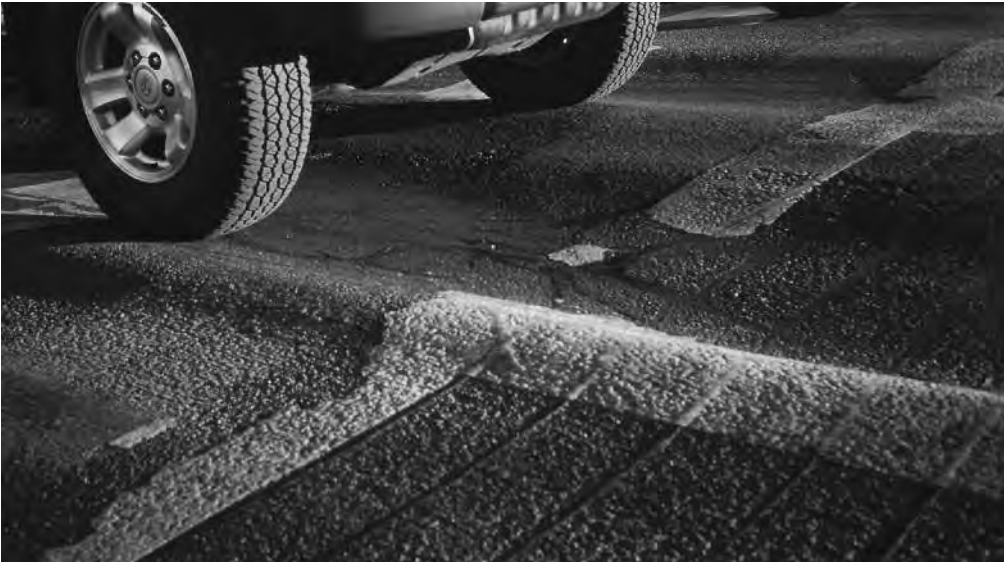
◀ Severe rutting over 2" caused by poor mix design.

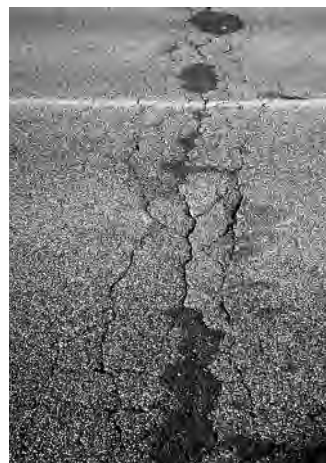
▲ Water enters unsealed cracks softening pavement and causing secondary cracks.

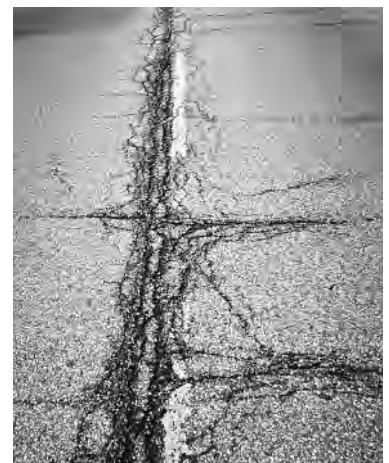
▲ Pavement ravels and erodes along open cracks causing deterioration.

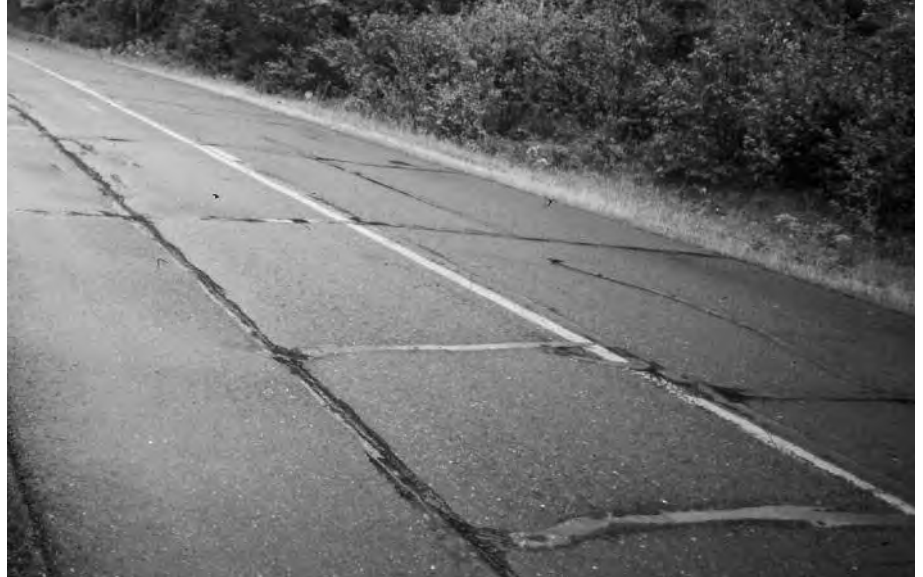
►
Concrete joints reflected through bituminous overlay.

Cracks in overlays reflect the crack pattern in the pavement underneath. They are difficult to prevent and correct. Thick overlays or reconstruction is usually required.

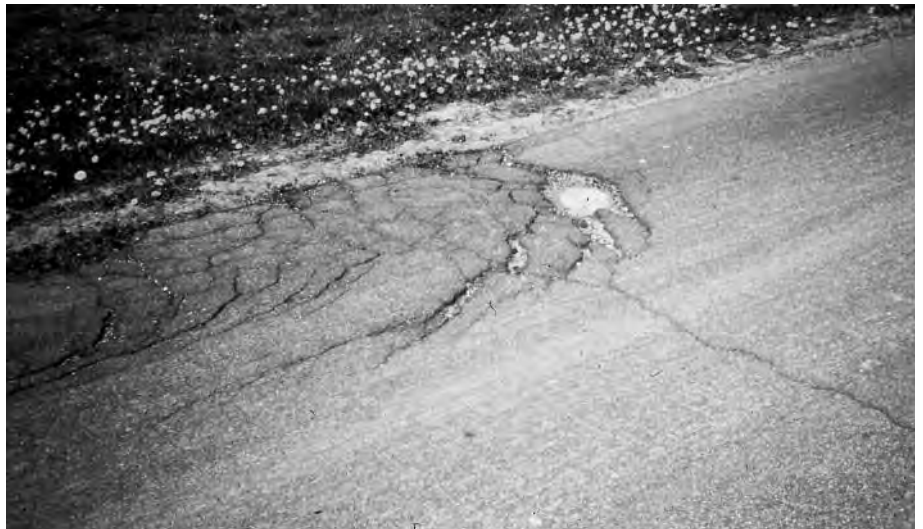
►
Crescent-shaped cracks characteristic of slippage.

Crescent or rounded cracks in the direction of traffic, caused by slippage between an overlay and an underlying pavement. Slippage is most likely to occur at intersections where traffic is stopping and starting. Repair by removing the top surface and resurfacing using a tack coat.

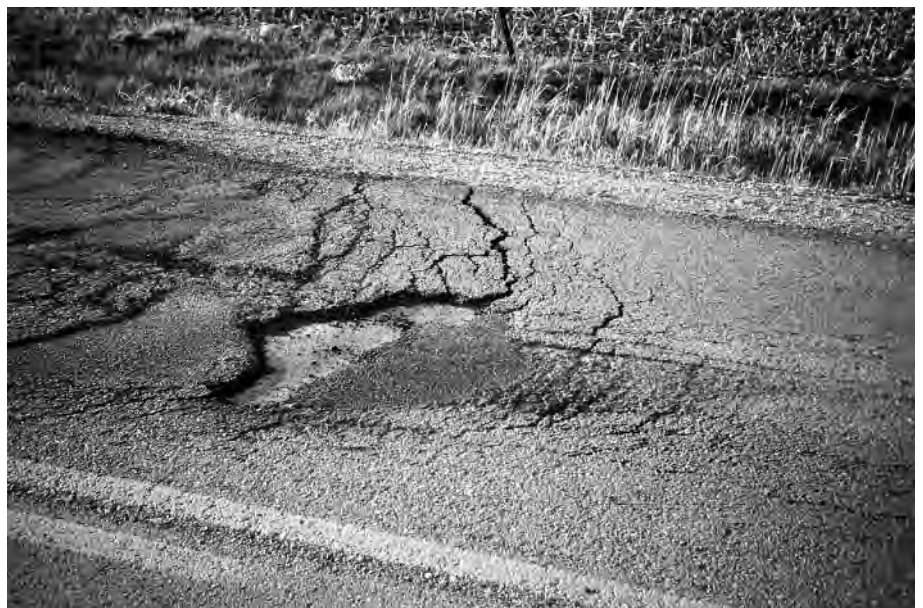
►
Loss of bond between pavement layers allows traffic to break loose pieces of surface.

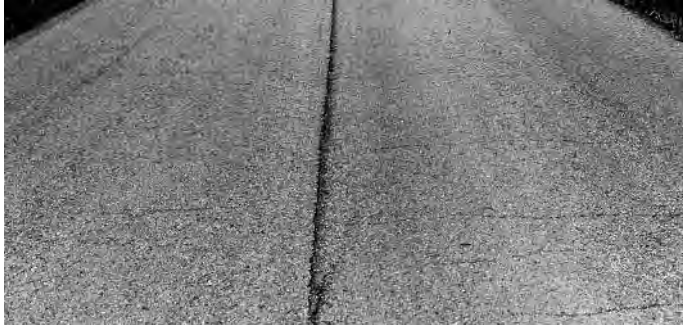
Centerline crack (still tight). ▶

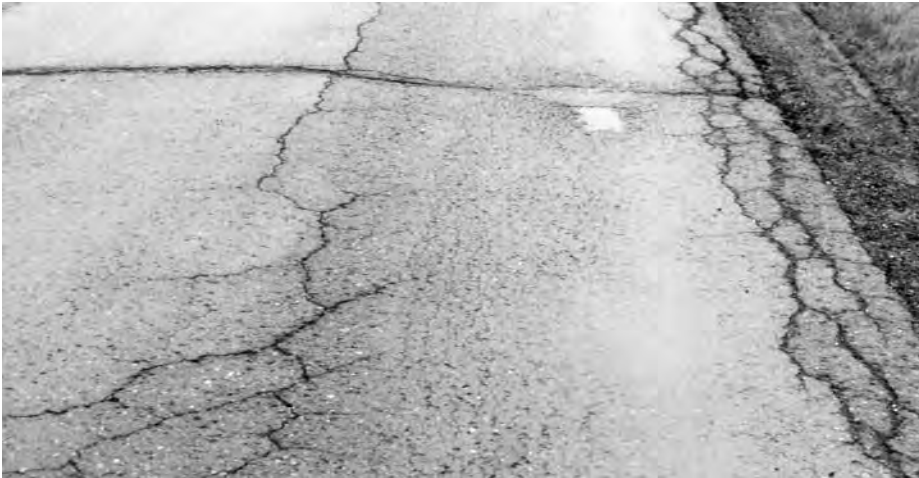
Edge cracking from weakened subbase and traffic loads. ▼

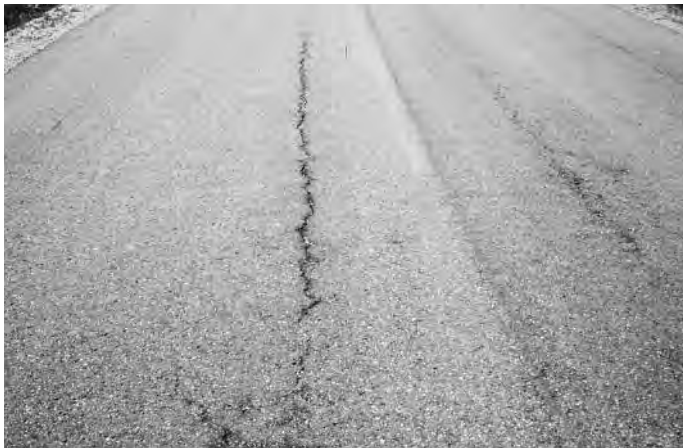
▶ First stage of wheelpath cracking caused by heavy traffic loads.

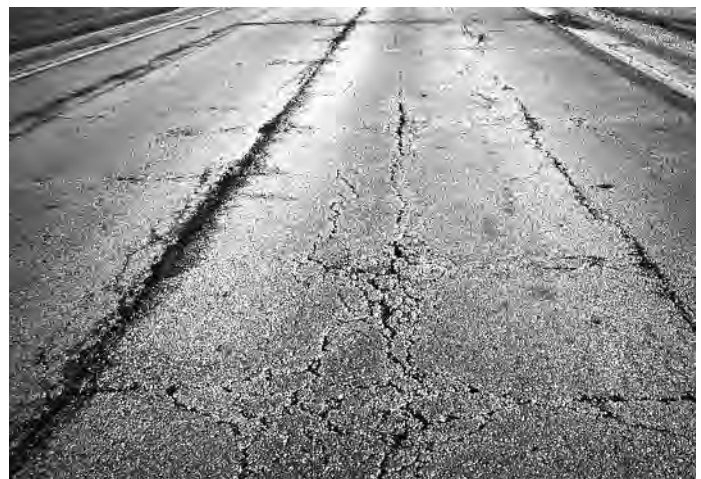
Multiple open, longitudinal cracks that are raveling. ▼

Filling and sealing cracks will reduce moisture penetration and prevent further subgrade weakening. Multiple longitudinal cracks in the wheel path or pavement edge indicate a need for strengthening with an overlay or reconstruction.

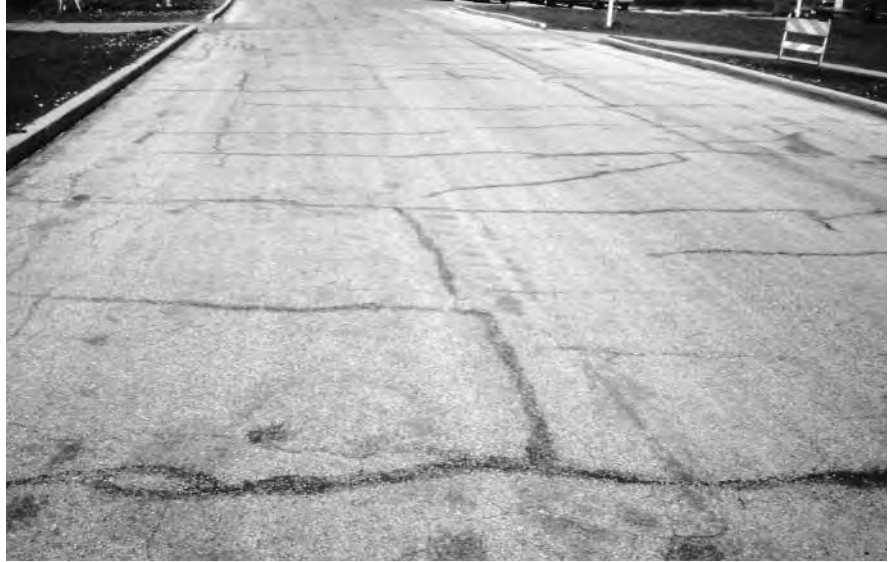
▶
Large blocks, approximately 10' across.

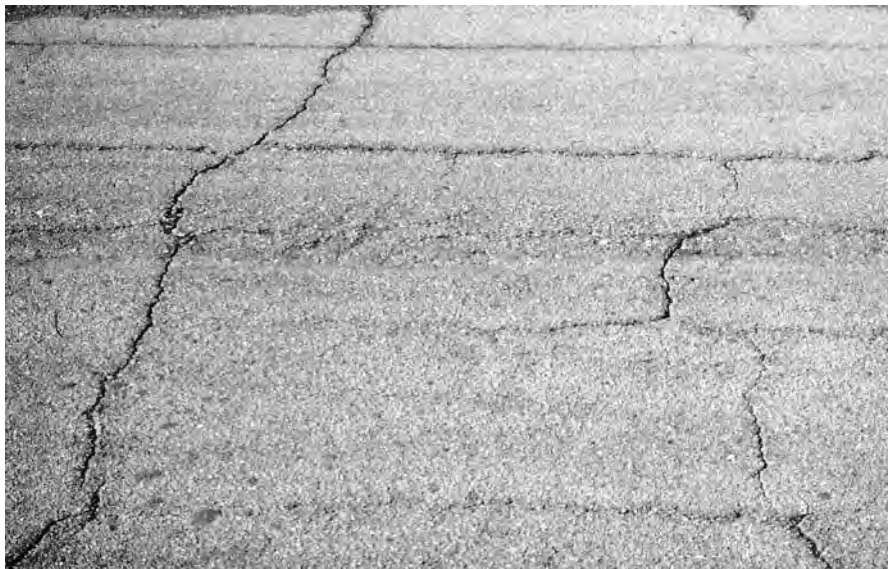
▶
Intermediate-size block cracking, 1'-5' across with open cracks.

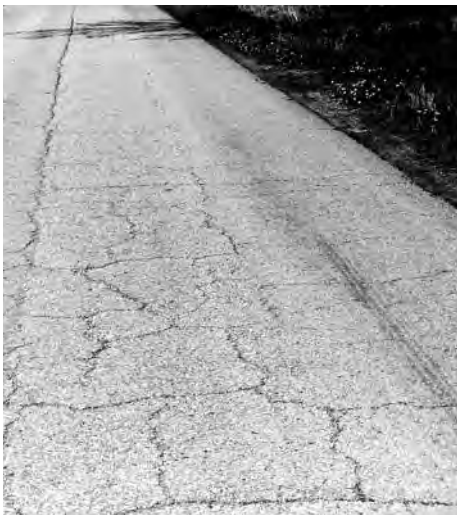
▲ **Extensive block cracking in an irregular pattern.**

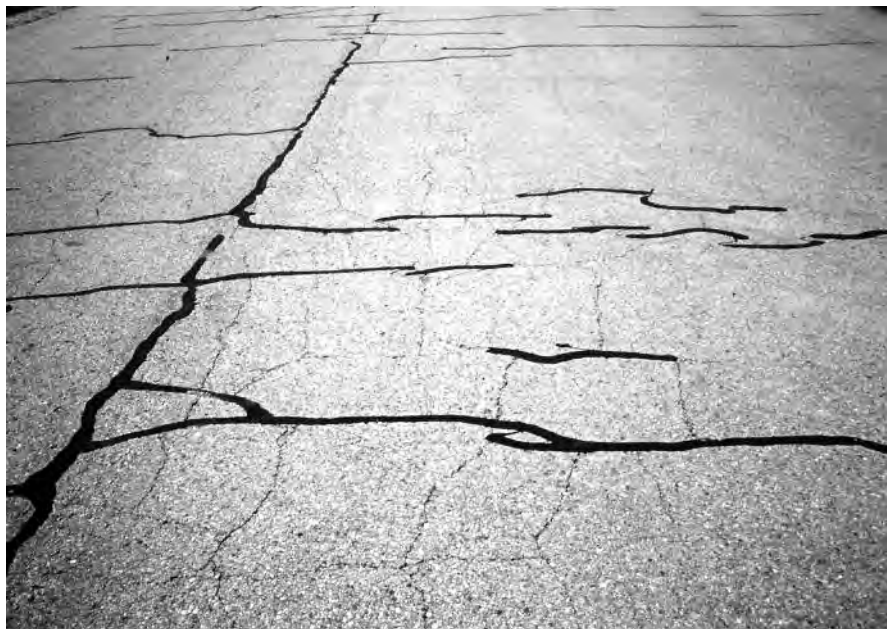
▶
Severe block cracking – 1' or smaller blocks. Tight cracks with no raveling.

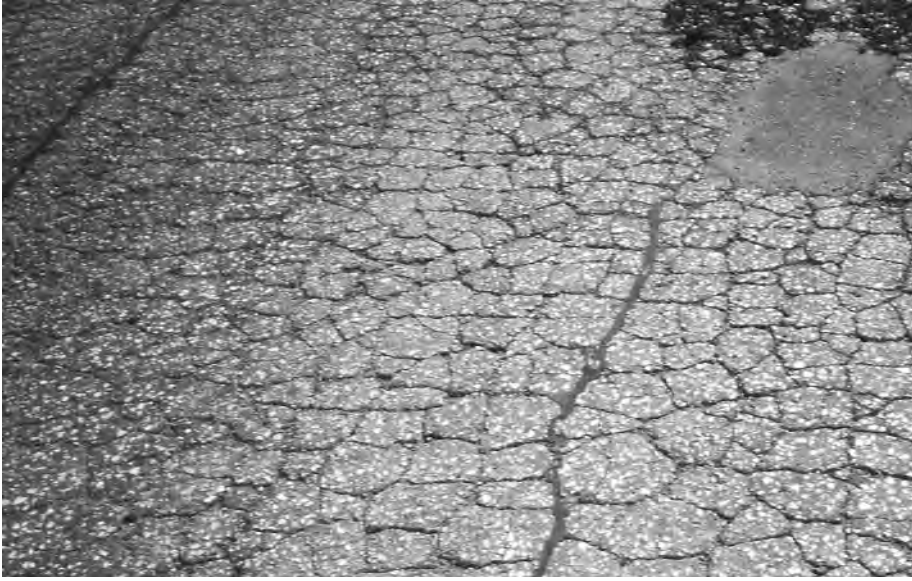
◀
Alligator crack pattern. Tight cracks and one patch.

Interconnected cracks forming small pieces ranging in size from about 1" to 6". This is caused by failure of the surfacing due to traffic loading (fatigue) and very often also due to inadequate base or subgrade support. Repair by excavating localized areas and replacing base and surface. Large areas require reconstruction. Improvements in drainage may often be required.

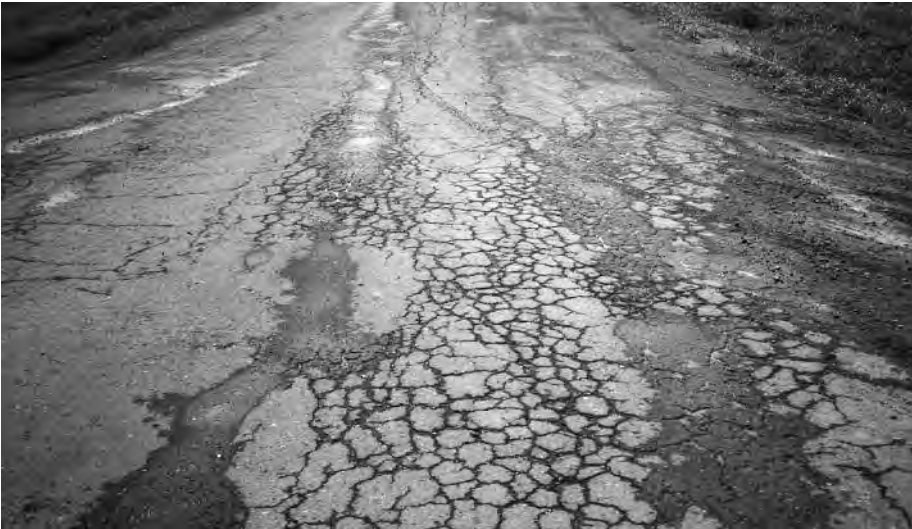
◀
Characteristic "chicken wire" crack pattern shows smaller pavement pieces and patching.

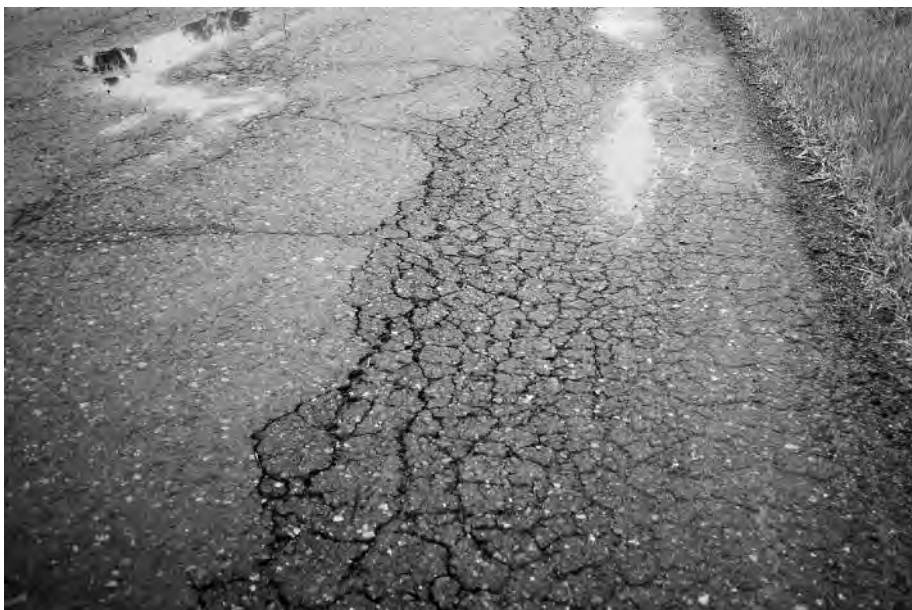
◀
Open raveled alligator cracking with settlement along lane edge most likely due to very soft subgrade.

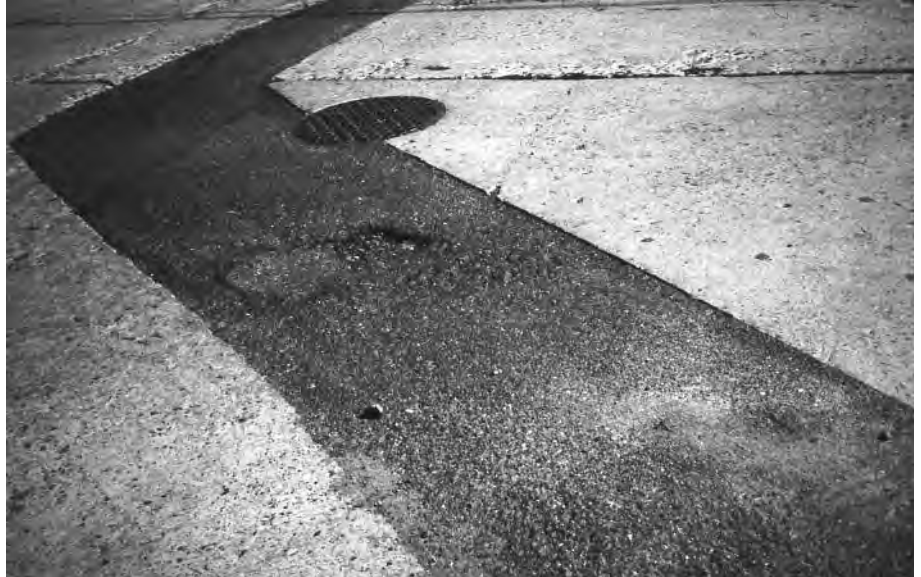
►
Typical repair of utility excavation. Patch in fair to good condition.

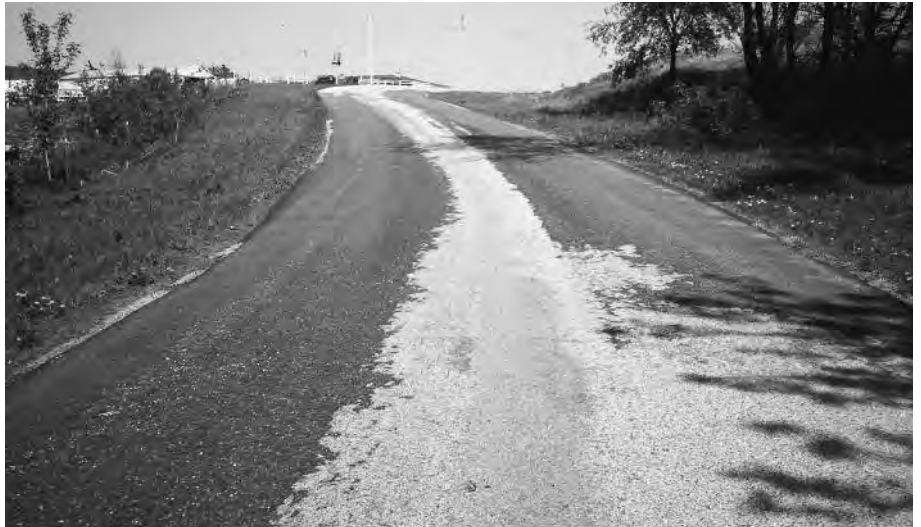
►
Edge wedging. Pavement edges strengthened with wedges of asphalt. Patch is in very good condition.

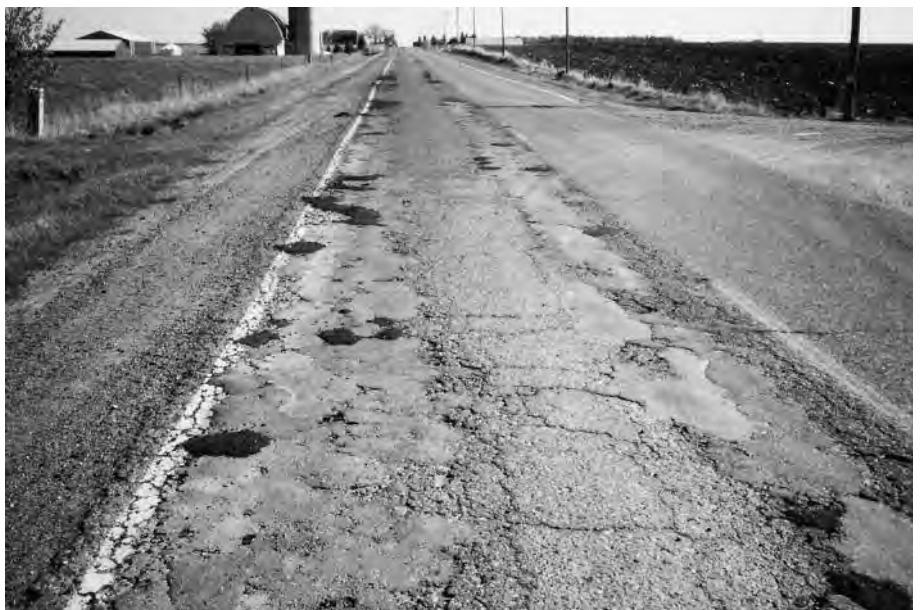
►
Extensive patching in very poor condition.

Original surface repaired with new asphalt patch material. This indicates a pavement defect or utility excavation which has been repaired. Patches with cracking, settlement or distortions indicate underlying causes still remain. Recycling or reconstruction are required when extensive patching shows distress.

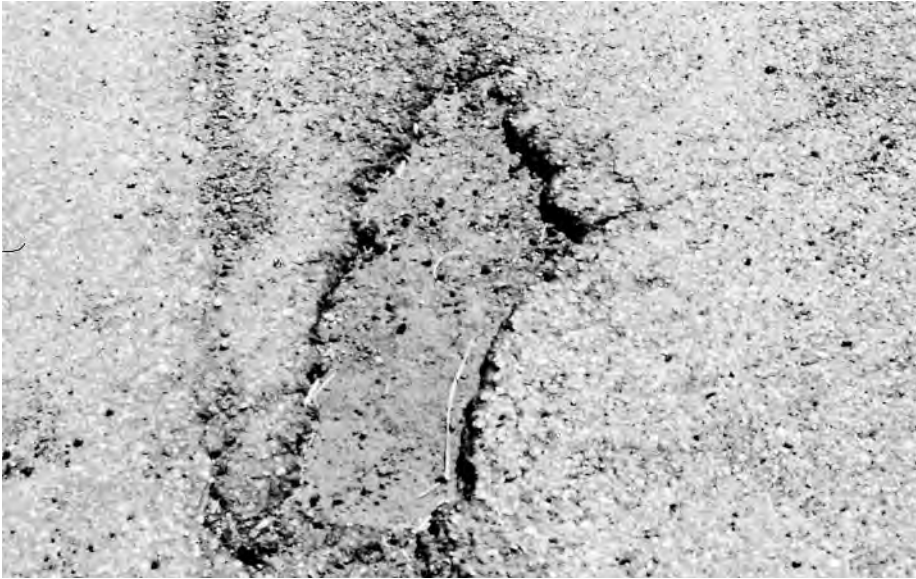
◀
Small pothole where top course has broken away.

Holes and loss of pavement material caused by traffic loading, fatigue and inadequate strength. Often combined with poor drainage. Repair by excavating or rebuilding localized potholes. Reconstruction required for extensive defects.

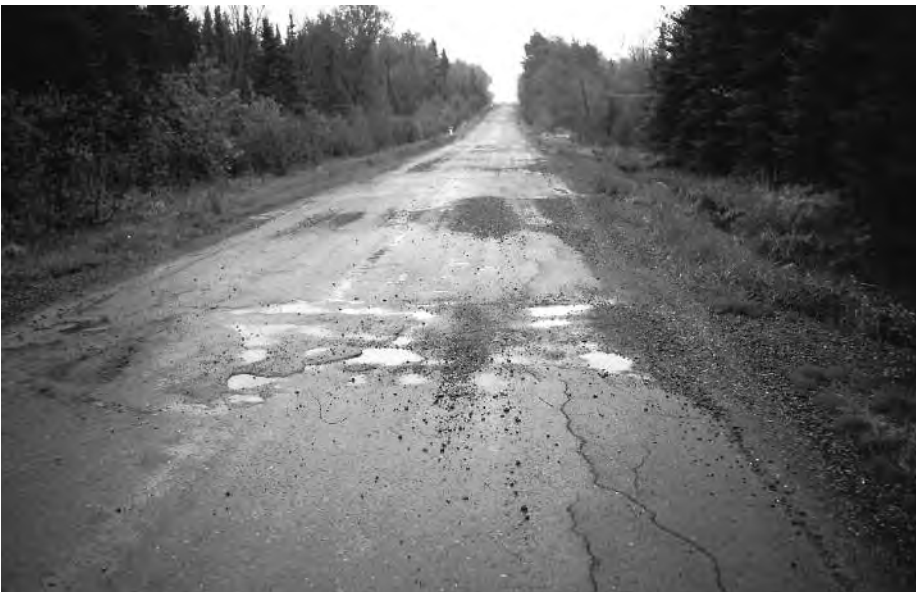
◀
Multiple potholes show pavement failure, probably due to poor subgrade soils, frost heave, and bad drainage.

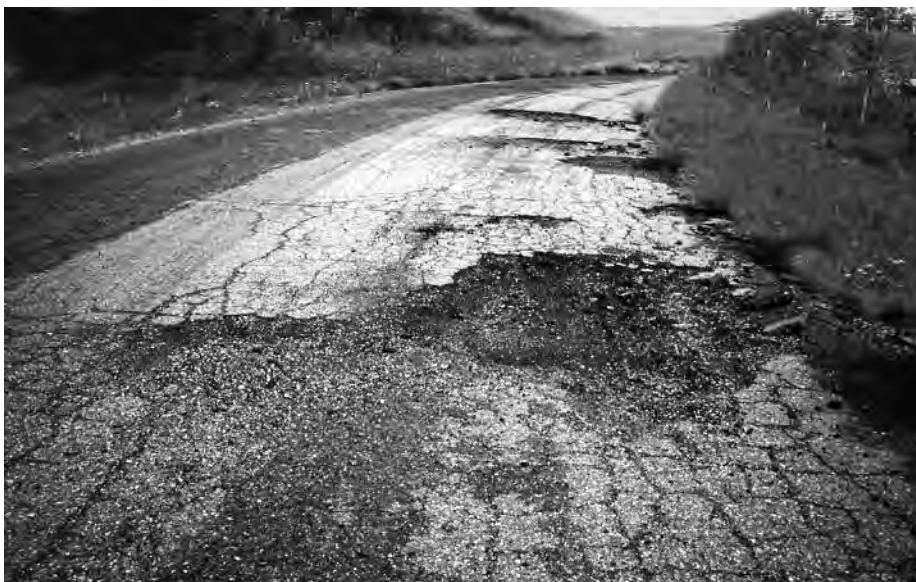
◀
Large, isolated potholes extend through base. Note adjacent alligator cracks which commonly deteriorate into potholes.

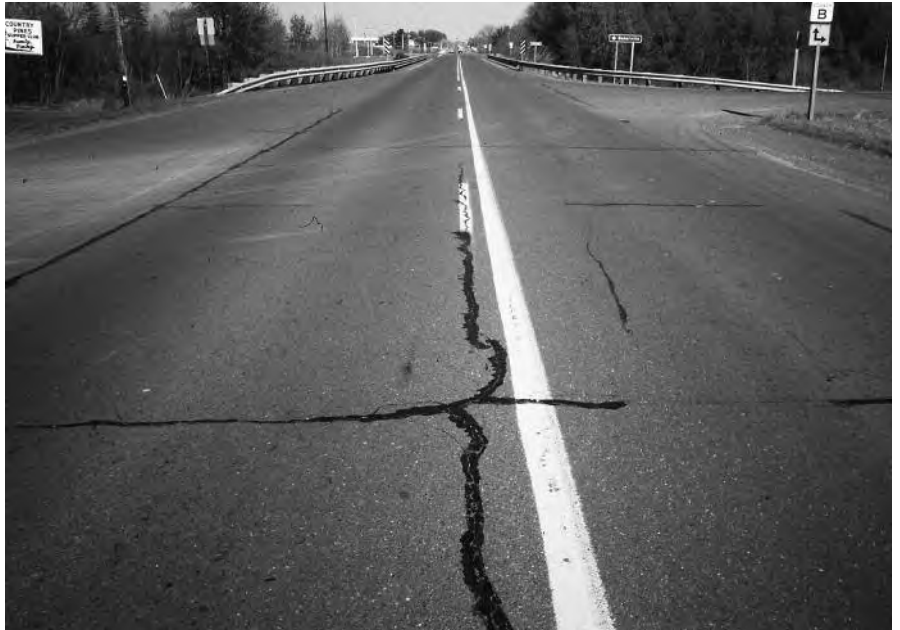
► **Tight longitudinal crack and sealed transverse cracks.**

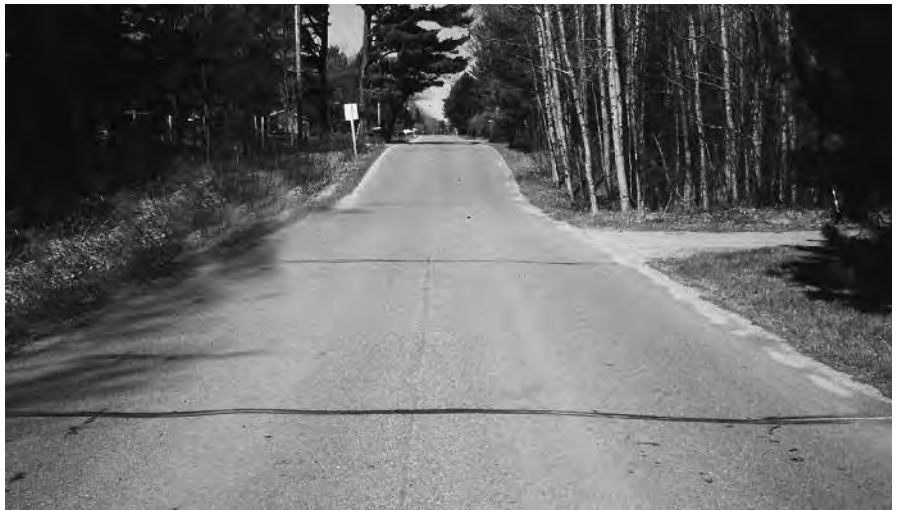
► **Transverse cracks about 10' or more apart. Maintain crack sealing program.**

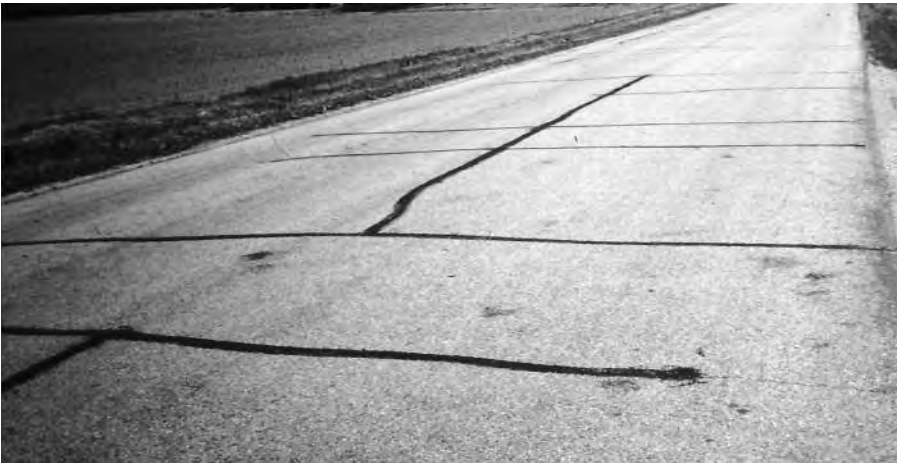
◀ **Slight surface raveling with tight cracks, less than 10' apart.**

◀ **Transverse cracks less than 10' apart; cracks well-sealed.**

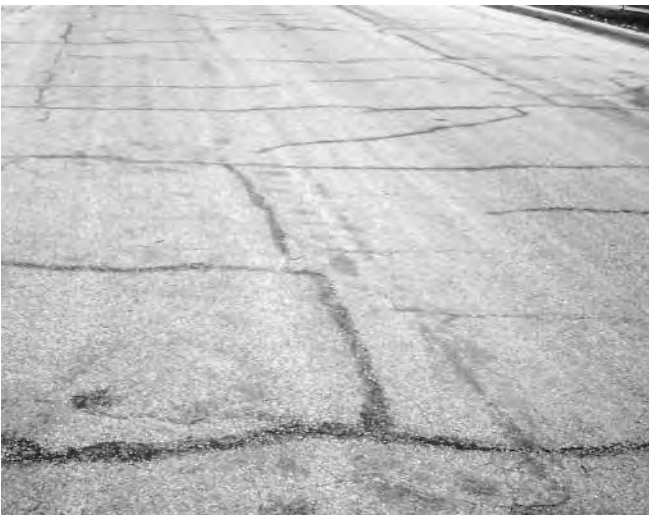
▼ **Large blocks, early signs of raveling and block cracking.**

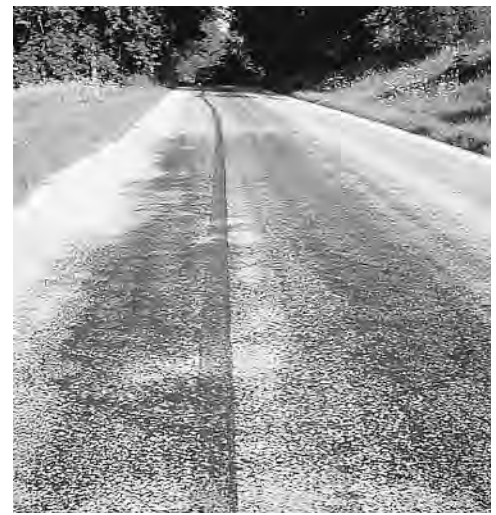
▼ **Moderate flushing.**

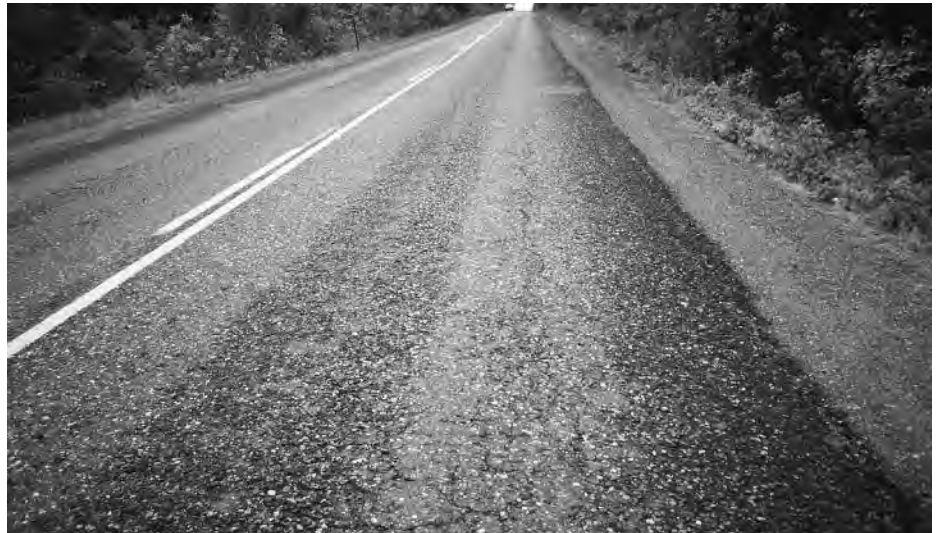
► Moderate to severe raveling in wheel paths.

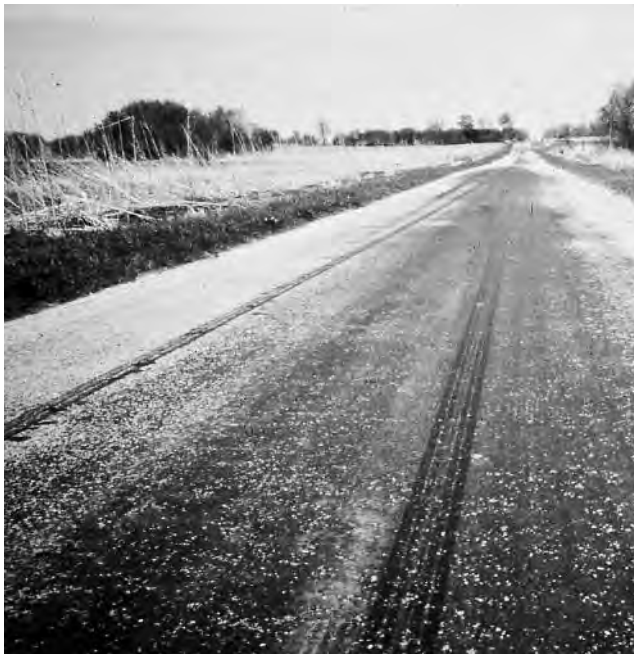
▼ Severe flushing.

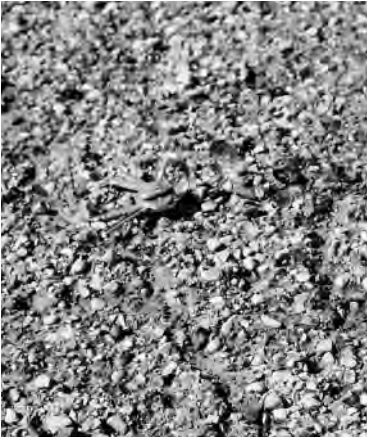
Severe raveling with
▼ extreme loss of aggregate.
