Treasure State Acres Road Maintenance Plan

DRAFT 2015 REPORT

**Lewis & Clark County
Public Works Department
and
Treasure State Acres Homeowners Assoc.**

Robert Peccia & Associates
Helena & Kalispell, Montana
RPA Project: 14513.000

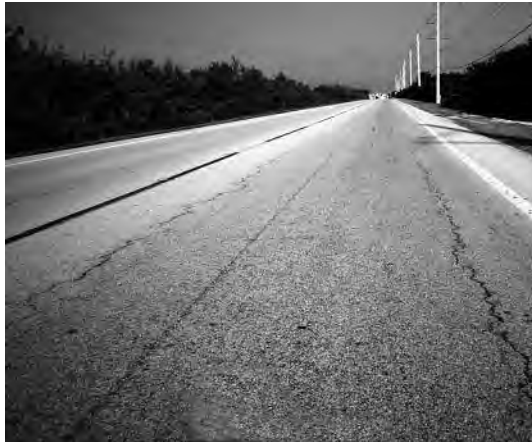
Load cracking and slight
▼ rutting in wheel path.

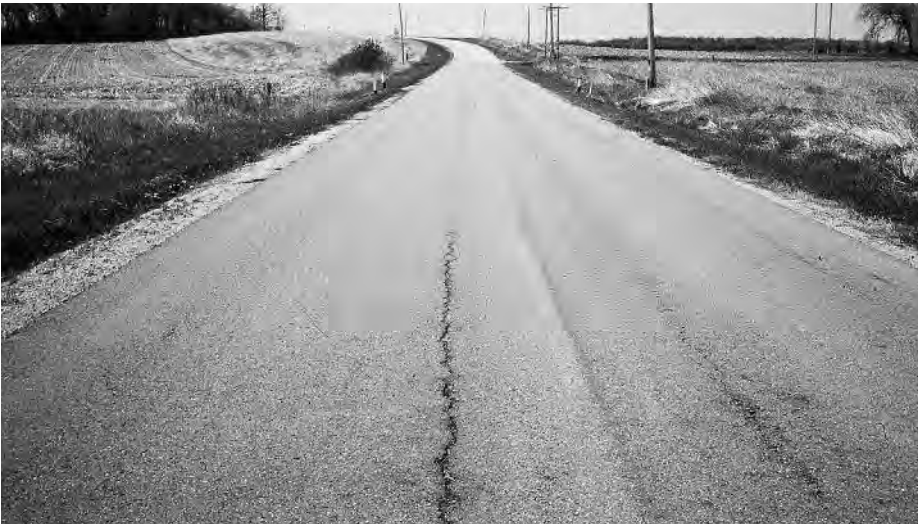
◀ **Longitudinal cracking; early load-related distress in wheel path. Strengthening needed.**

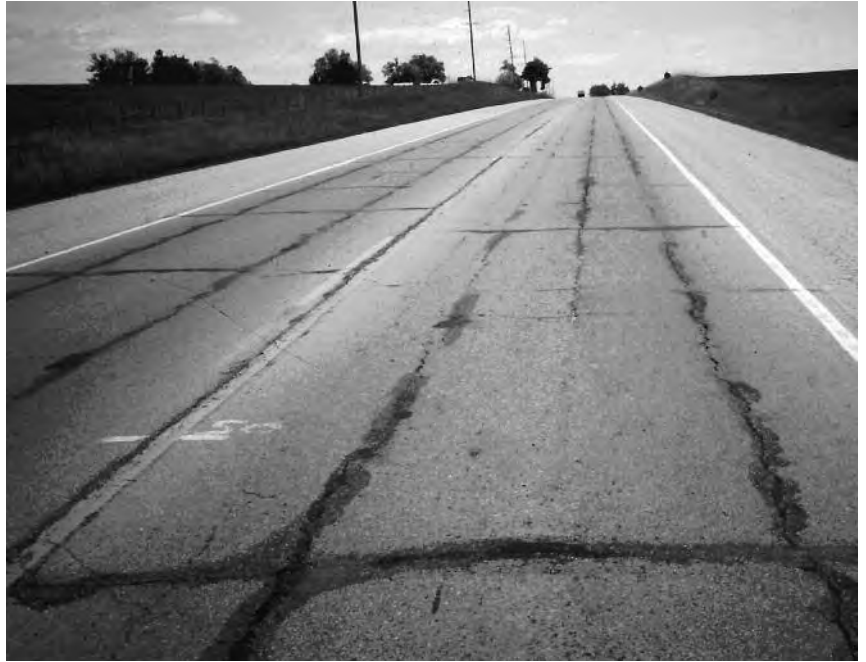
►
Many wide and raveled cracks indicate need for milling and overlay.

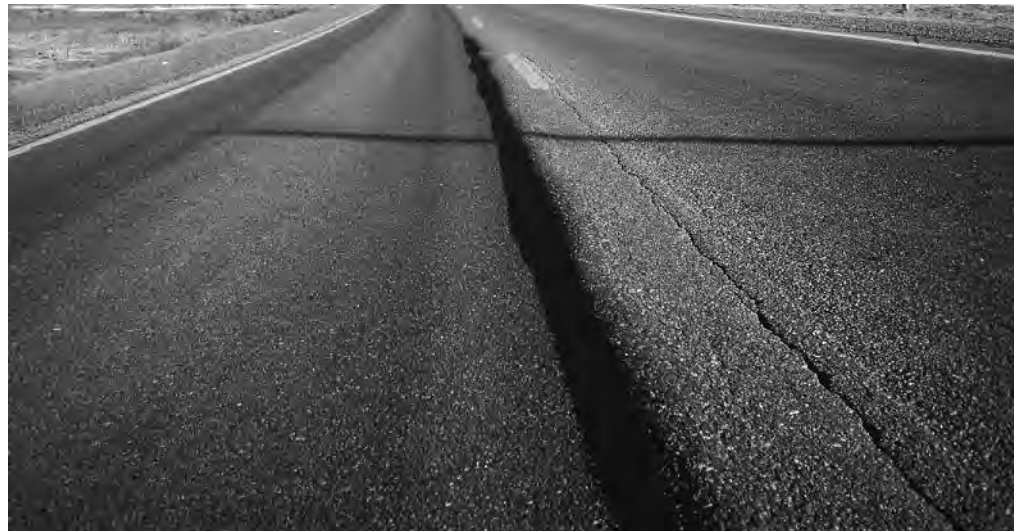
►
Ruts need mill and overlay.

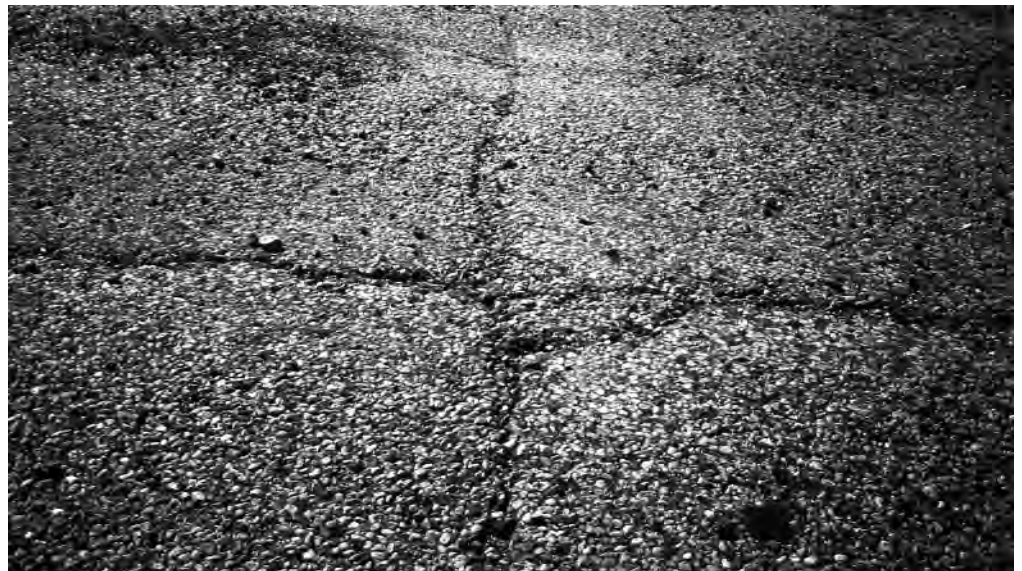
►
Open and raveled block cracks.

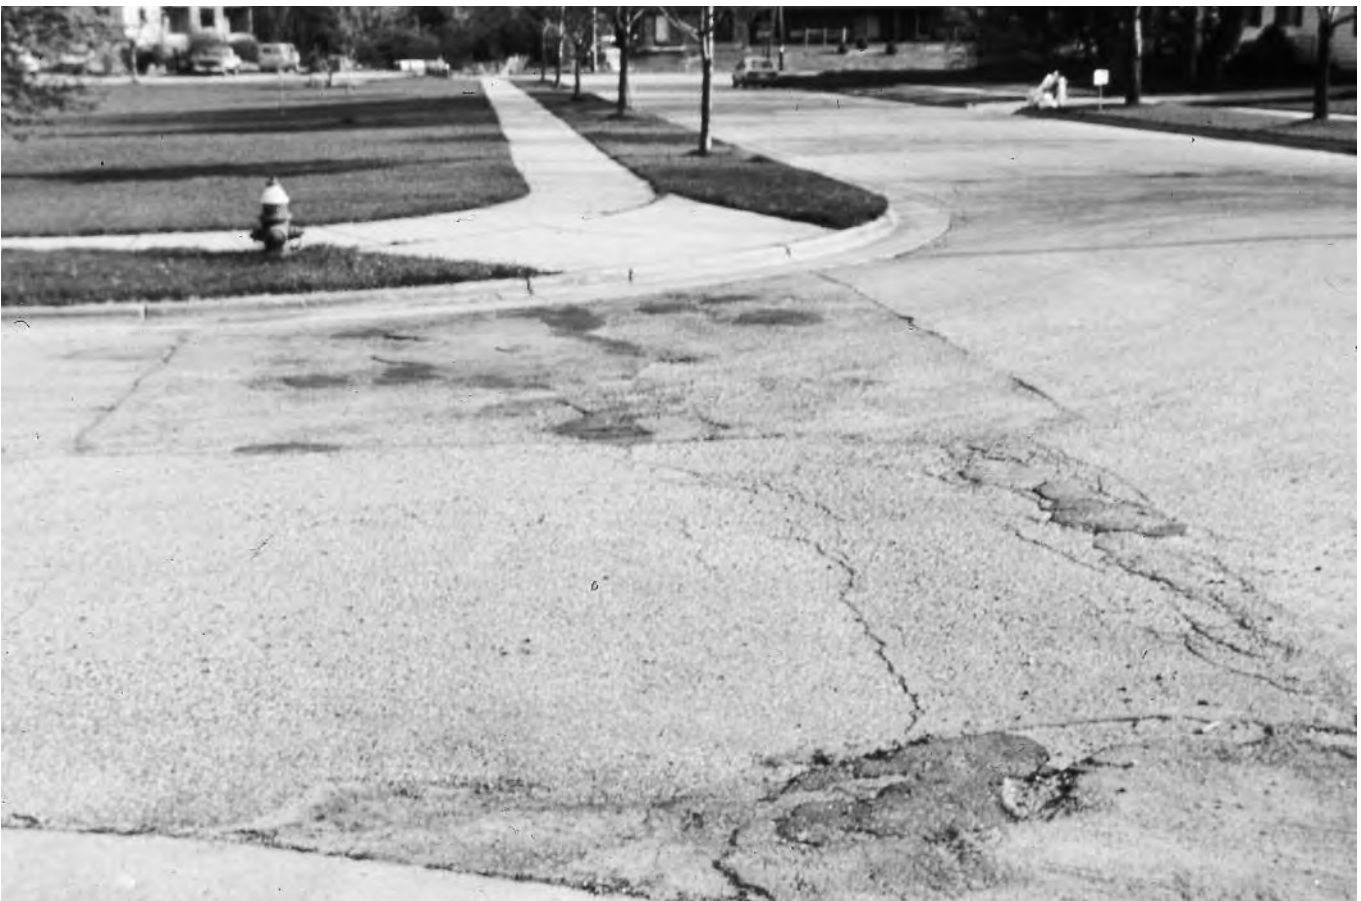
▼ **Distortion with patches**
in poor condition. Repair
and overlay.

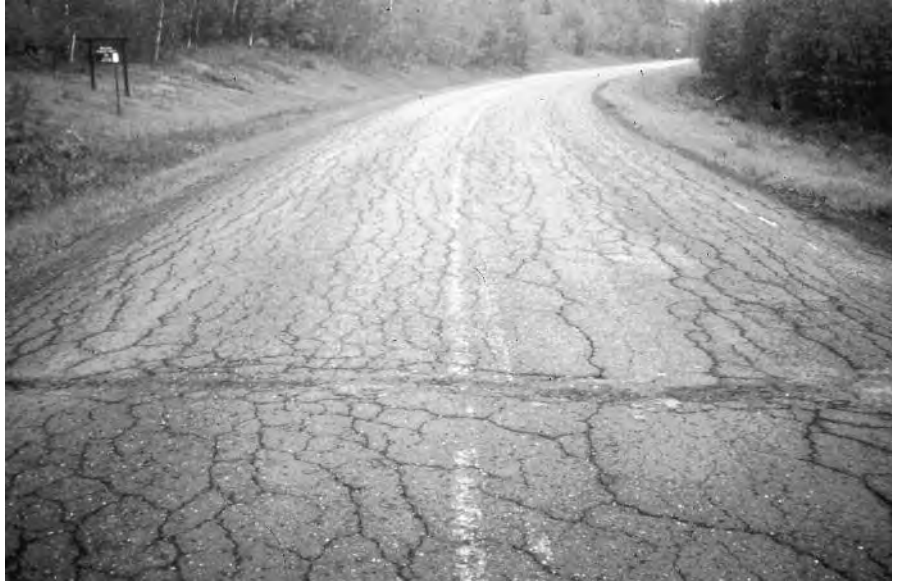
► **Extensive alligator cracking. Pulverize and rebuild.**

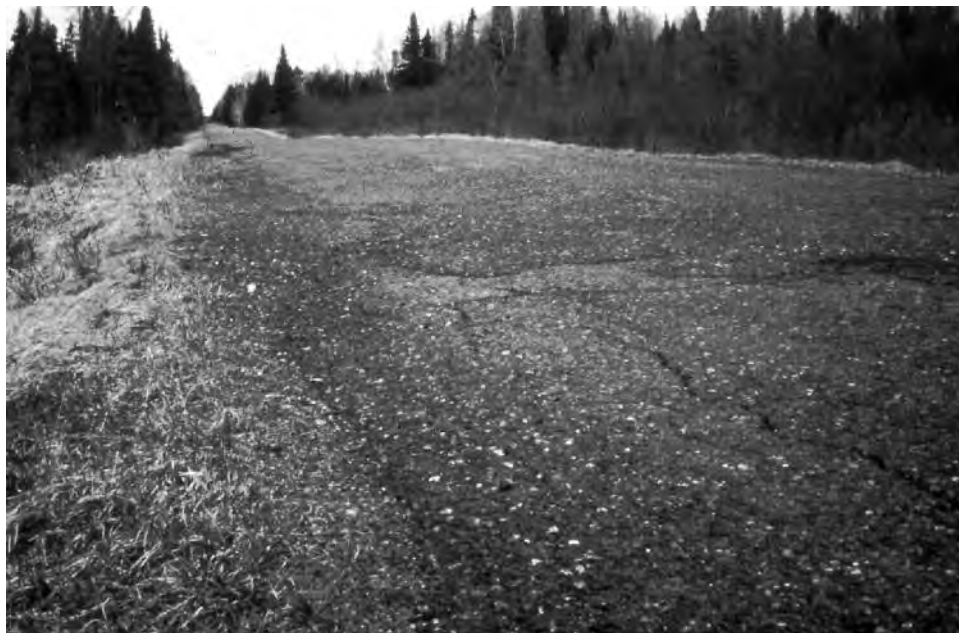
► **Severe frost damage. Reconstruct.**

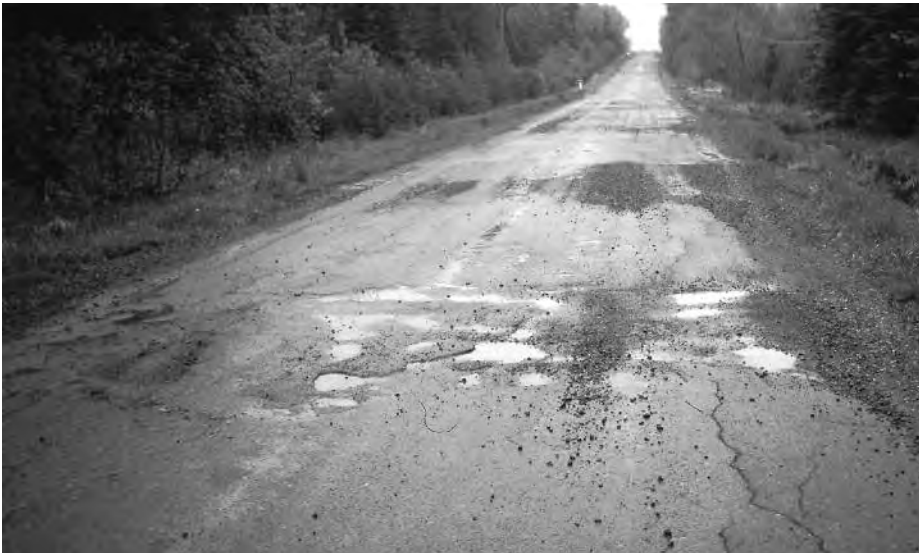
▲ **Severe rutting. Strengthen base and reconstruct.**

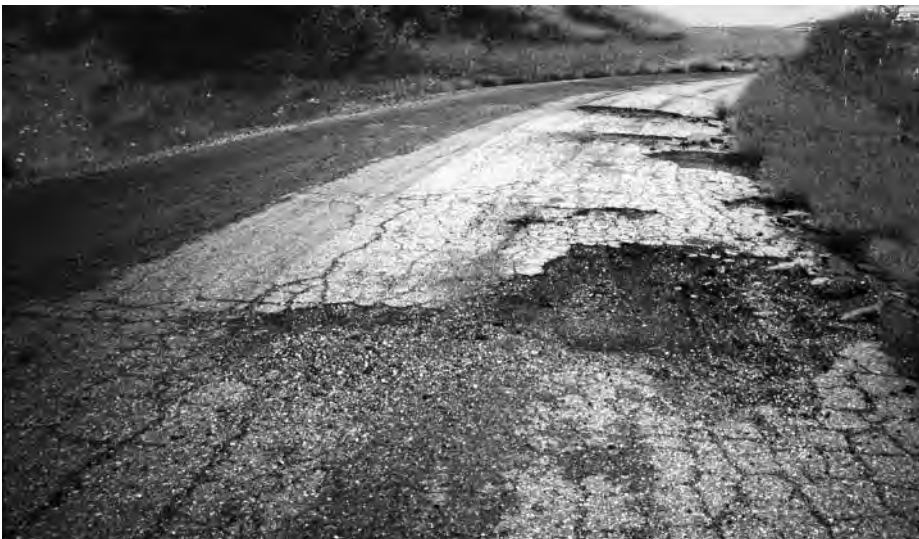
Potholes from frost damage. Reconstruct.

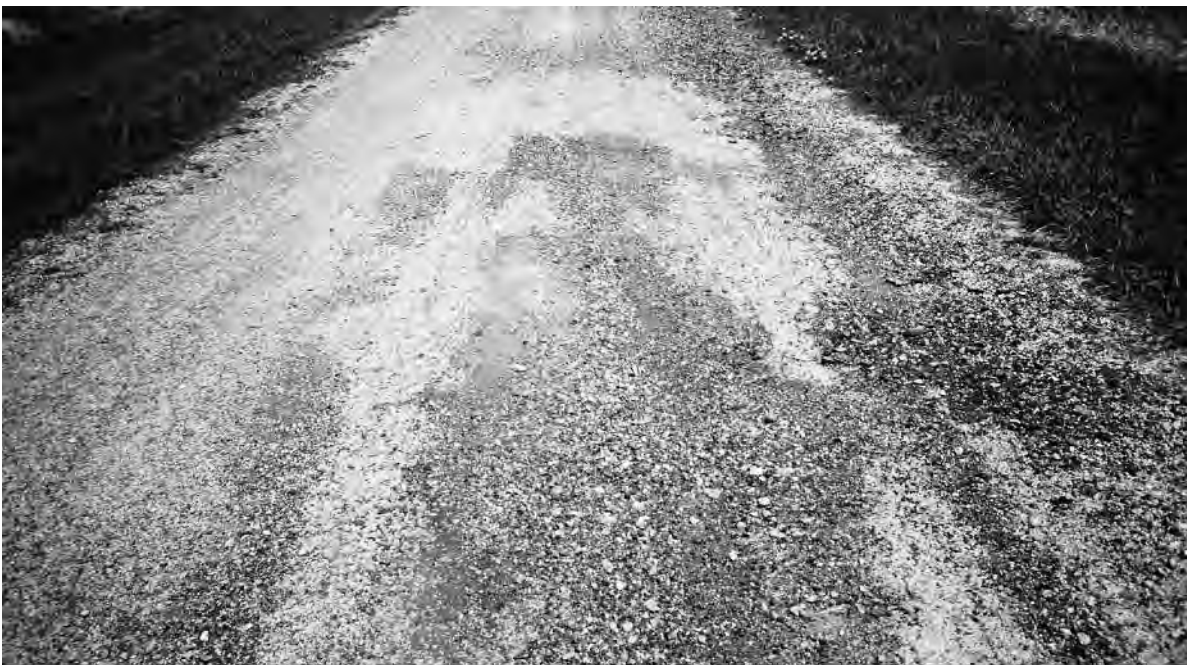
Potholes and severe alligator cracking. Failed pavement. Reconstruct.

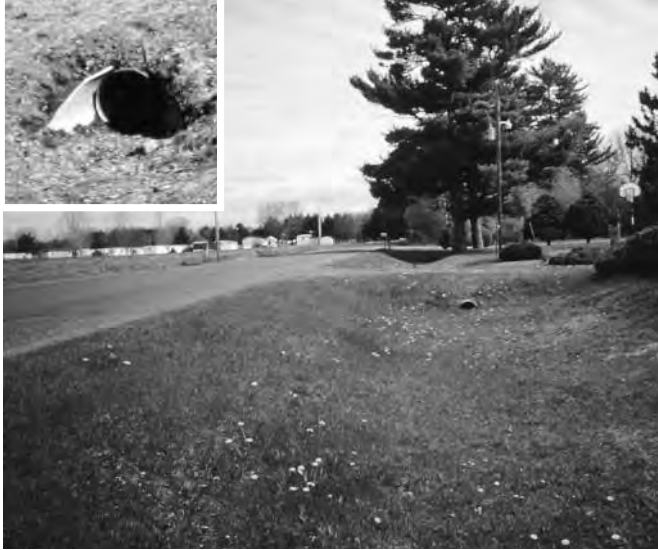
RATING: Good

Good rural ditch and driveway culvert. Culvert end needs cleaning.

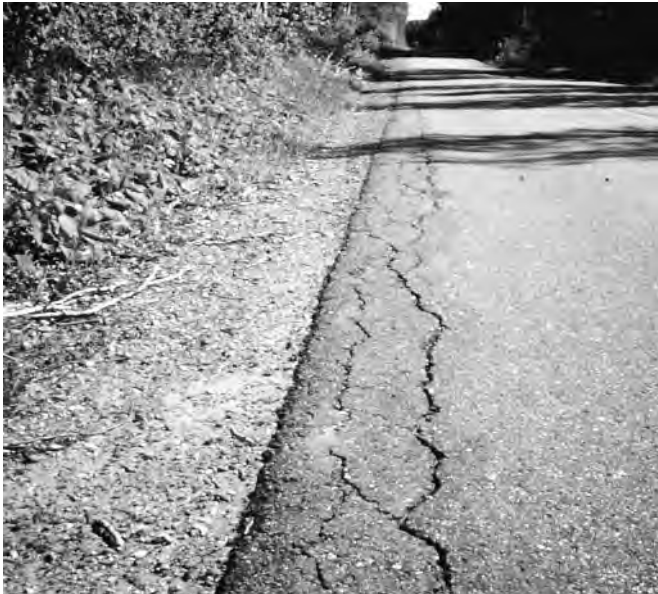
RATING: Fair

High shoulder and no ditch lead to pavement damage. Needs major ditch improvement for a short distance.

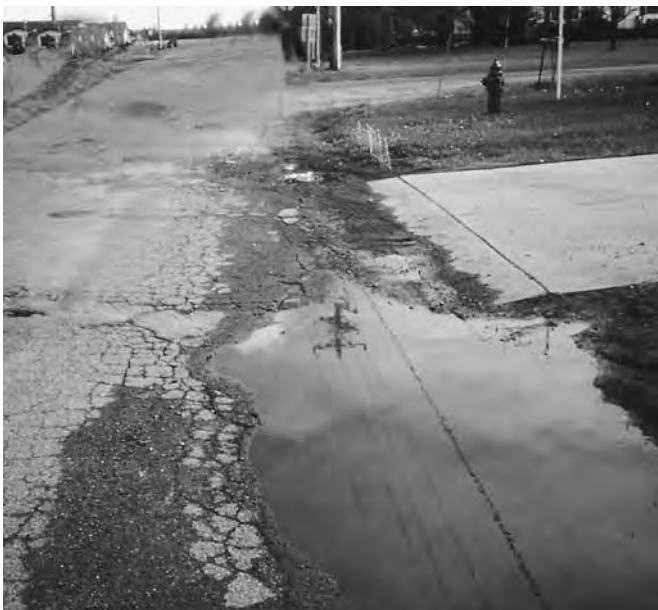
RATING: Poor

No drainage leads to failed pavement.
